## FIELD INSPECTION REPORT

| Project Name: | Mountain Valley Pipeline | Inspector: | Marshall Willis |
| Inspection Date: | Thursday, July 20, 2023 | Project Contact: | Brian Clauto, Cory Chalmers |
| Spread I:<br>Franklin County | STA 13632+25 – 13690+91 | Weather: | Wet |

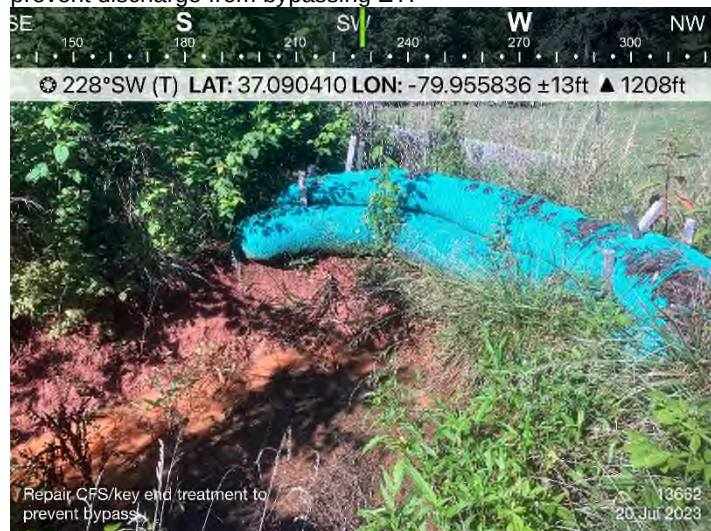
**Figure 1: STA 13662+00** – Repair CFS ET and key into WB to prevent discharge from bypassing ET.

- STA 13662+00: Repair CFS ET and key into WB to prevent discharge from bypassing ET.

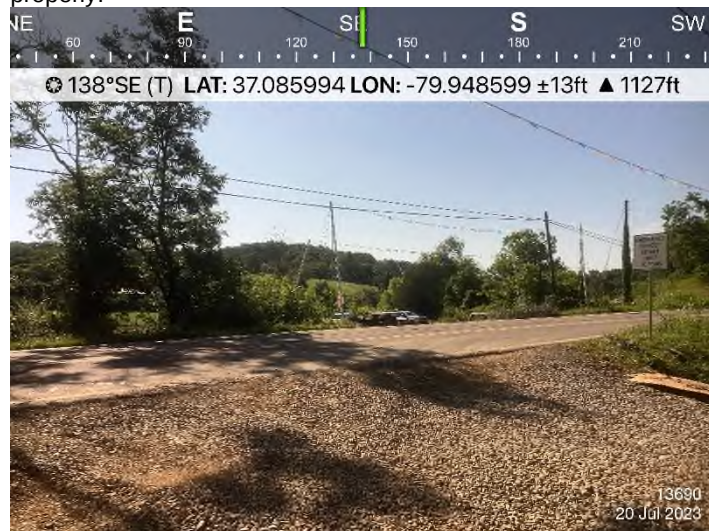
**Figure 2: STA 13690+00** – Controls in place and functioning properly.

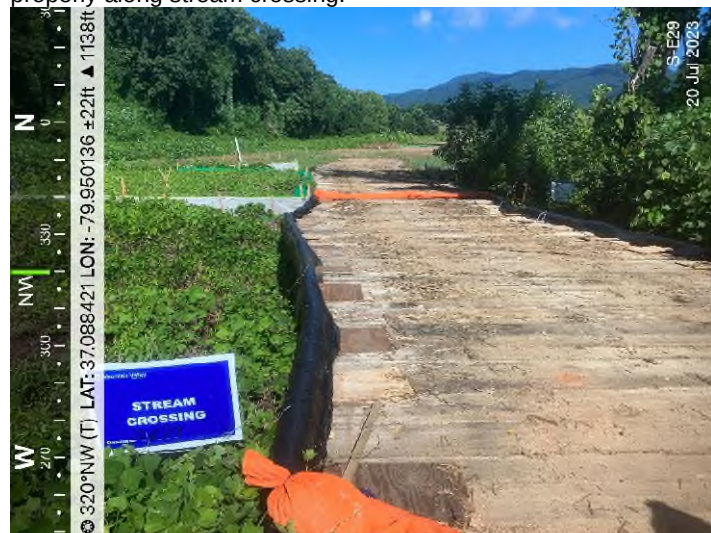
**Figure 3: Stream S-E29** – Controls in place and functioning properly along stream crossing.

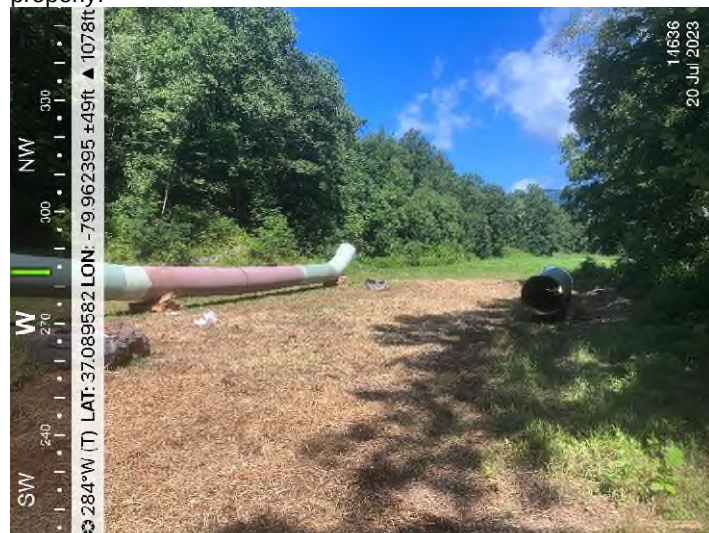
**Figure 4: STA 14636+00** – Controls in place and functioning properly.
