## FIELD INSPECTION REPORT

| Project Name: | Mountain Valley Pipeline | Inspector: | Marshall Willis |
| Spread I:<br>Franklin County | STA 13748+30 – 13786+55<br>MVP-FR-300 | Weather: | Dry |

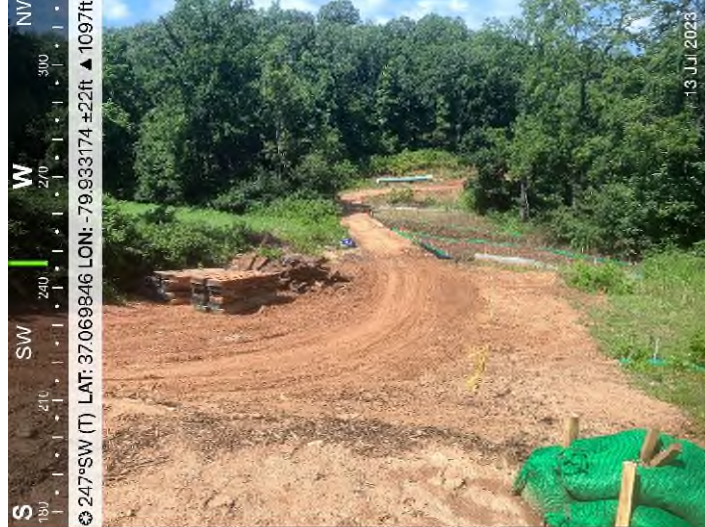
**Figure 1: STA 13783+00 – Controls in place and functioning properly.**

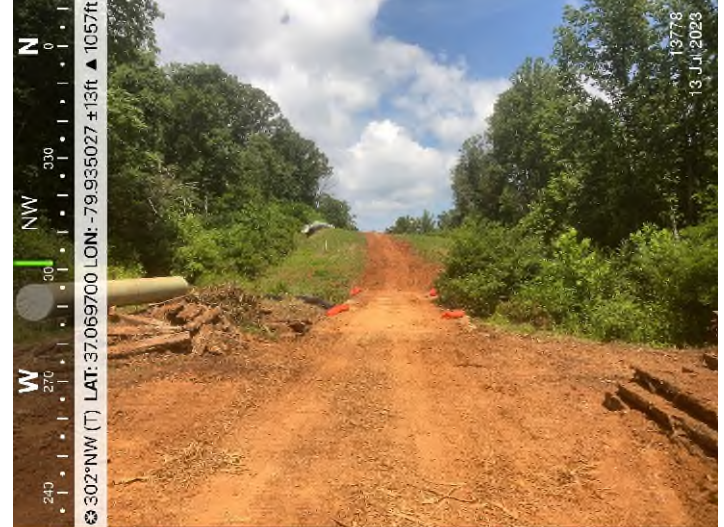
**Figure 2: STA 13778+00 – Controls in place and functioning properly.**

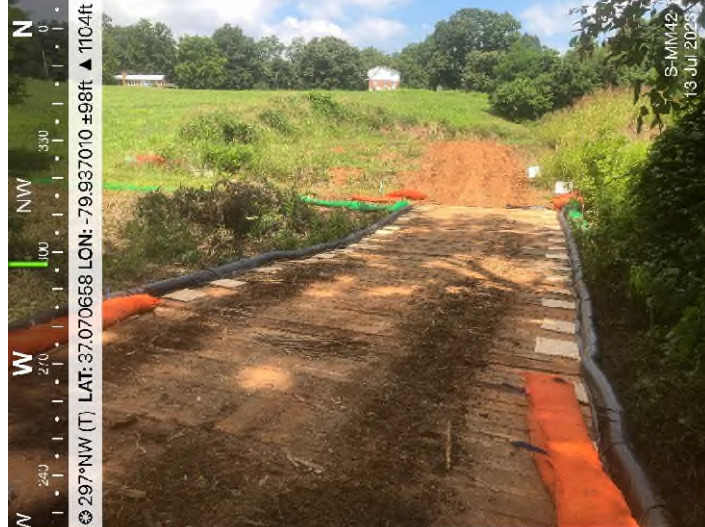
**Figure 3: Stream S-MM42 - Controls in place and functioning properly.**

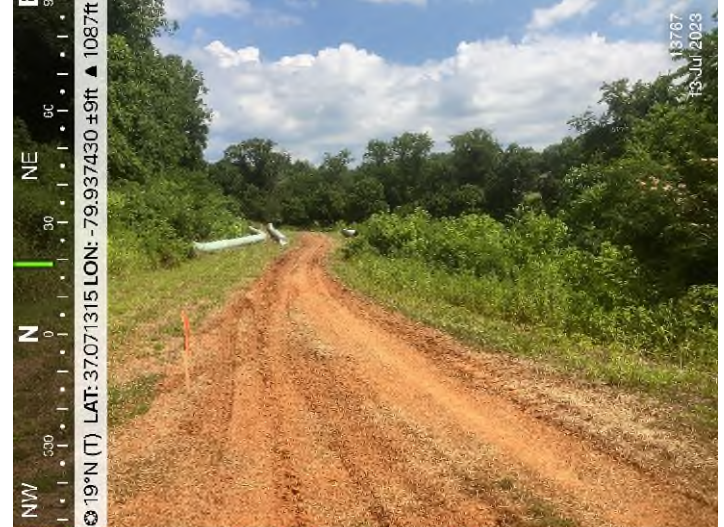
**Figure 4: STA 13767+00 – Controls in place and functioning properly.**
