FIELD INSPECTION REPORT

Project Name:	Mountain Valley Pipeline	Inspector:	Marshall Willis
Inspection Date:	Wednesday, July 19, 2023	Project Contact:	Brian Clauto, Cory Chalmers
Spread H: Franklin County	STA 13340+00 – 13345+00 STA 13260+00 – 13365+00 MVP-FR-293.01	Weather:	Wet

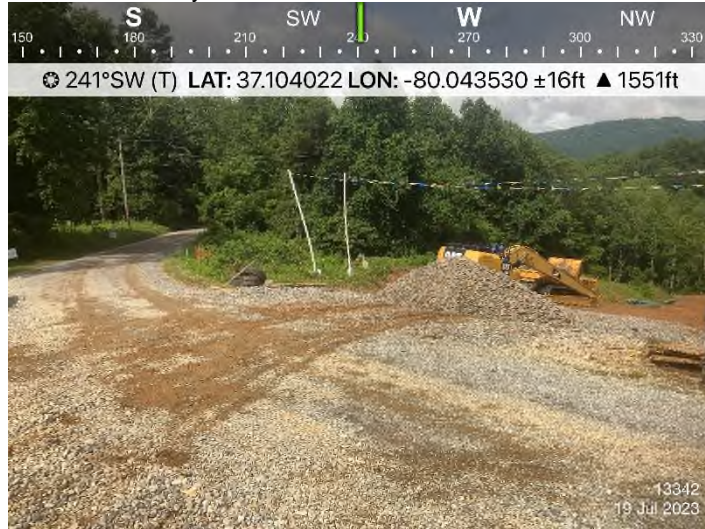
Figure 1: Websters Corner Rd. – Crews adding more stone to RCE and roadway.

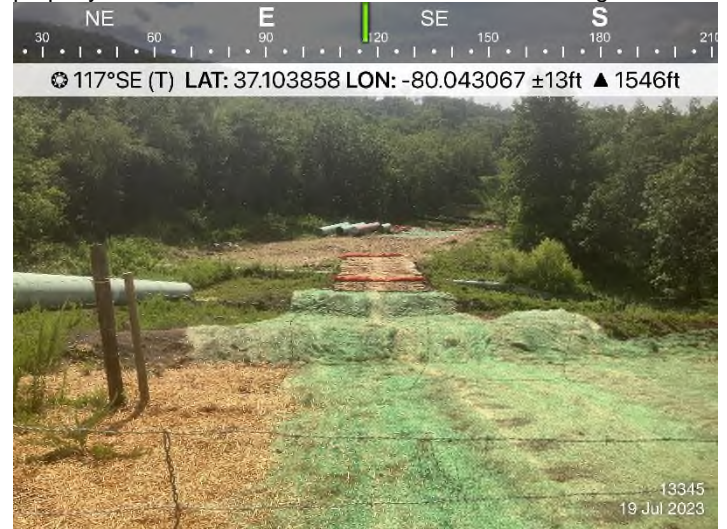
Figure 2: STA 13345+00 – Controls in place and functioning properly. Area stabilized with straw and erosion matting.

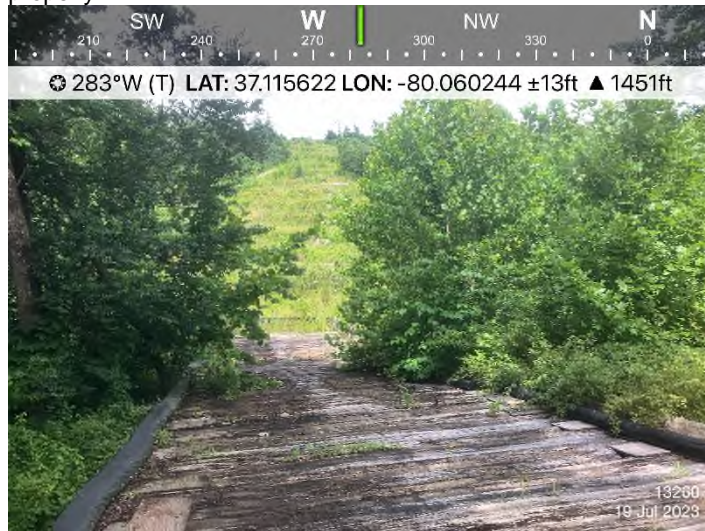
Figure 3: STA 13260+00 – Controls in place and functioning properly.

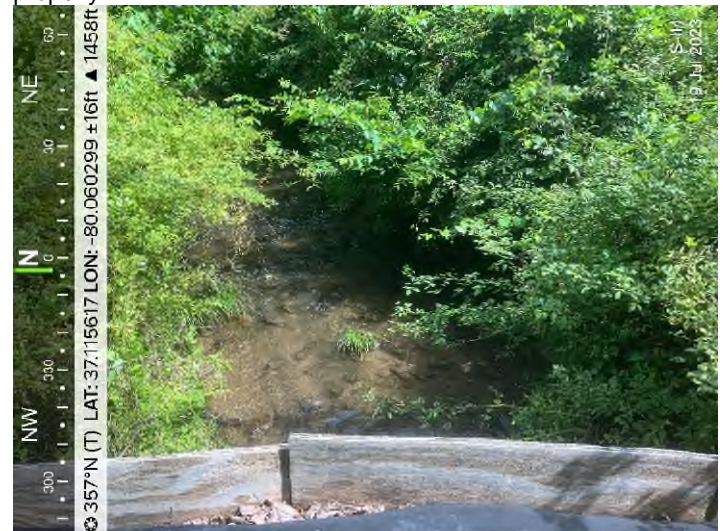
Figure 4: Stream S-II4 – Controls in place and functioning properly.
