## FIELD INSPECTION REPORT

| Project Name: | Mountain Valley Pipeline | Inspector: | Marshall Willis |
| Inspection Date: | Wednesday, July 12, 2023 | Project Contact: | Brian Clauto, Cory Chalmers |
| Spread H:<br>Montgomery County | STA 12117+00 – 12140+24<br>MVP-MN-272 | Weather: | Dry |

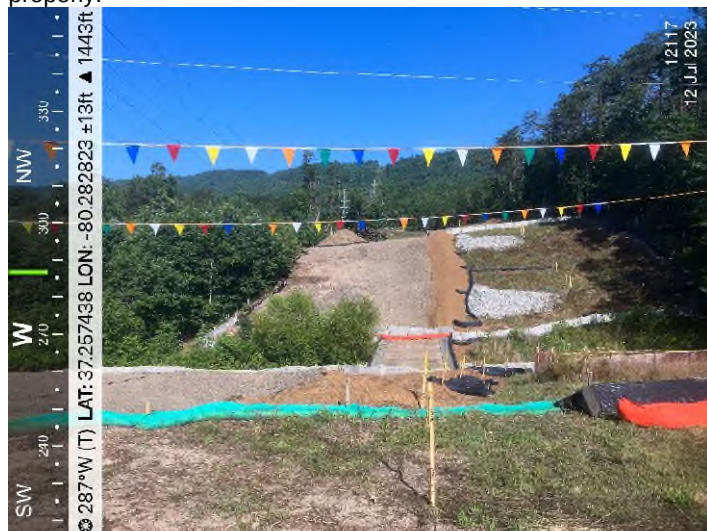
**Figure 1: STA 12117+00 – Controls in place and functioning properly.**

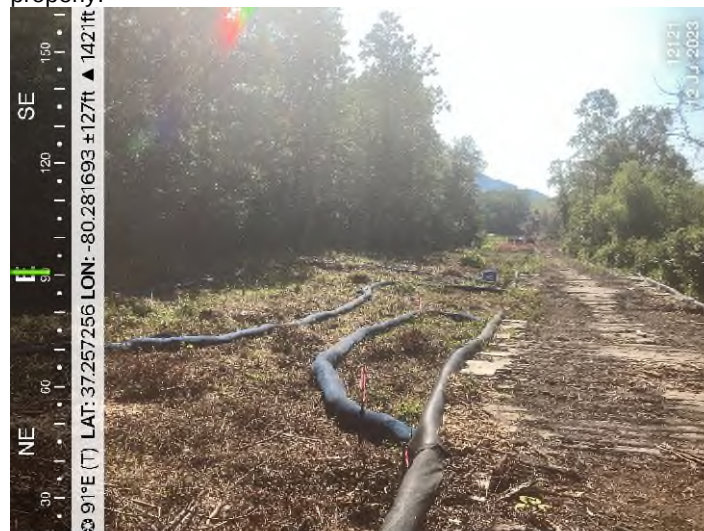
**Figure 2: STA 12121+00 - Controls in place and functioning properly.**

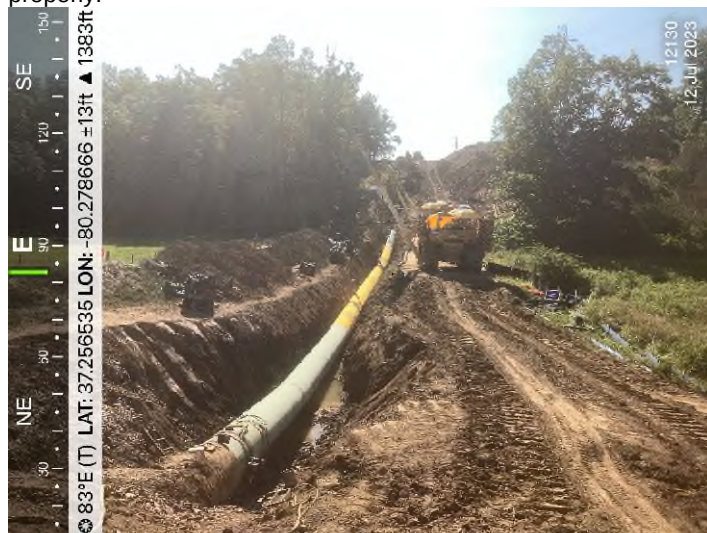
**Figure 3: STA 12130+00 - Controls in place and functioning properly.**

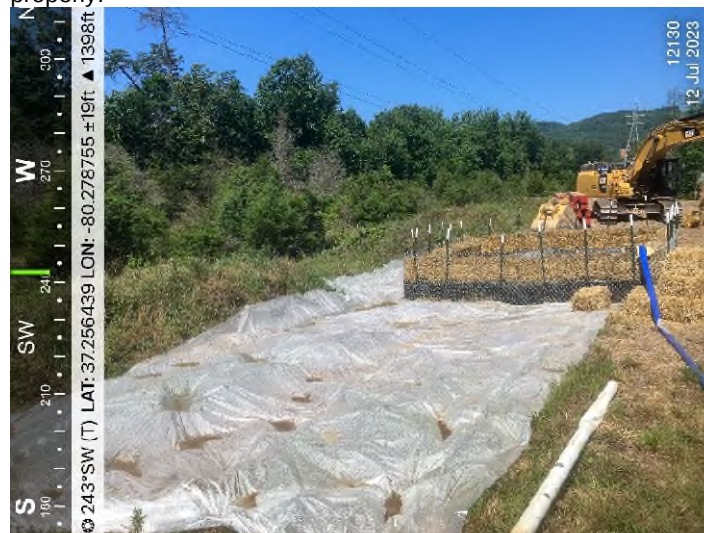
**Figure 4: STA 12129+00 - Controls in place and functioning properly.**
