## FIELD INSPECTION REPORT

| Project Name: | Mountain Valley Pipeline | Inspector: | Marshall Willis |
| Spread H:<br>Montgomery County | STA 12119+17 – 12140+24<br>MVP-MN-272 | Weather: | Dry |

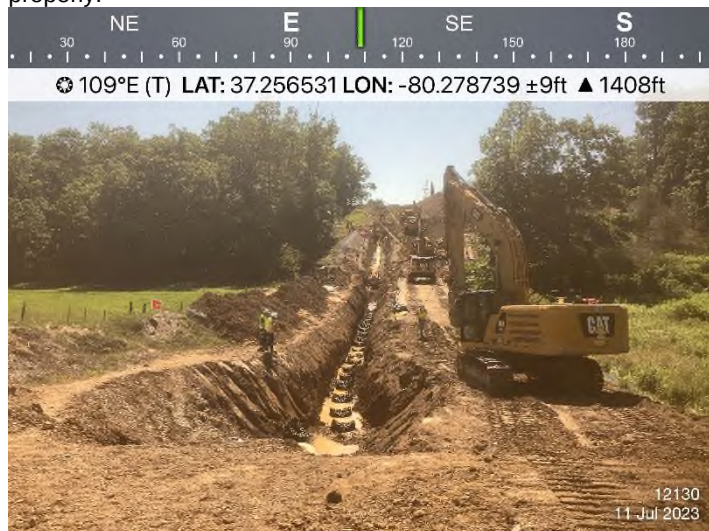
**Figure 1: STA 12130+00** – Controls in place and functioning properly.

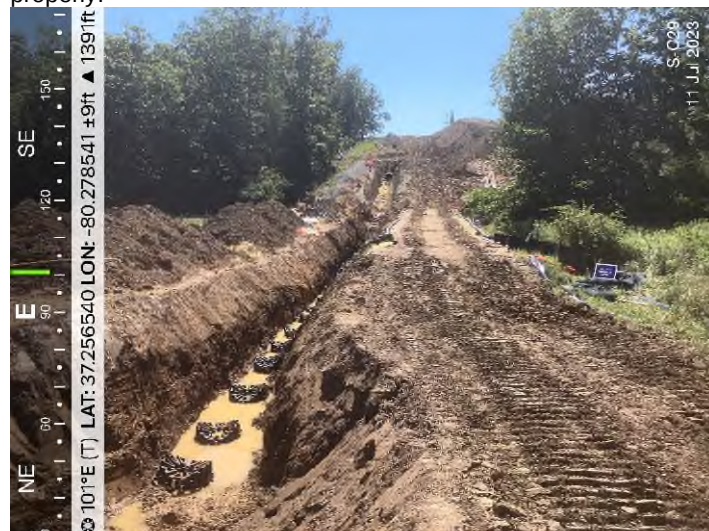
**Figure 2: Stream S-C29** – Controls in place and functioning properly.

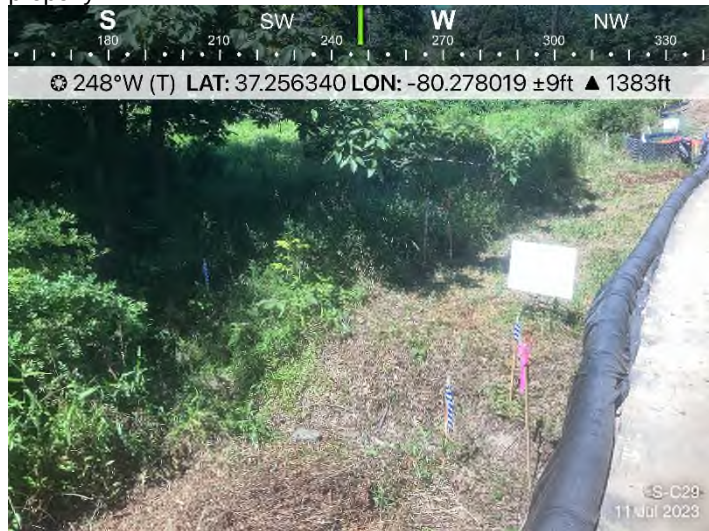
**Figure 3: Stream S-C29** - Controls in place and functioning properly.

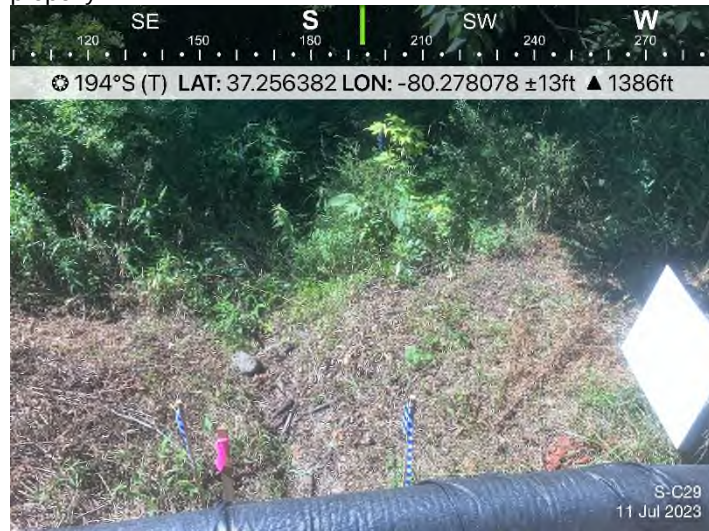
**Figure 4: Stream S-C29** - Controls in place and functioning properly.
