## FIELD INSPECTION REPORT

| <b>Project Name:</b> | Mountain Valley Pipeline | <b>Inspector:</b> | Marshall Willis |
| <b>Spread H:<br/>Montgomery County</b> | STA 12130+00 – 12140+00<br>MVP-MN-272<br>MVP-MN-275 | <b>Weather:</b> | Dry |

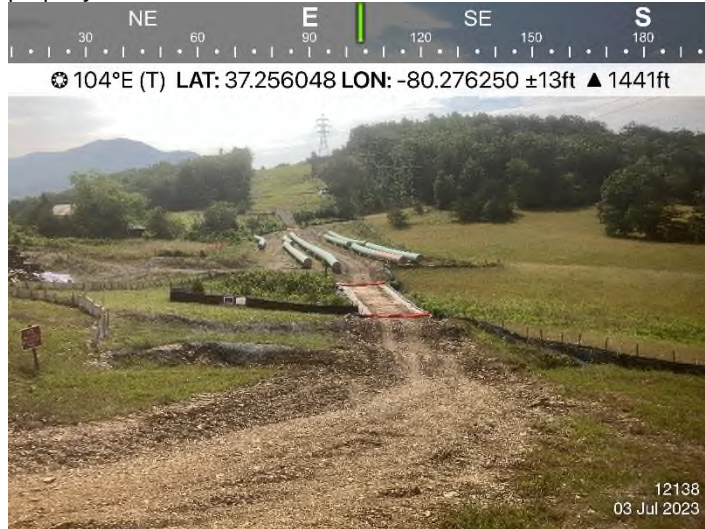
**Figure 1: STA 12138+00 – Controls in place and functioning properly.**

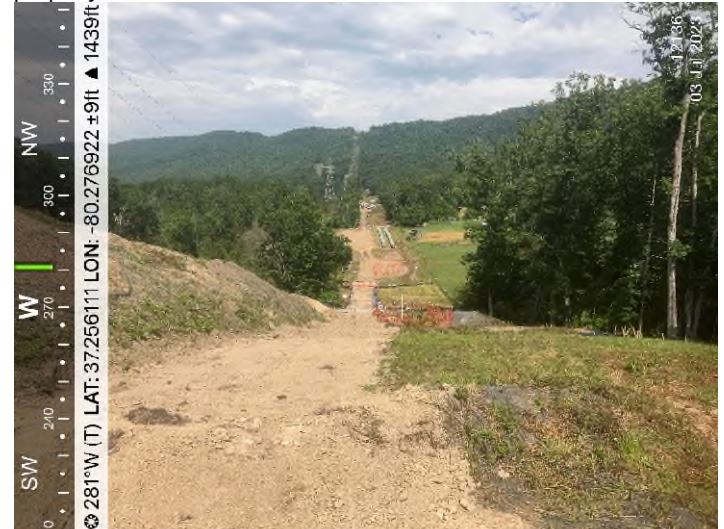
**Figure 2: STA 12136+00 – Controls in place and functioning properly.**

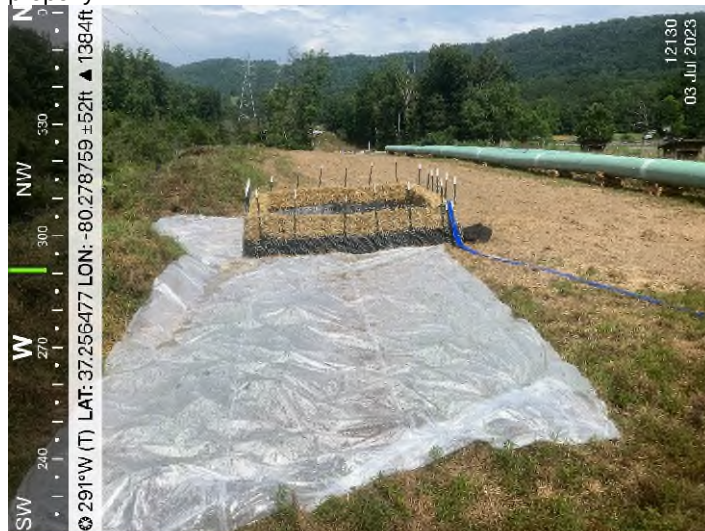
**Figure 3: STA 12130+00 – Controls in place and functioning properly.**

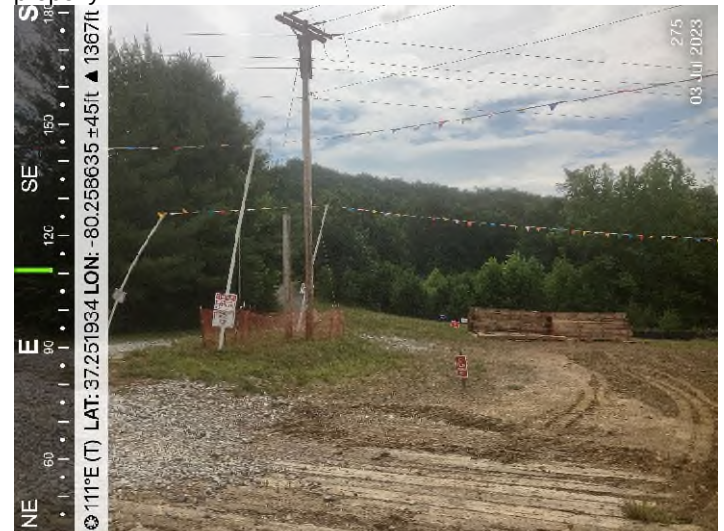
**Figure 4: MVP-MN-275 – Controls in place and functioning properly.**
