FIELD INSPECTION REPORT

Project Name:	Mountain Valley Pipeline	Inspector:	Marshall Willis
Inspection Date:	Monday, August 7, 2023	Project Contact:	Brian Clauto, Cory Chalmers
Spread I: Franklin County	STA 13850+00 – 13860+00 MVP-FR-303.01 STA 13784+75 – 13811+81 MVP-FR-300	Weather:	Wet

FIELD INSPECTION PHOTO LOG

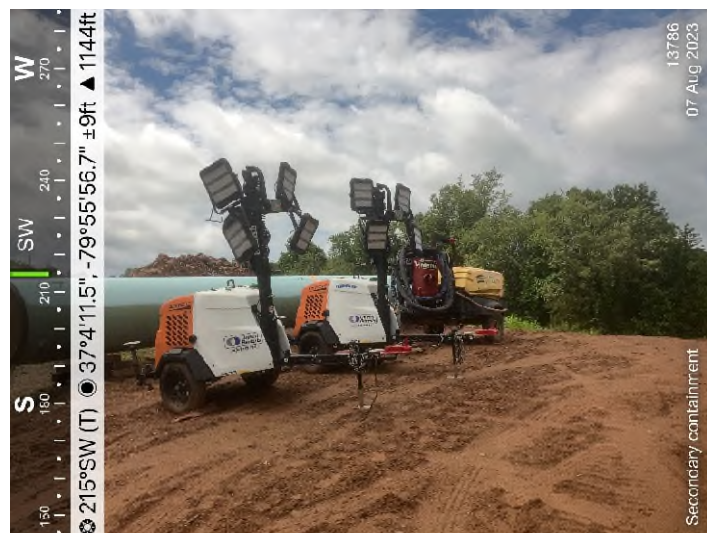
Figure 1: STA 13786+00 – Missing secondary containment.

- STA 13786+00: Install secondary containment in accordance with the SPCC plan.

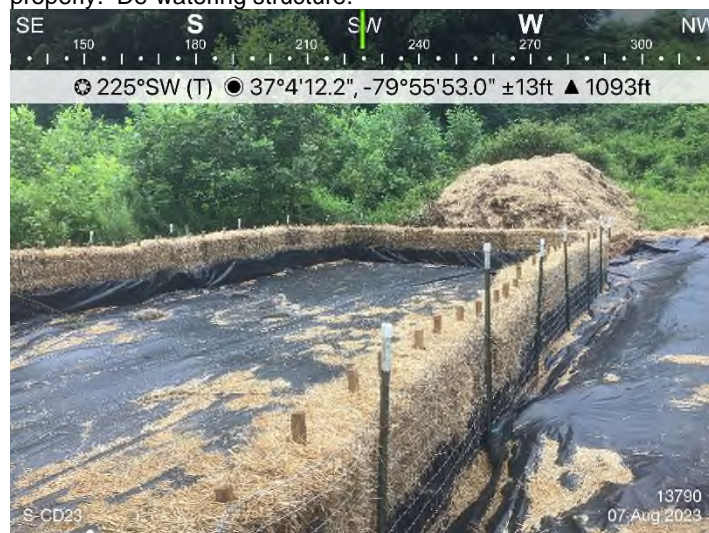
Figure 2: STA 13790+00 – Controls in place and functioning properly. De-watering structure.

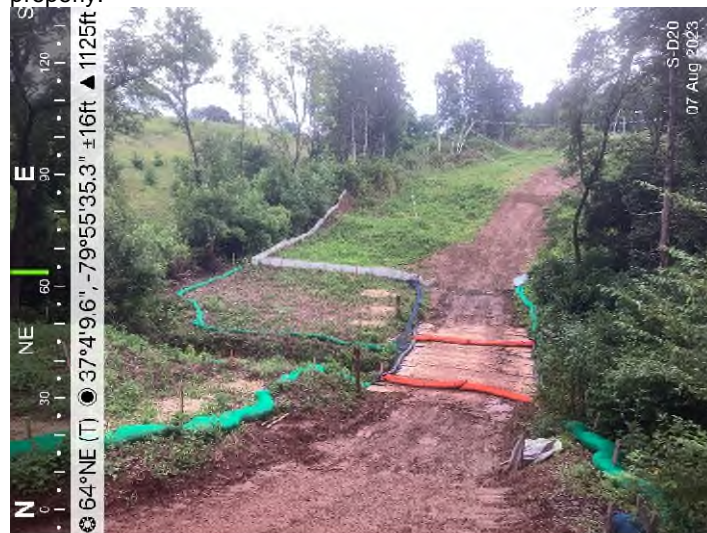
Figure 3: Stream S-D20 – Controls in place and functioning properly.

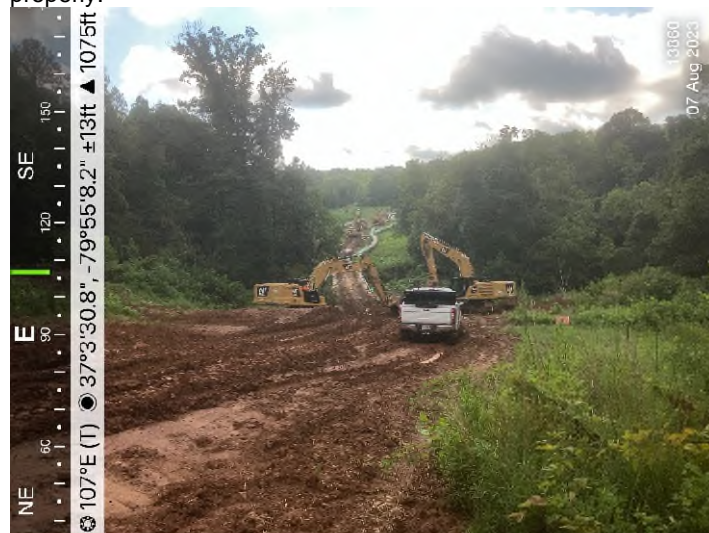
Figure 4: STA 13860+00 – Controls in place and functioning properly.
