## FIELD INSPECTION REPORT

| Project Name: | Mountain Valley Pipeline | Inspector: | Marshall Willis |
| Spread I:<br>Franklin County | STA 14131+28 – 14171+36<br>MVP-FR-309 | Weather: | Dry |

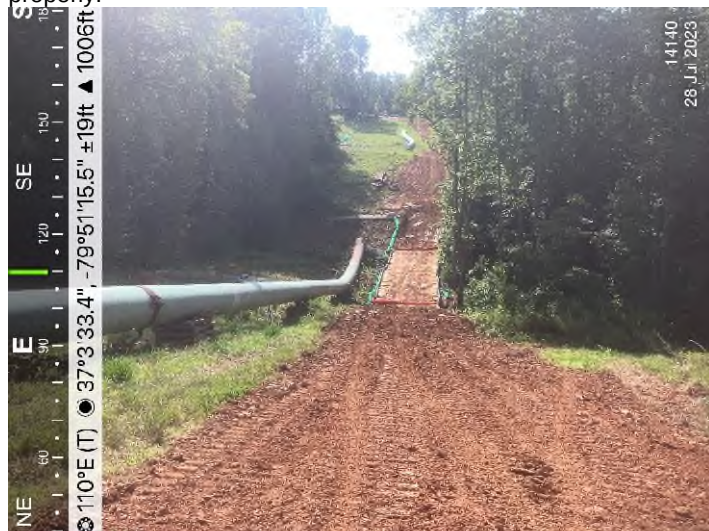
**Figure 1: STA 14140+00 – Controls in place and functioning properly.**

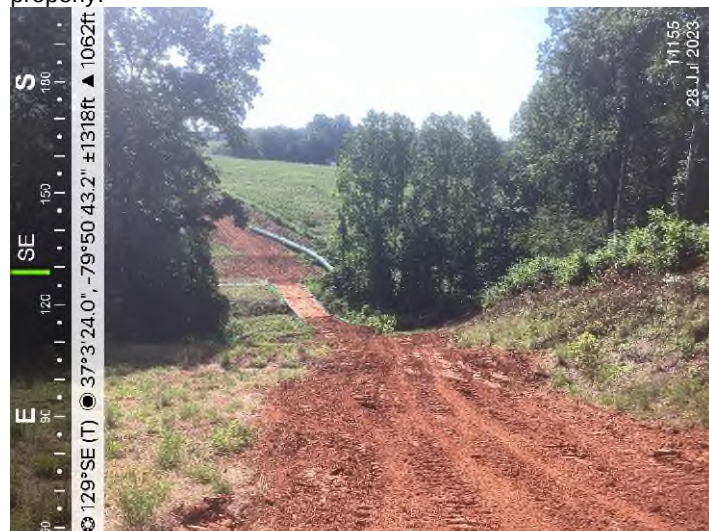
**Figure 2: STA 14155+00 – Controls in place and functioning properly.**

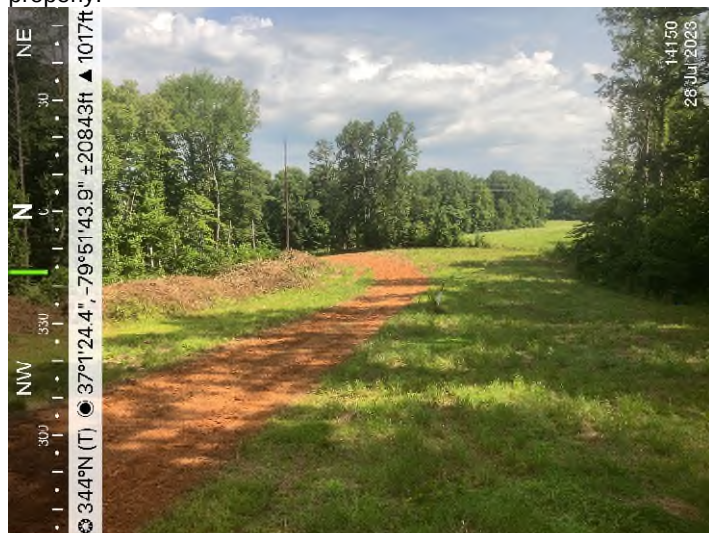
**Figure 3: STA 14150+00 – Controls in place and functioning properly.**

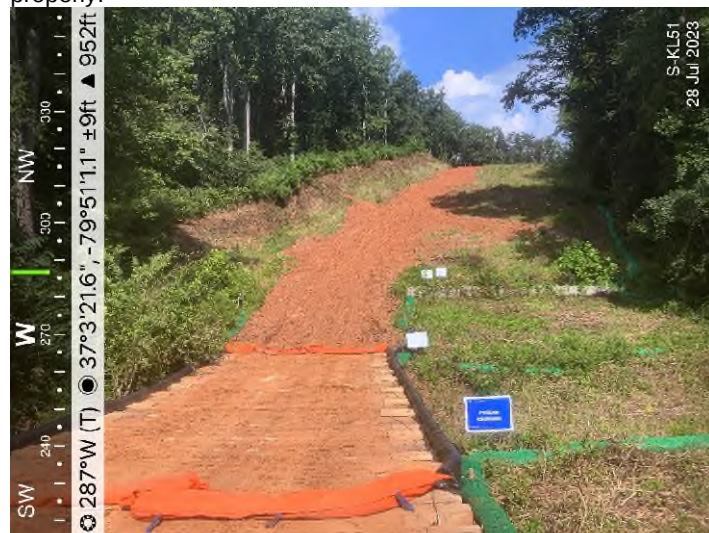
**Figure 4: Stream S-KL51 – Controls in place and functioning properly.**
