## FIELD INSPECTION REPORT

| <b>Project Name:</b> | Mountain Valley Pipeline | <b>Inspector:</b> | Marshall Willis |
| <b>Spread I:<br/>Franklin County</b> | STA 13826+95 – 13855+00<br>MVP-FR-302<br>MVP-FR-303.01 | <b>Weather:</b> | Dry |

## FIELD INSPECTION PHOTO LOG

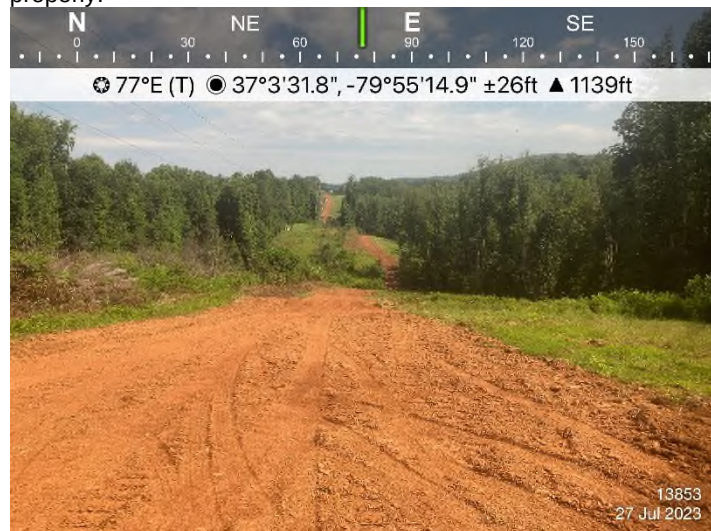
**Figure 1: STA 13853+00** – Controls in place and functioning properly.

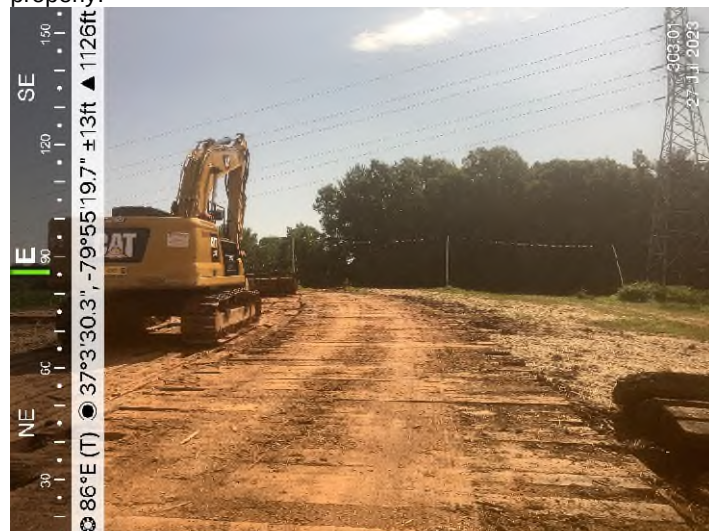
**Figure 2: MVP-FR-303.01** – Controls in place and functioning properly.

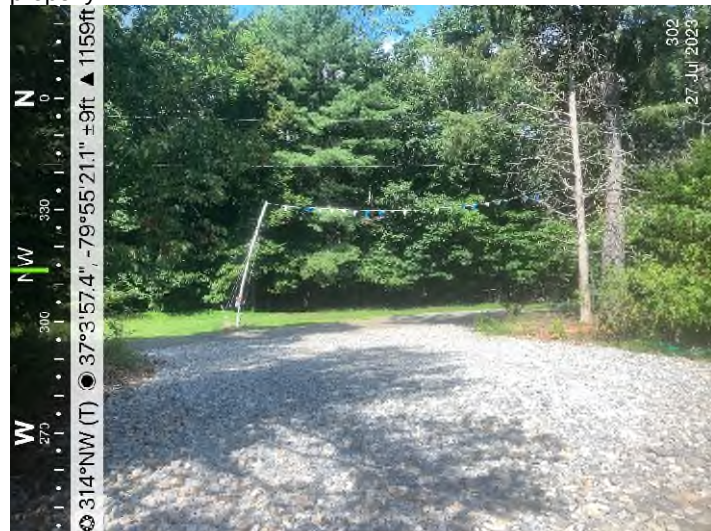
**Figure 3: MVP-FR-302** – Controls in place and functioning properly.

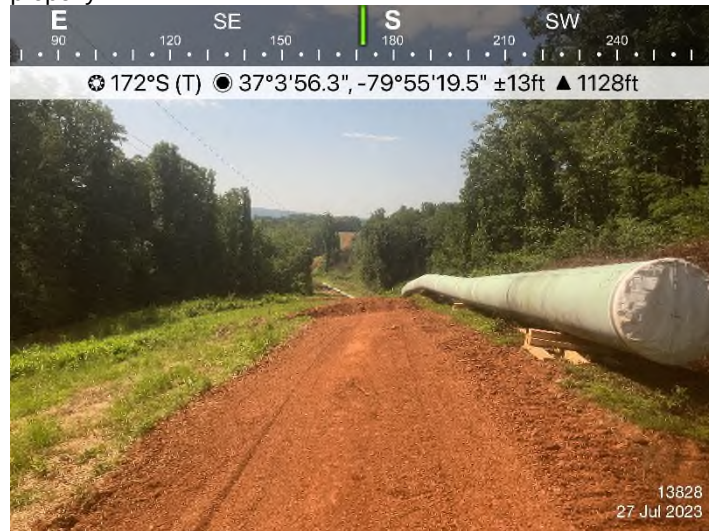
**Figure 4: STA 13828+00** – Controls in place and functioning properly.
