FIELD INSPECTION REPORT

Project Name:	Mountain Valley Pipeline	Inspector:	Marshall Willis
Inspection Date:	Tuesday, July 25, 2023	Project Contact:	Brian Clauto, Cory Chalmers
Spread H: Franklin County	STA 13342+67 – 13316+13	Weather:	Dry

FIELD INSPECTION PHOTO LOG

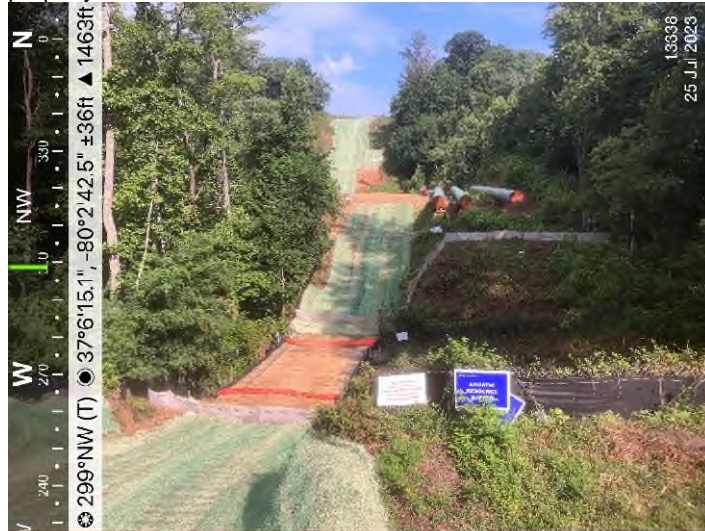
Figure 1: STA 13338+00 – Controls in place and functioning properly.

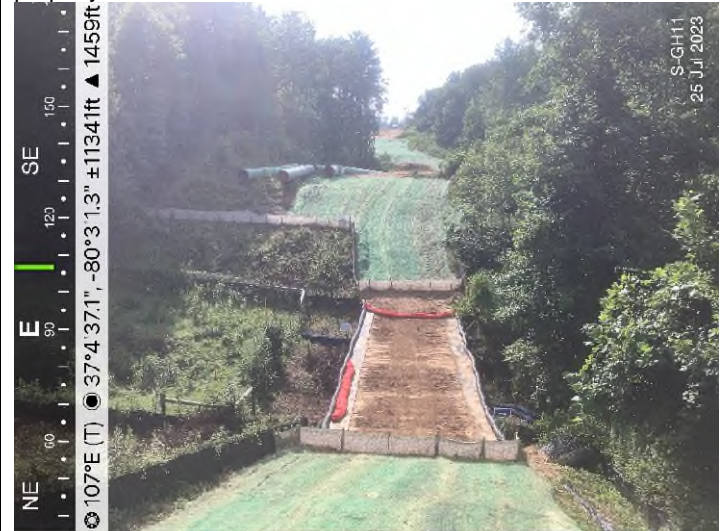
Figure 2: Stream S-GH11 – Controls in place and functioning properly.

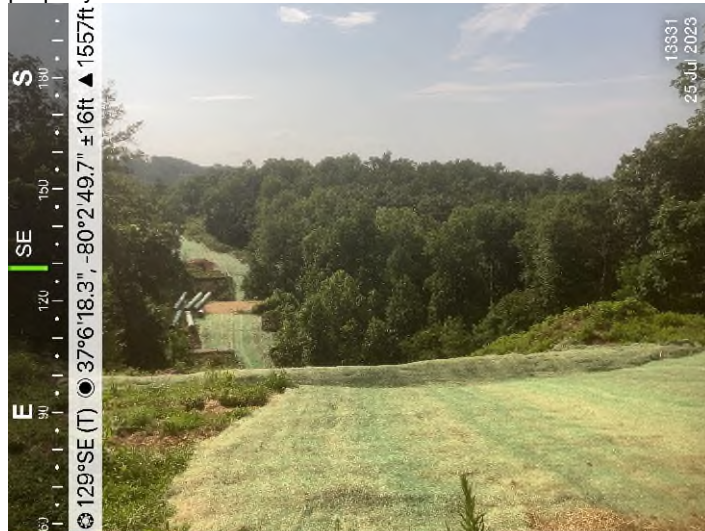
Figure 3: STA 13331+00 – Controls in place and functioning properly.

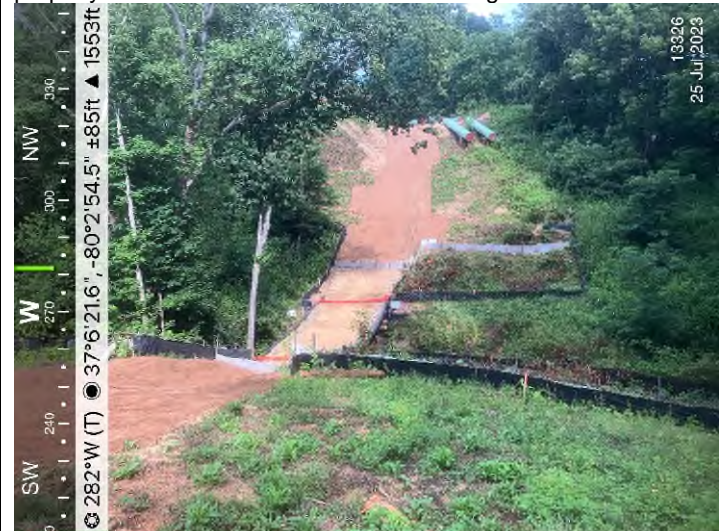
Figure 4: STA 13326+00 – Controls in place and functioning properly. Area stabilized with erosion matting and straw.
