Project Name:	Mountain Valley Pipeline	Inspector:	Matthew Grant
Inspection Date:	Thursday, August 24, 2023	Project Contact:	Brian Clauto
Spread H: Roanoke	Sta 12705-12716+55 ATWS 1627, 955, 955A AR RO280	Weather:	Dry

FIELD INSPECTION PHOTO LOG

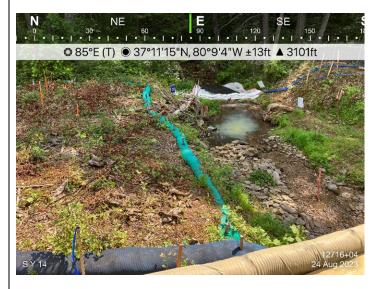
Figure 1: Designated crossing S-Y14, ECD's are in place.

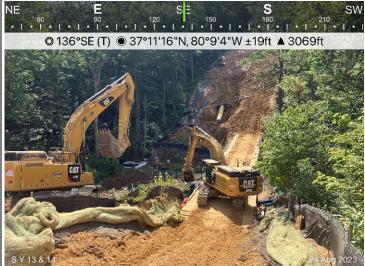
<u>Figure 2</u>: Above designated crossings S-Y13 & S-Y14, ECD's are in place.

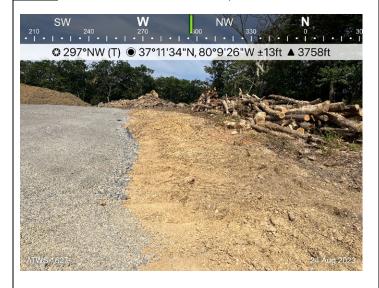
3.	Areas of of	fsite s	sediment deposition ob	serve	d?				\boxtimes		
Routine Maintenance: (72-Hour Deadline from Notification) - ATWS 1627, area near the perimeter of workspace are denuded and require stabilization. Ineffective Controls: (24-Hour Deadline from Notification) - N/A. Recommended Corrective Action: Maintain and install all controls per the approved PSS&S.												
Deadline: Within 72-Hour of Notification The recommended corrective action deadline date applies to all conditions noted on this report unless otherwise noted. If listed condition(s) currently constitute non-compliance and/or corrective actions are not completed by the deadline, other enforcement actions may be issued to the entity responsible for ensuring compliance on the above project. Inspector Signature:

Figure 3: ATWS 1627, denuded area requires stabilization.
