## FIELD INSPECTION REPORT

<b>Project Name:</b>	Mountain Valley Pipeline	<b>Inspector:</b>	Marshall Willis
<b>Inspection Date:</b>	Friday, August 18, 2023	<b>Project Contact:</b>	Brian Clauto, Cory Chalmers
<b>Spread H: Roanoke County</b>	STA 12866+00 – 12870+00 STA 12773+00 – 12777+00 MVP-RO-282 MVP-RO-283 MVP-RO-280	<b>Weather:</b>	Dry

# FIELD INSPECTION PHOTO LOG

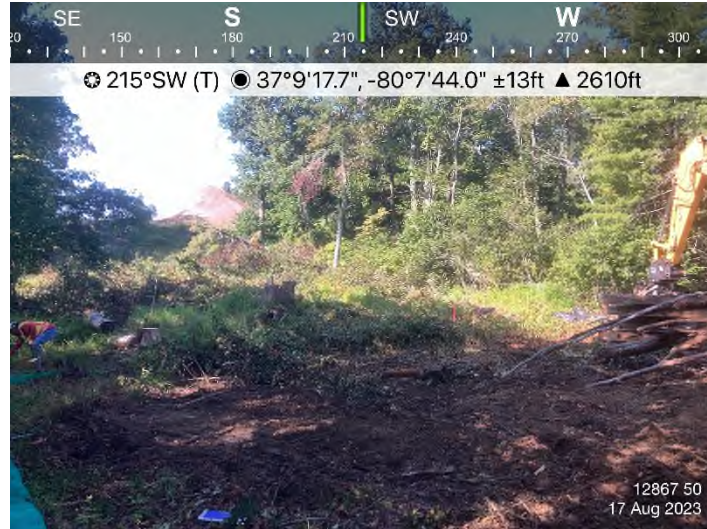
**Figure 1: STA 12867+50** – Installing timber matting through W-EF46.

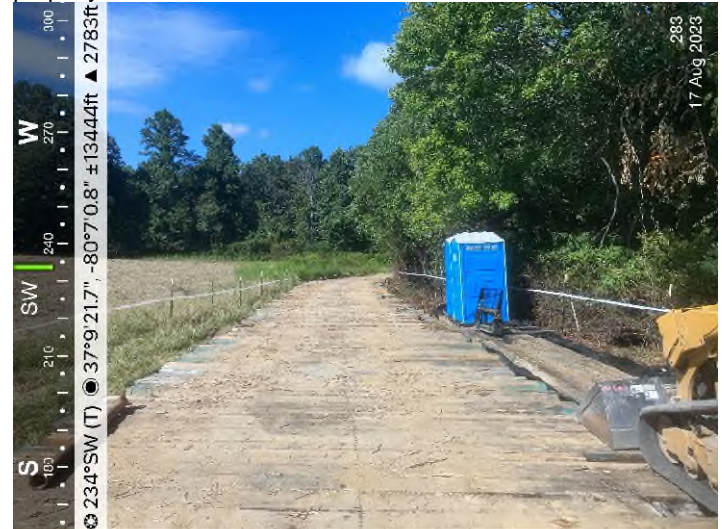
**Figure 2: MVP-RO-283** – Controls in place and functioning properly.

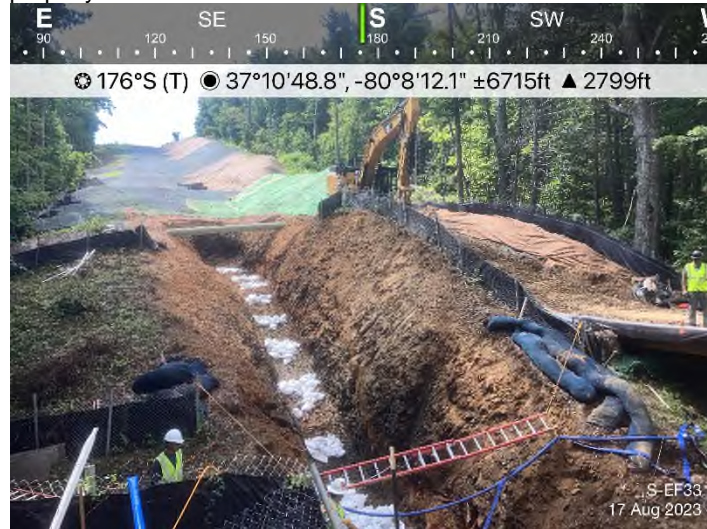
**Figure 3: Stream S-EF33** – Controls in place and functioning properly.

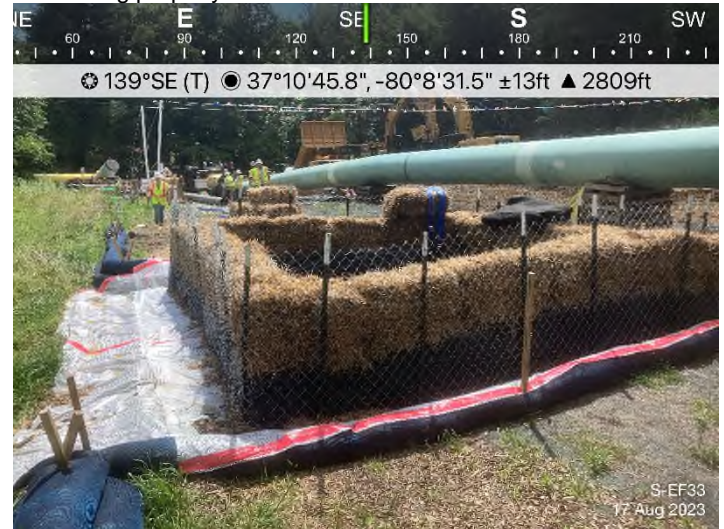
**Figure 4: Stream S-EF33** – Dewatering structure in place and functioning properly.
