FIELD INSPECTION REPORT

Project Name:	Mountain Valley Pipeline	Inspector:	Matthew Grant
Inspection Date:	Wednesday, August 30, 2023	Project Contact:	Brian Clauto
Spread I: Franklin	Sta 14062+17-14131+28 AR FR 309	Weather:	Wet

FIELD INSPECTION PHOTO LOG

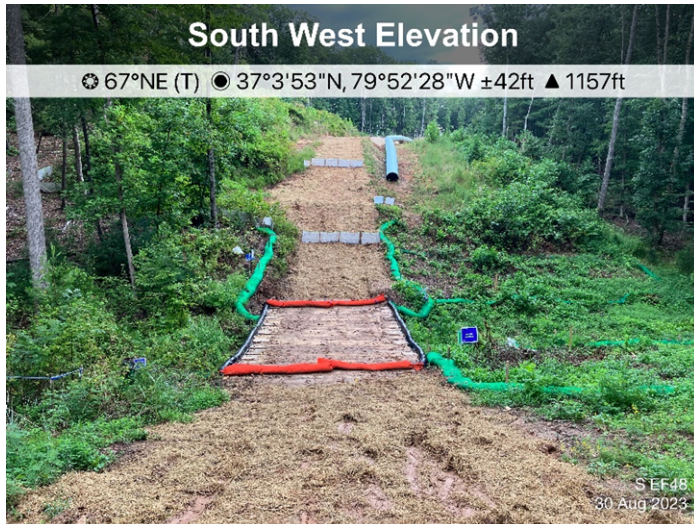
- Comments: Inspected the following resources: S-EF48, S-KL41

- Figure 1: Designated crossing S-EF48, ECD's are in place.

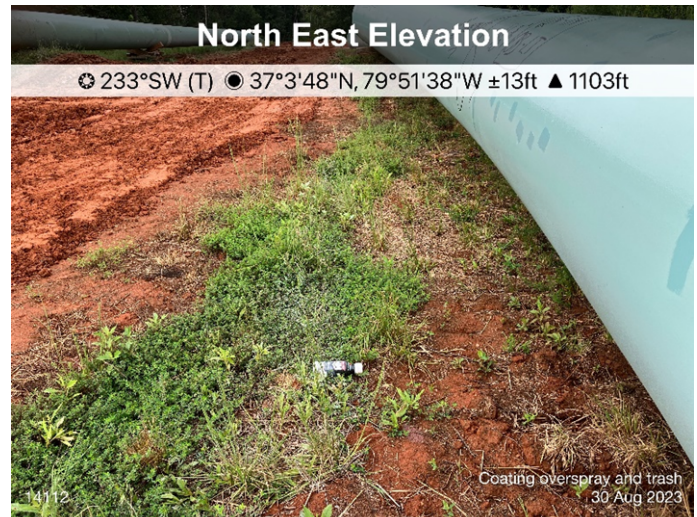
- Figure 2: Sta 14112 coating overspray and trash

- Sta 14071+69 Clean water diversion not per current specifications, build to current specs.
- Sta 14111+00 to 14112+00 pipe coating material on ground, remove overspray and dispose of properly.
- Sta 14110+00 pipe coating material on ground, remove overspray and dispose of properly.
- Sta 14105+85 end treatment requires maintenance.
- Sta 14102+69 CFS requires maintenance.
- Sta 14100+09 to 14102+00 pipe coating material on ground, remove overspray and dispose of properly.
- Sta 14099+00 pipe coating material on ground, remove overspray and dispose of properly.
- Sta 14080+50 to 14078+00 fill slope not built to specifications.
- Sta 14081+00 water flow path blocked on waterbar.
- Sta 14081+00 pipe coating material on ground, remove overspray and dispose of properly.

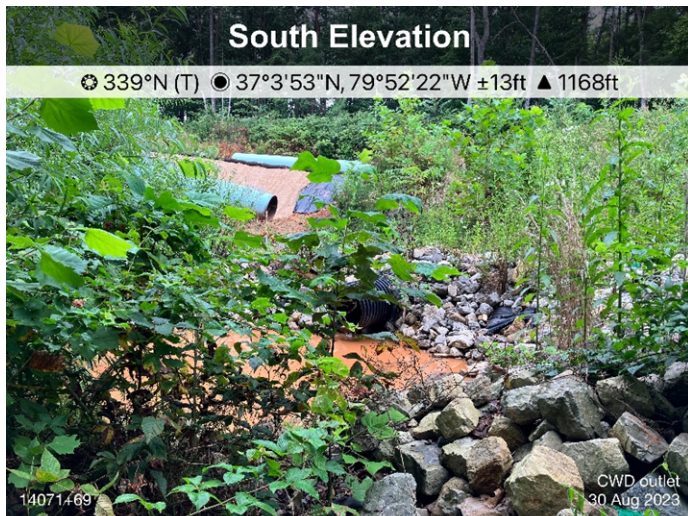
- Figure 3: Sta 14071+69, CWD not built to current specs.

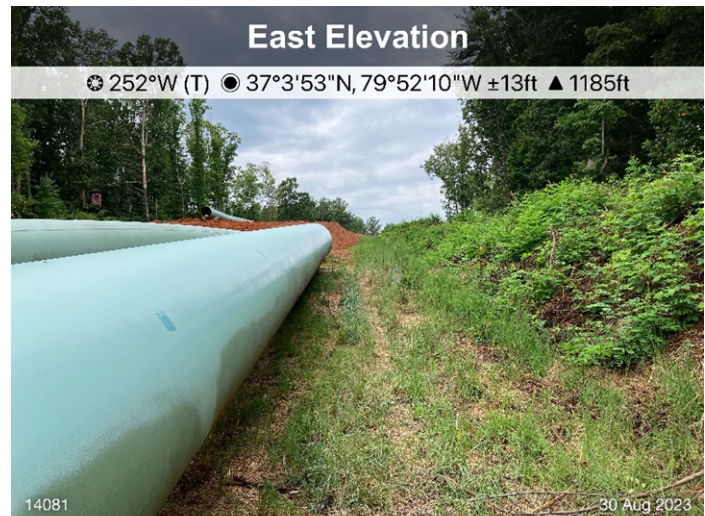
- Figure 4: Sta 14081 pipe coating overspray on ground

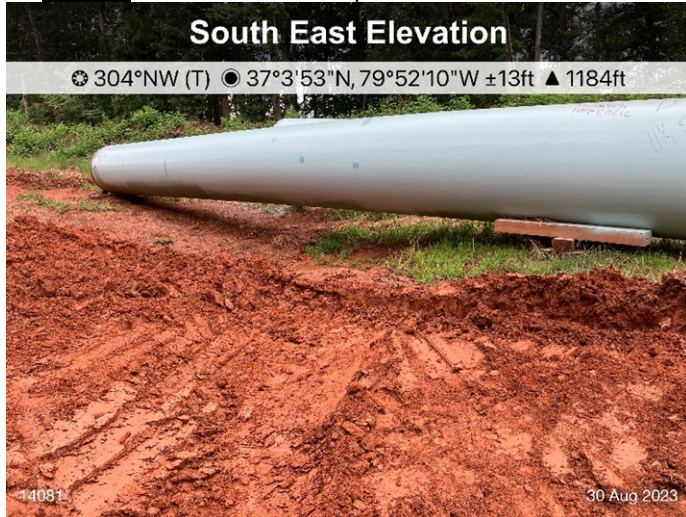
Figure 5: Sta 14081 WB flow path blocked

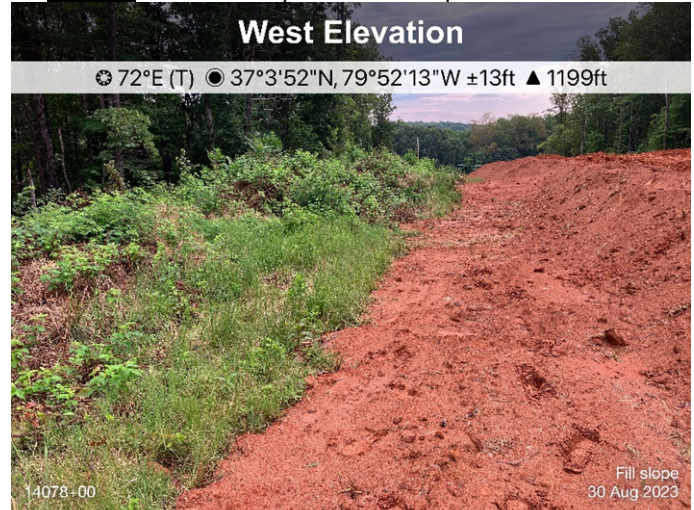
Figure 6: 14078 fill slope not built to spec.

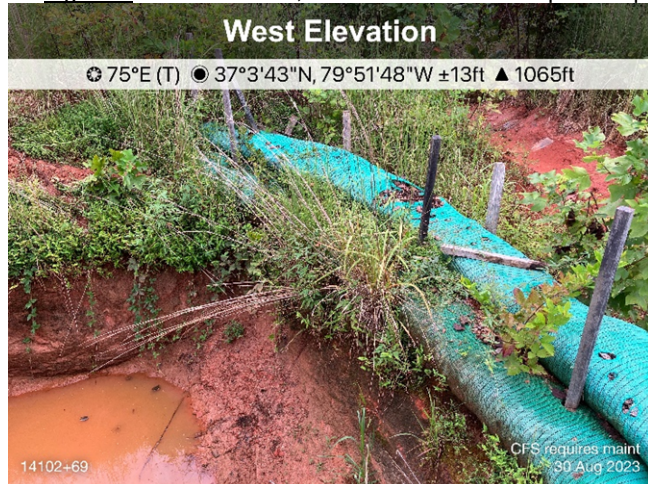
- Figure 9: Sta 14102+69, CFS end treatment requires repair.

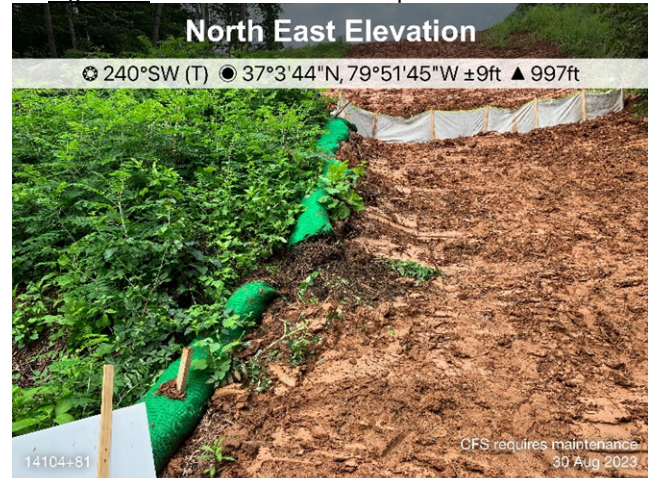
- Sta 14104+91 CFS requires maintenance.

- Figure 10: Sta14104+81 CFS requires maintenance

Recommended Corrective Action: Maintain and install all controls per the approved PSS&S.

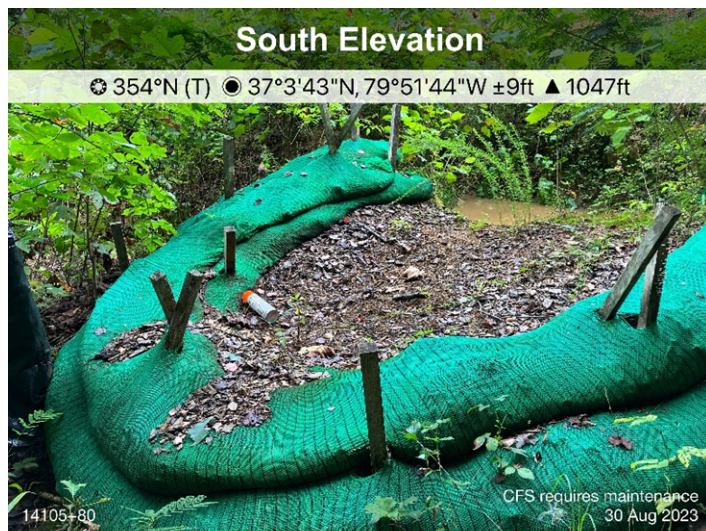
- Figure 11: Sta 14105+80 sump end treatment requires maintenance.

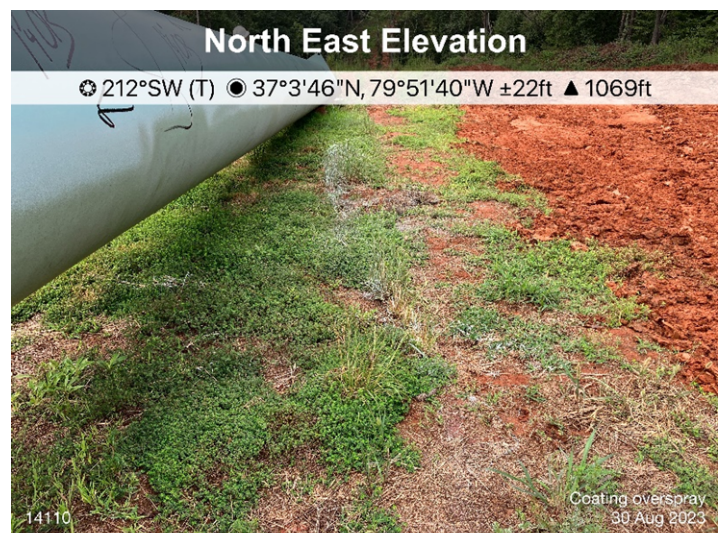
- Figure 12: Sta 14110 coating overspray
