## FIELD INSPECTION REPORT

| Project Name: | Mountain Valley Pipeline | Inspector: | Marshall Willis |
| Inspection Date: | Thursday, September 7, 2023 | Project Contact: | Brian Clauto, Cory Chalmers |
| Spread I:<br>Franklin County | STA 13852+46 – 13867+57<br>MVP-FR-303.01 | Weather: | Wet |

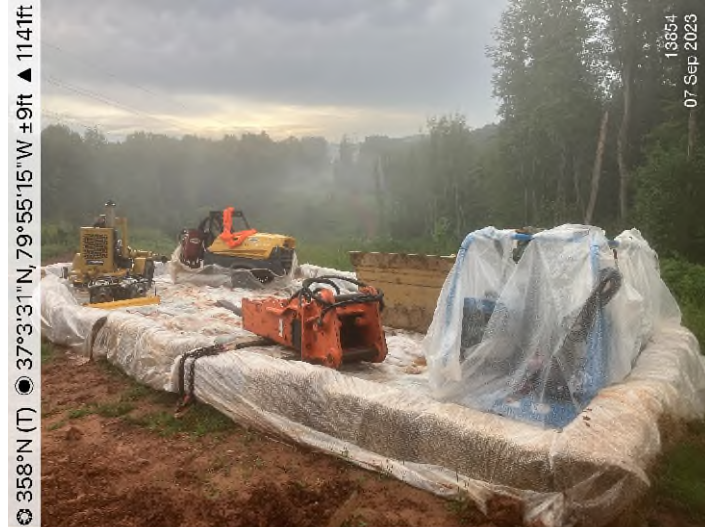
**Figure 1: STA 13854+00** – Controls in place and functioning properly.

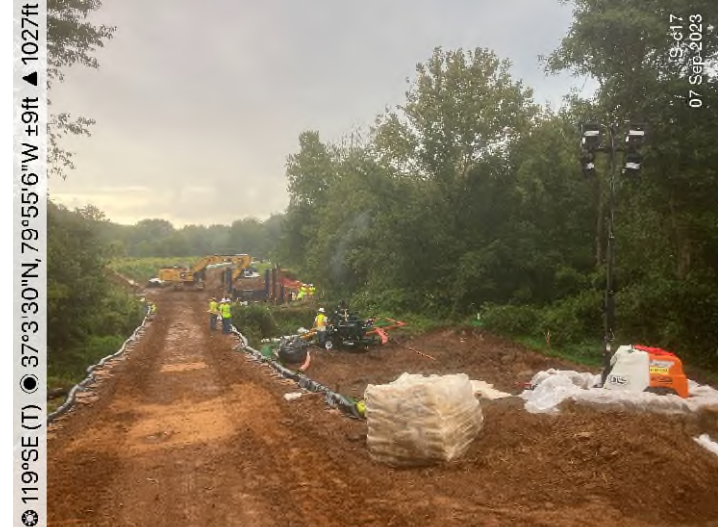
**Figure 2: STA 13862+00** – Controls in place and functioning properly.

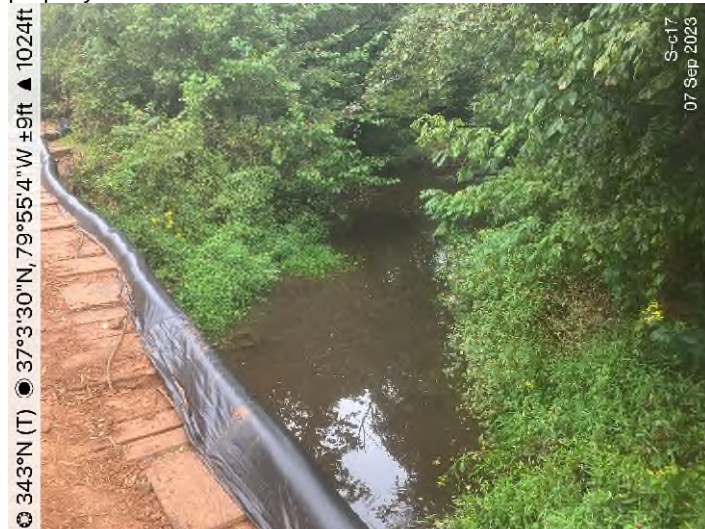
**Figure 3: Stream S-C17** – Controls in place and functioning properly.

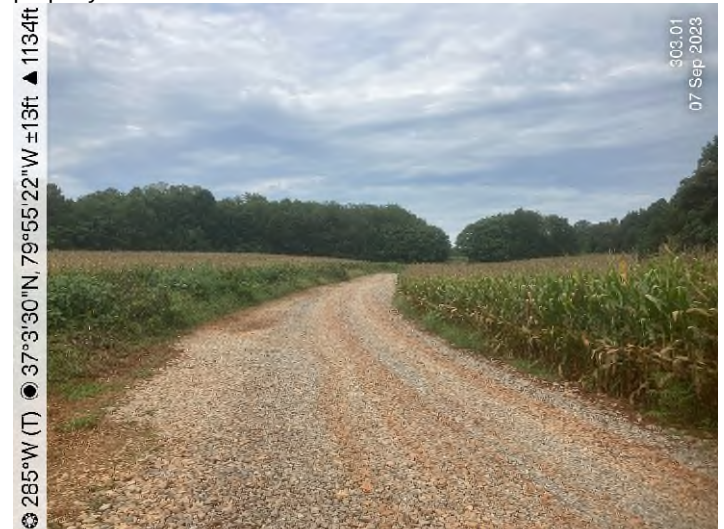
**Figure 4: MVP-FR-303.01** – Controls in place and functioning properly.
