## **FIELD INSPECTION REPORT**

Project Name:	Mountain Valley Pipeline	Inspector:	Marshall Willis
Inspection Date:	Thursday, September 14, 2023	Project Contact:	Brian Clauto, Cory Chalmers
Spread I: Franklin County	STA 14649+47 – 14712+33	Weather:	Dry

## **FIELD INSPECTION PHOTO LOG**

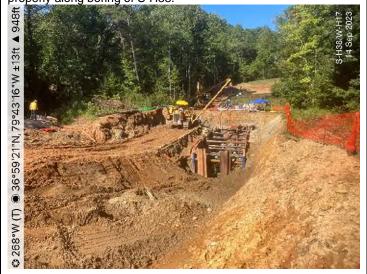
Figure 3: Stream S-H38- Controls in place and functioning properly along boring of S-H38.

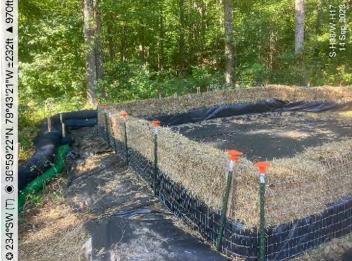
Figure 4: Stream S-H38- Controls in place and functioning properly along boring of S-H38.
