FIELD INSPECTION REPORT

Project Name:	Mountain Valley Pipeline	Inspector:	Marshall Willis
Inspection Date:	Tuesday, September 19, 2023	Project Contact:	Brian Clauto, Cory Chalmers
Spread H: Roanoke County	STA 12801+75 – 12866+36 STA 12598+00 – 12637+17 MVP-RO-283 MVP-RO-279.01	Weather:	Dry

FIELD INSPECTION PHOTO LOG

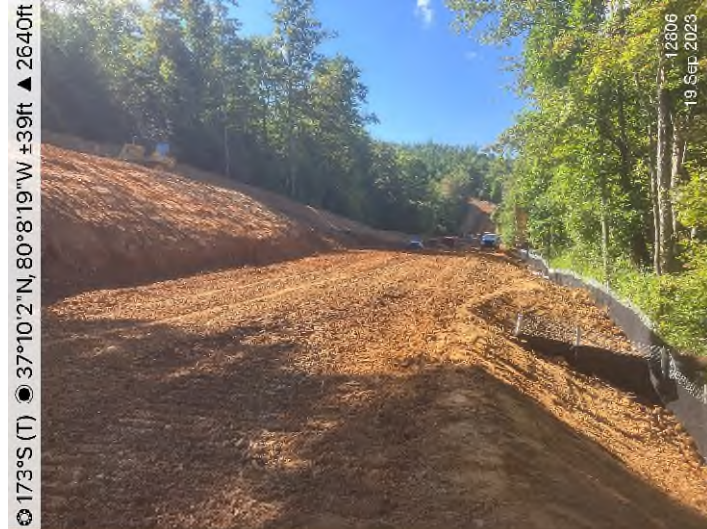
Figure 1: STA 12806+00 – Controls in place and functioning properly.

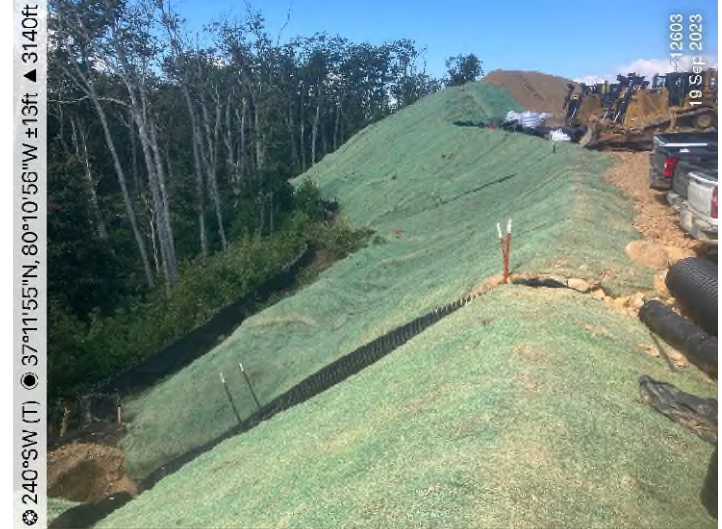
Figure 2: STA 12603+00 – Controls in place and functioning properly.

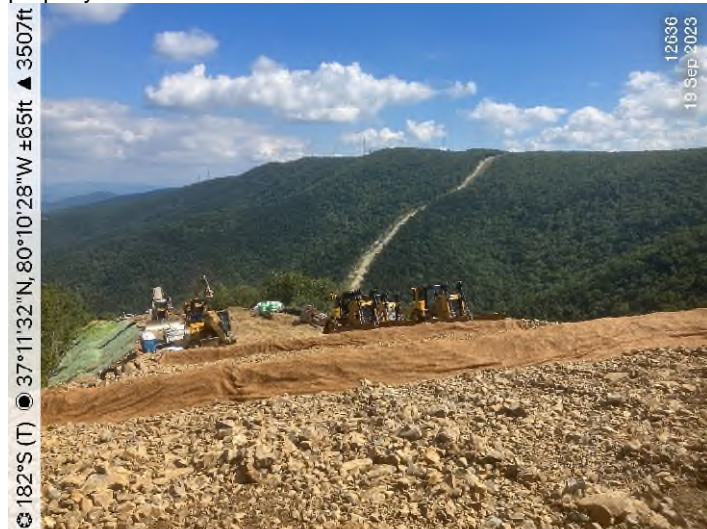
Figure 3: STA 12636+00 – Controls in place and functioning properly.

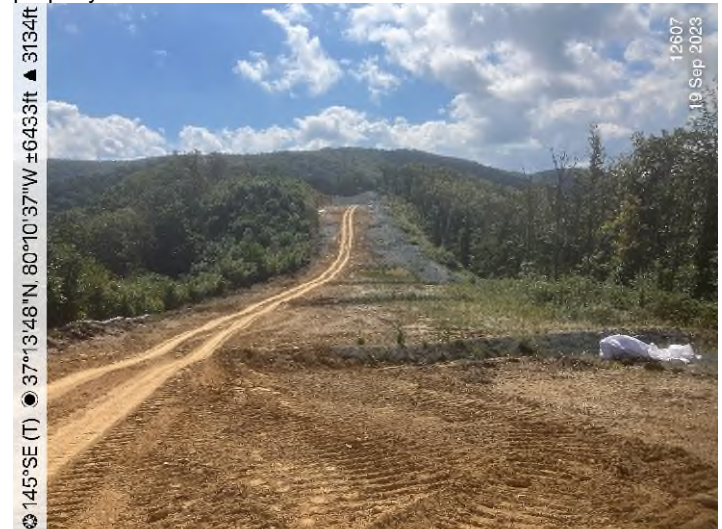
Figure 4: STA 12607+00 – Controls in place and functioning properly.
