FIELD INSPECTION REPORT

Project Name:	Mountain Valley Pipeline	Inspector:	Marshall Willis
Inspection Date:	Wednesday, October 18, 2023	Project Contact:	Brian Clauto, Cory Chalmers
Spread I: Franklin County Pittsylvania County	STA 14915+96 - 14928+52 STA 15025+00 - 15063+77	Weather:	Dry

FIELD INSPECTION PHOTO LOG

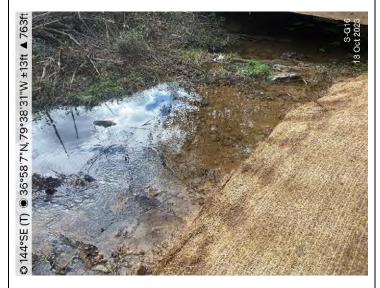
<u>Figure 1</u>: **Stream S-G16** – Erosion matting, and seed applied to stabilize repaired bank.

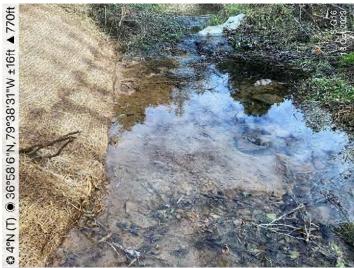
Figure 2: Stream S-G16 – Evidence of minor remaining fill material within stream post remediation.

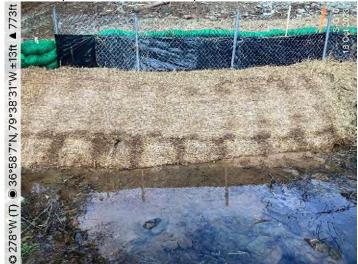
<u>Figure 3</u>: **Stream S-G16** – Erosion matting, and seed applied to stabilize repaired bank. Controls repaired and reinstalled.

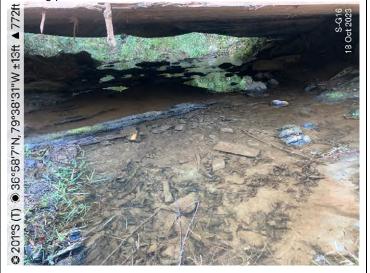
<u>Figure 4</u>: **Stream S-G16** – Looking downstream under bridge crossing post remediation efforts.
