FIELD INSPECTION REPORT

Project Name:	Mountain Valley Pipeline	Inspector:	Marshall Willis
Inspection Date:	Thursday, October 12, 2023	Project Contact:	Brian Clauto, Cory Chalmers
Spread I: Franklin County Pittsylvania County	STA 14171+36 – 14290+84 STA 14101+26 – 14131+28 STA 14411+09 – 14422+44 STA 15063+85 – 15073+89	Weather:	Dry

FIELD INSPECTION PHOTO LOG

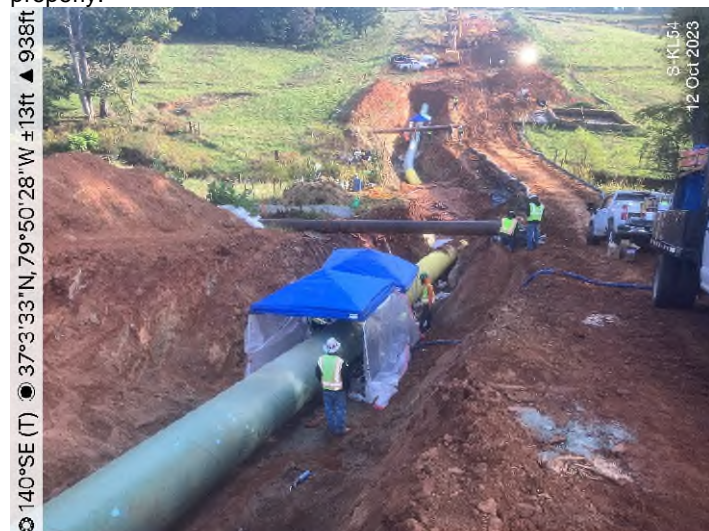
Figure 1: Stream S-KL54 – Controls in place and functioning properly.

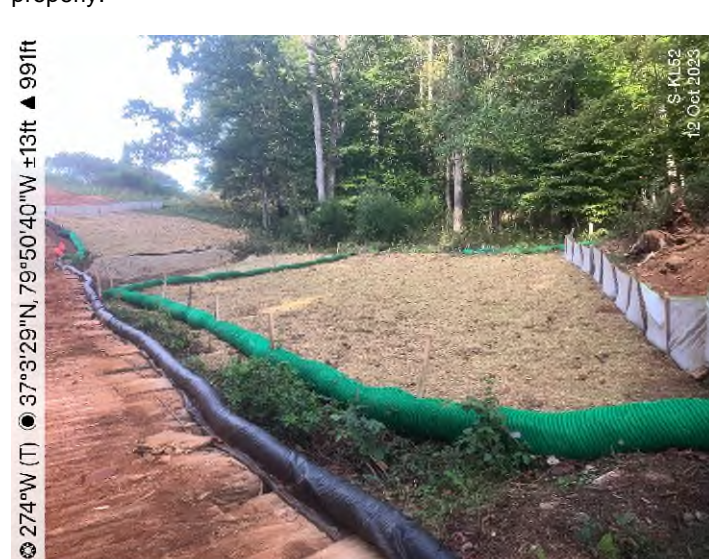
Figure 2: Stream S-KL52 – Controls in place and functioning properly.

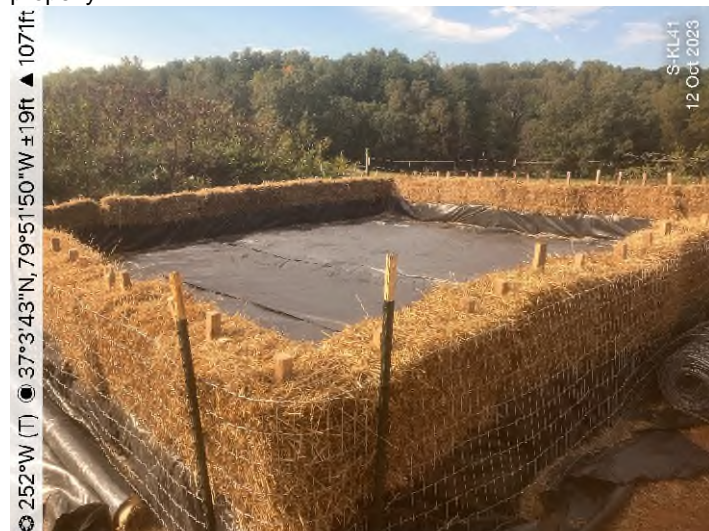
Figure 3: Stream S-KL41 – Controls in place and functioning properly.

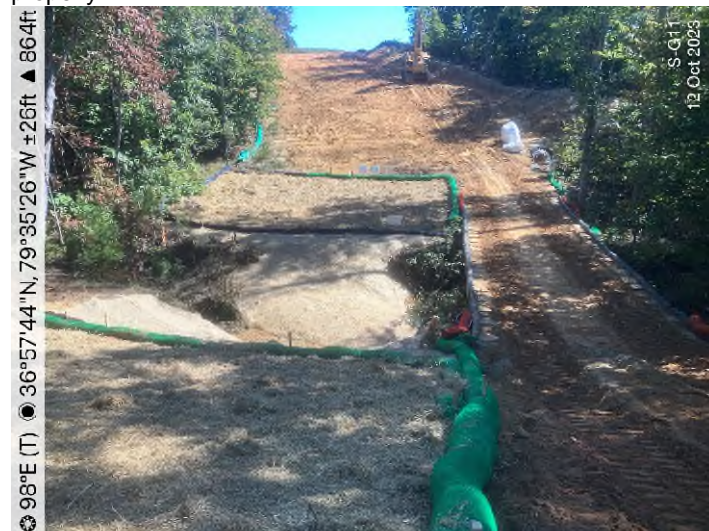
Figure 4: Stream S-G11 – Controls in place and functioning properly.
