## FIELD INSPECTION REPORT

| <b>Project Name:</b> | Mountain Valley Pipeline | <b>Inspector:</b> | Marshall Willis |
| <b>Spread I:<br/>Franklin County</b> | STA 13826+95 – 13890+00<br>MVP-FR-302<br>MVP-FR-303.01 | <b>Weather:</b> | Dry |

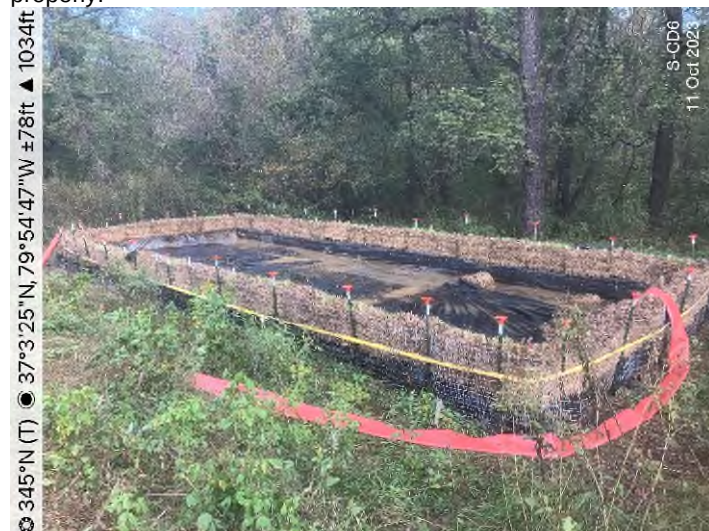
**Figure 1: Stream S-CD6** – Controls in place and functioning properly.

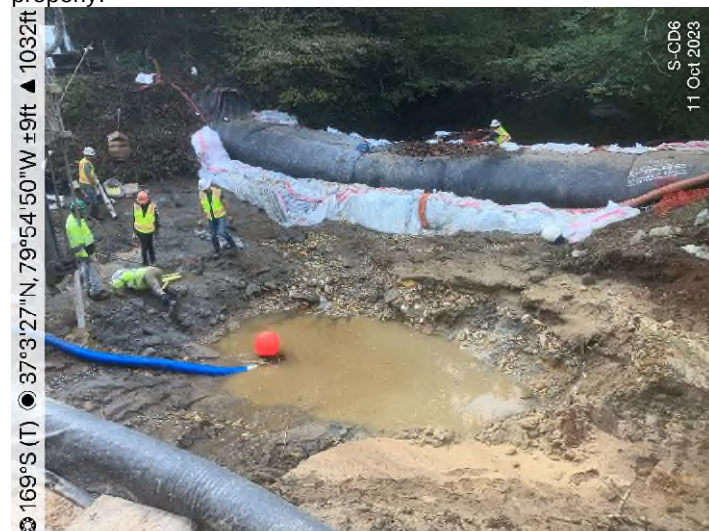
**Figure 2: Stream S-CD6** – Controls in place and functioning properly.

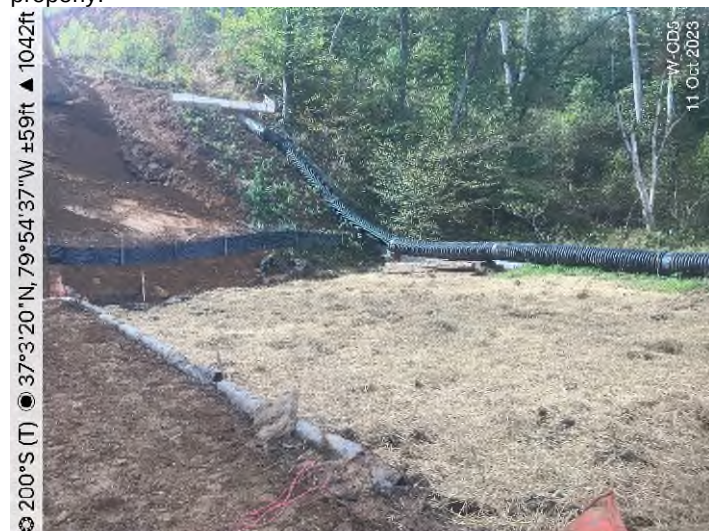
**Figure 3: Wetland W-CD5** – Controls in place and functioning properly.
