## FIELD INSPECTION REPORT

<b>Project Name:</b>	Mountain Valley Pipeline	<b>Inspector:</b>	Marshall Willis
<b>Inspection Date:</b>	Thursday, October 26, 2023	<b>Project Contact:</b>	Brian Clauto, Cory Chalmers
<b>Spread H: Roanoke County Franklin County</b>	STA 12973+81 – 12993+90 STA 13023+69 – 13033+59 STA 13342+67 – 13352+23 MVP-FR-292	<b>Weather:</b>	Dry

## FIELD INSPECTION PHOTO LOG

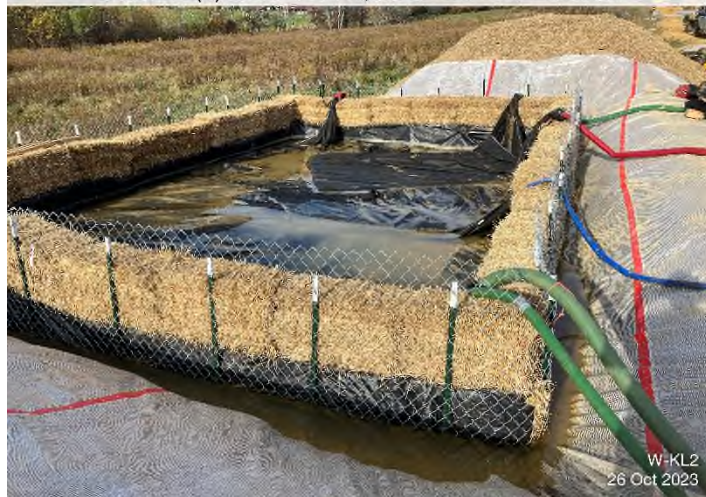
**Figure 1: Stream S-B22** – Controls installed and properly functioning.

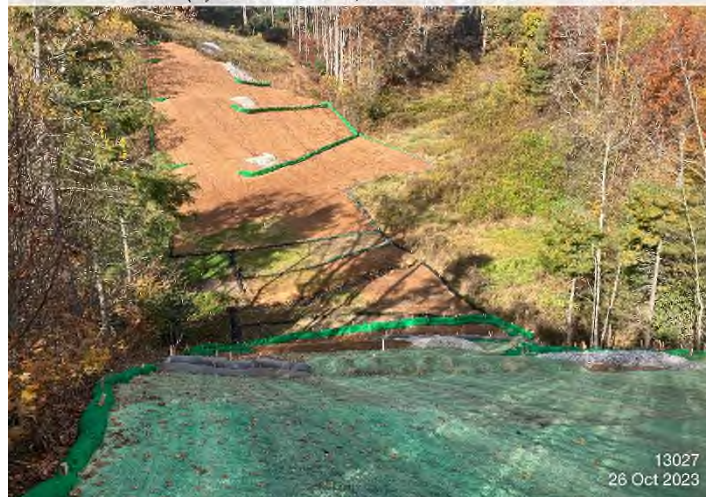
**Figure 2: STA 13027+00** – Controls installed and properly functioning.

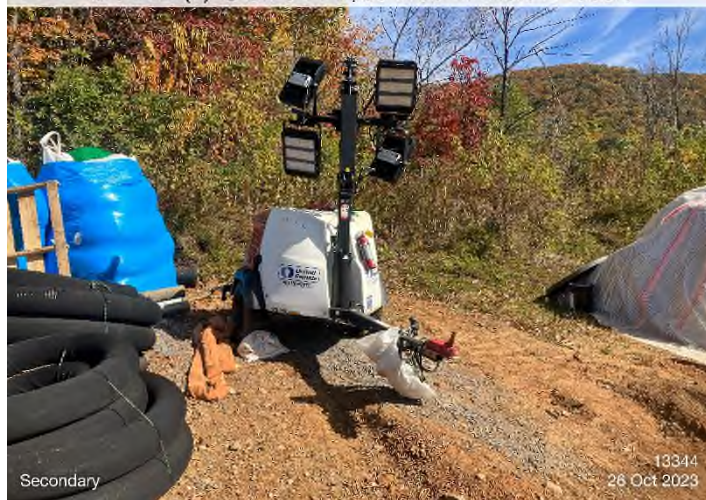
- STA 13344+00: Secondary containment needed.

**Figure 3: STA 13344+00** – Secondary containment needed.

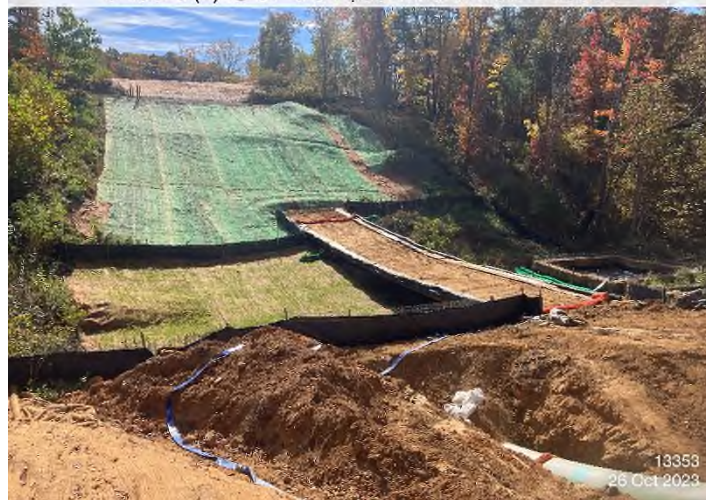
**Figure 4: STA 13353+00** – Controls installed and properly functioning.
