FIELD INSPECTION REPORT

Project Name:	Mountain Valley Pipeline	Inspector:	Marshall Willis
Inspection Date:	Monday, October 23, 2023	Project Contact:	Brian Clauto, Cory Chalmers
Spread H: Montgomery County Franklin County	STA 12380+04 – 12410+00 STA 12422+32 – 12435+16 STA 13413+13 – 13418+00 MVP-MLV-AR-27 MVP-MN-279	Weather:	Dry

FIELD INSPECTION PHOTO LOG

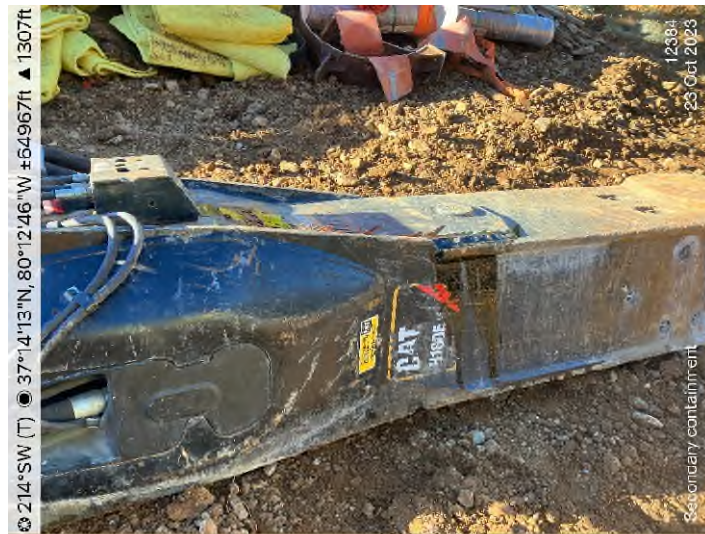
Figure 1: STA 12384+00 – Secondary containment needed.

- STA 12384+00: Secondary containment needed.
- STA 12380+04: Install erosion matting per-specifications.

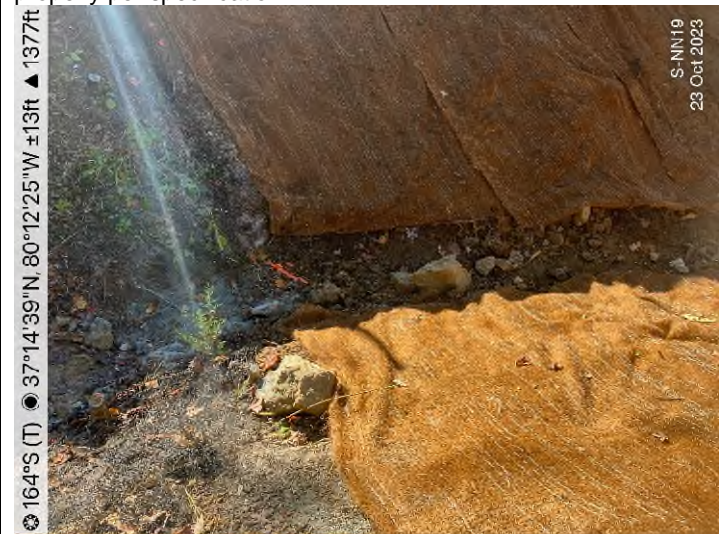
Figure 2: Stream S-NN19 – Erosion matting not keyed in properly per specification.

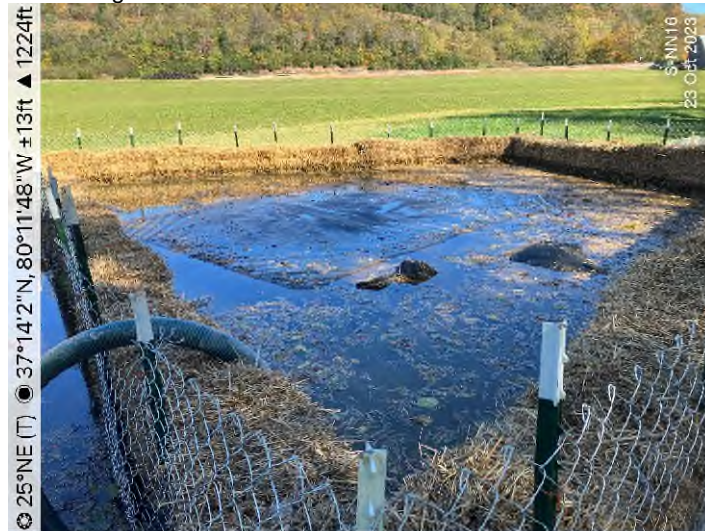
Figure 3: Stream S-NN16 – Controls installed and properly functioning.

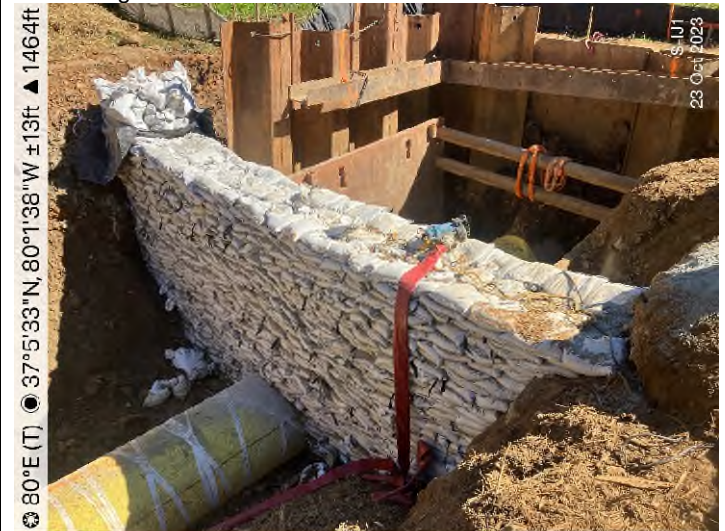
Figure 4: Stream S-IJ1 – Controls installed and properly functioning.
