Project Name:	Mountain Valley Pipeline	Inspector:	Matthew Grant
Inspection Date:	Tuesday, October 31, 2023	Project Contact:	Brian Clauto
Spread H: Montgomery	Sta 12450-12424, 13112+18- 12107+72, 12120-12126 ATWS 727, 725 AR MN279, 271	Weather:	Dry

FIELD INSPECTION PHOTO LOG

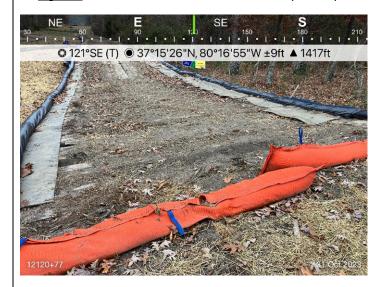
- Sta 12120+77 CFS wattle torn and requires repair. Ineffective Controls: (24-Hour Deadline from Notification) - N/A.												
Re	ecommende	ed Correct	ive A	Action: N/A								
Deadline: Within 72-Hour of Notification The recommended corrective action deadline date applies to all conditions noted on this report unless otherwise noted. If listed condition(s) currently constitute non-compliance and/or corrective actions are not completed by the deadline, other enforcement actions may be issued to the entity responsible ensuring compliance on the above project.												
Ins	pector Sign	ature:		1 all noth	and the

Figure 1: Sta 12120+77 CFS wattle torn and requires repair.

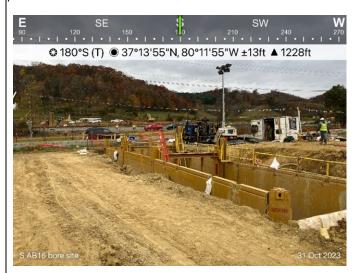
Figure 2: Bore site for designated crossing S-AB16, ESC's are in place.

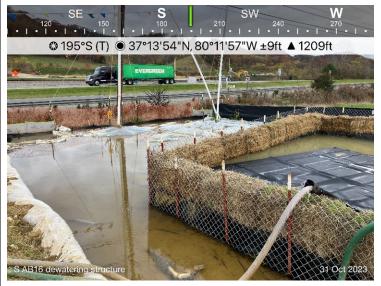
Figure 3: Dewatering structure for designated crossing S-AB16.

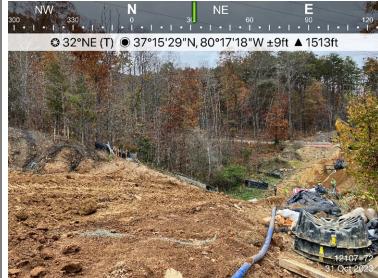
Figure 4: Sta 12107+72, ESC's are in place.
