Project Name:	Mountain Valley Pipeline	Inspector:	Matthew Grant
Inspection Date:	Tuesday, November 14, 2023	Project Contact:	Brian Clauto
Spread H: Roanoke	Sta 12960+34-12950, 12993+73- 12981 ATWS 1306, 1305, 954 AR 287	Weather:	Dry

## FIELD INSPECTION PHOTO LOG

**Project Name:** Mountain Valley Pipeline

Date: Tuesday, November 14, 2023

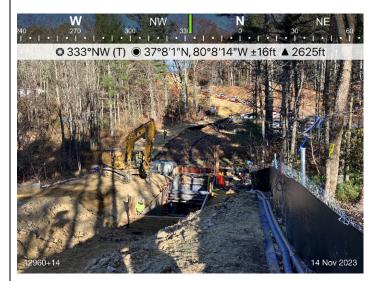
Figure 1: Sta 12960+14, controls are in place.

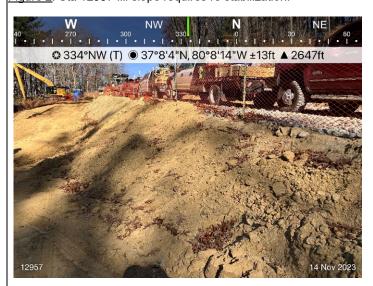
3.	Areas of of	fsite s	sediment deposition o	bserve	d?				$\boxtimes$		
■ Comments: Inspected the following resources: S-Y7, S-Y8, W-Y2, S-Z17, S-Z16, W-B24. S-B21, W-B25, S-B22, S-B22, S-B23, W-KL2, W-ST1  Routine Maintenance: (72-Hour Deadline from Notification)  - Sta. 12957 fill slope requires additional stabilization.  - Sta 12991+33 stockpile requires re stabilization.  - Ineffective Controls: (24-Hour Deadline from Notification)  - N/A.  Recommended Corrective Action: Maintain and install all controls per the approved PSS&S.												
Deadline: Within 72-Hour of Notification  The recommended corrective action deadline date applies to all conditions noted on this report unless otherwise noted. If listed condition(s) currently constitute non-compliance and/or corrective actions are not completed by the deadline, other enforcement actions may be issued to the entity responsible ensuring compliance on the above project.  Inspector Signature:

Figure 2: Sta 12957 fill slope requires re stabilization.

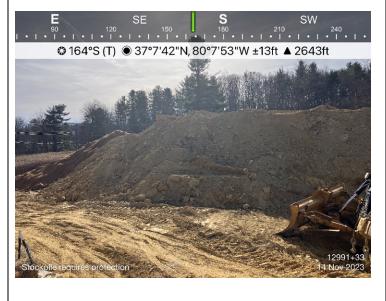
Figure 3: Sta 12991+33 stockpile requires re stabilization.

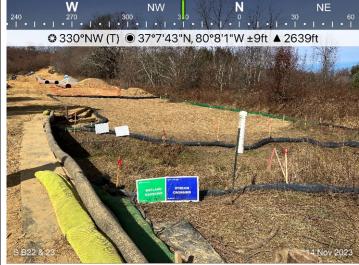
Figure 4: Designated crossings S-B22 and S-B23, ESC's are in place.
