FIELD INSPECTION REPORT

Project Name:	Mountain Valley Pipeline	Inspector:	Marshall Willis
Inspection Date:	Thursday, November 16, 2023	Project Contact:	Brian Clauto, Cory Chalmers
Spread I: Franklin County	STA 14861+31 – 14928+52 STA 14776+65 – 14795+12 MVP-FR-322	Weather:	Dry

FIELD INSPECTION PHOTO LOG

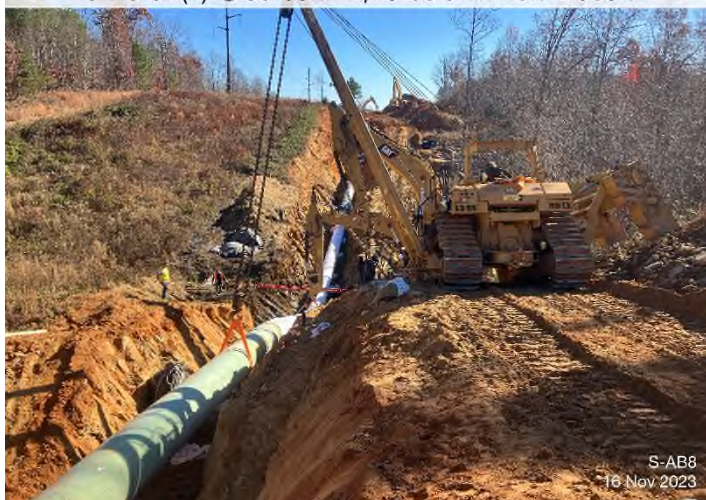
Figure 1: Stream S-AB8 – Controls in place and functioning properly.

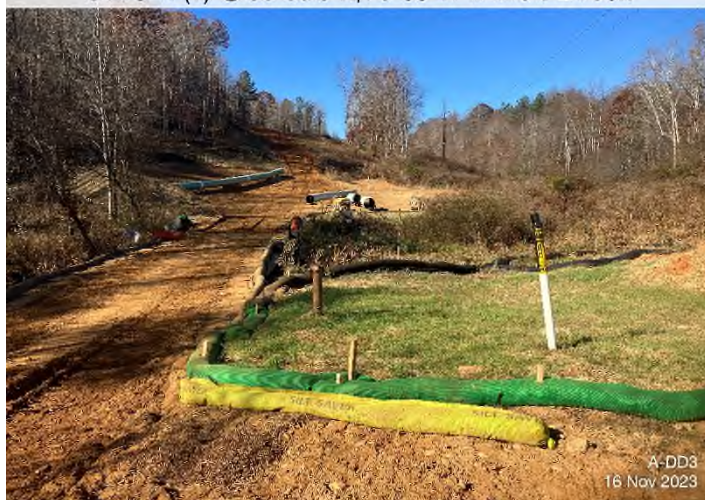
Figure 2: Stream S-DD3 – Controls in place and functioning properly.

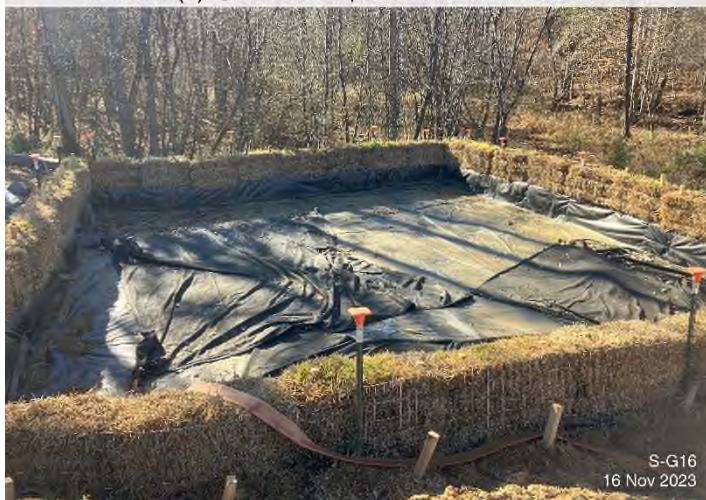
Figure 3: Stream S-G16 – Controls in place and functioning properly.

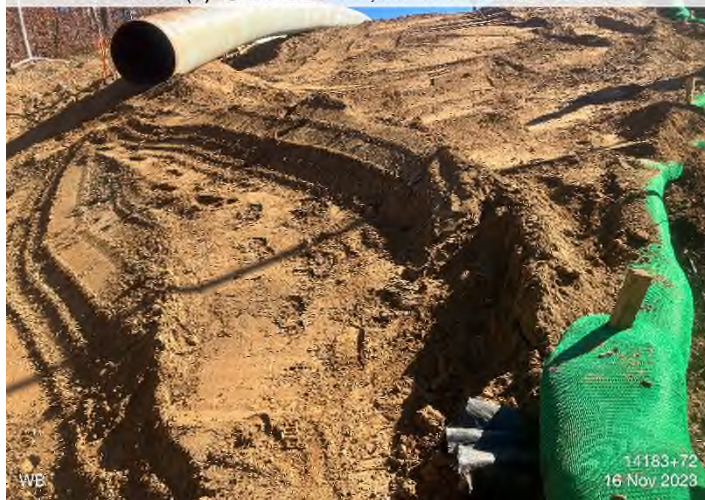
Figure 4: STA 14183+72 – Install temp. WB per specifications.

- STA 14183+72: Install temp. WB per specification.

Deadline: Within 24-Hour of Notification
