## FIELD INSPECTION REPORT

<b>Project Name:</b>	Mountain Valley Pipeline	<b>Inspector:</b>	Marshall Willis
<b>Inspection Date:</b>	Wednesday, November 15, 2023	<b>Project Contact:</b>	Brian Clauto, Cory Chalmers
<b>Spread I: Franklin County Pittsylvania County</b>	STA 15619+48 – 15647+43 STA 14518+57 – 14546+75 MVP-FR-317	<b>Weather:</b>	Dry

## FIELD INSPECTION PHOTO LOG

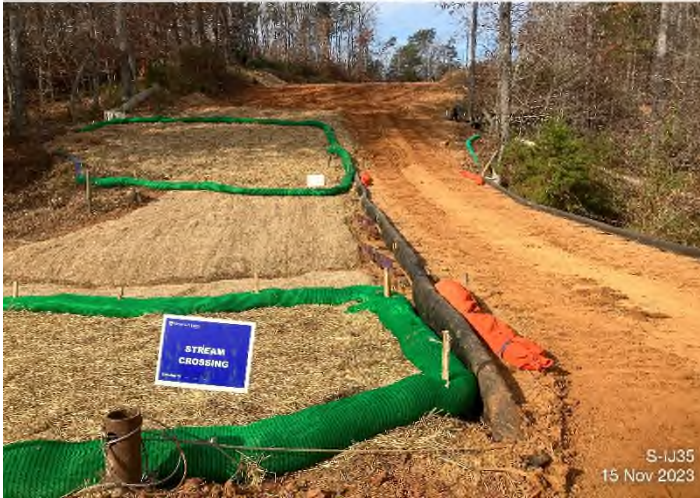
**Figure 1: Stream S-IJ35** – Controls in place and functioning properly.

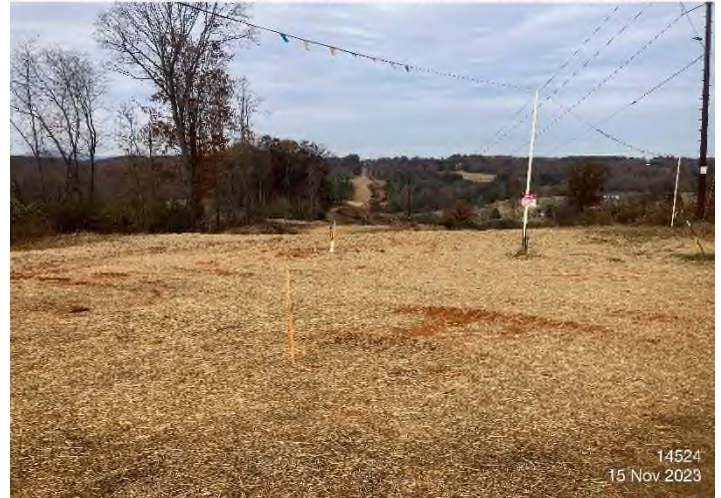
**Figure 2: STA 14524+00** – Controls in place and functioning properly.
