## FIELD INSPECTION REPORT

<b>Project Name:</b>	Mountain Valley Pipeline	<b>Inspector:</b>	Marshall Willis
<b>Inspection Date:</b>	Thursday, November 2, 2023	<b>Project Contact:</b>	Brian Clauto, Cory Chalmers
<b>Spread I:</b> Franklin County Pittsylvania County	STA 14850+00 – 14863+92 STA 15346+00 – 15260+00 STA 15595+00 – 15619+00 MVP-PI-332	<b>Weather:</b>	Dry

## FIELD INSPECTION PHOTO LOG

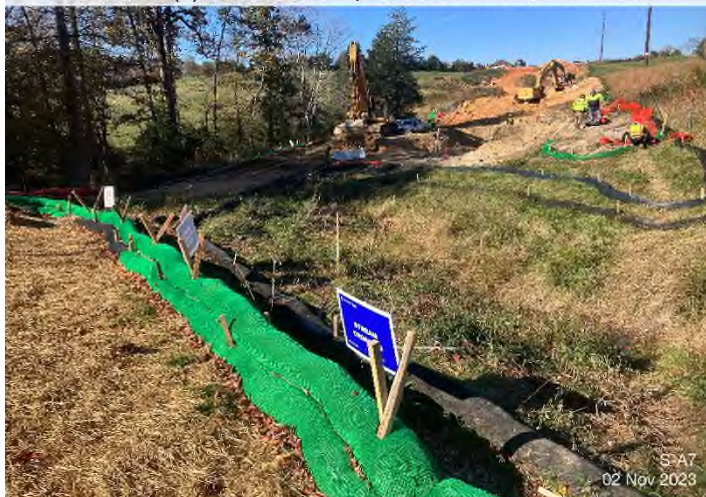
**Figure 1: Stream S-A7** – Controls installed and properly functioning.

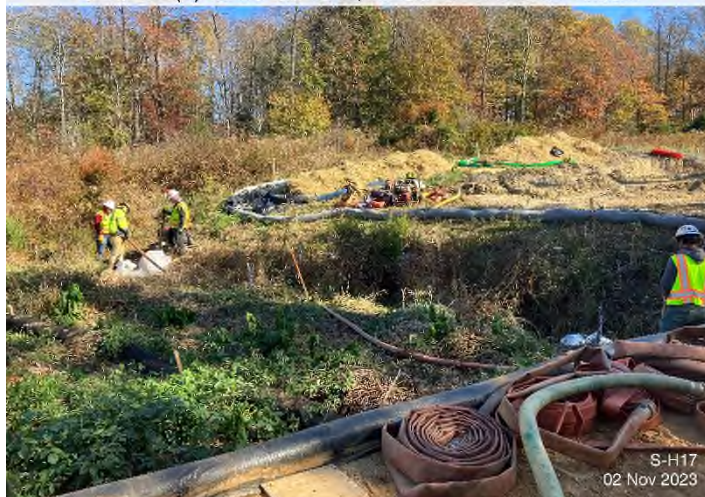
**Figure 2: Stream S-H17** – Controls installed and properly functioning.

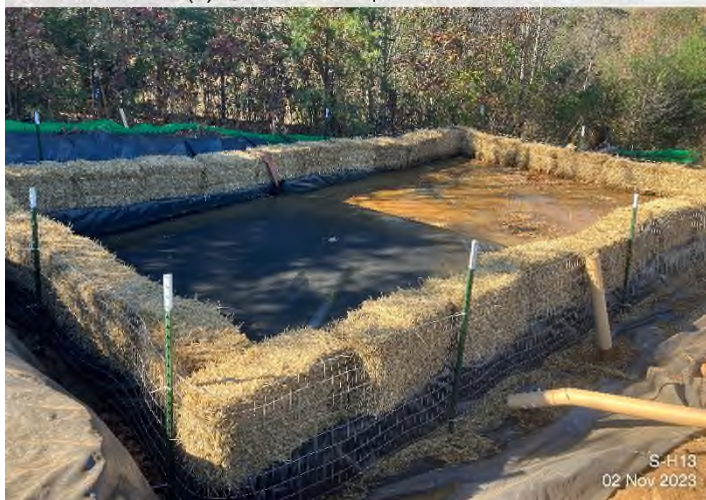
**Figure 3: Stream S-H13** – Controls installed and properly functioning.

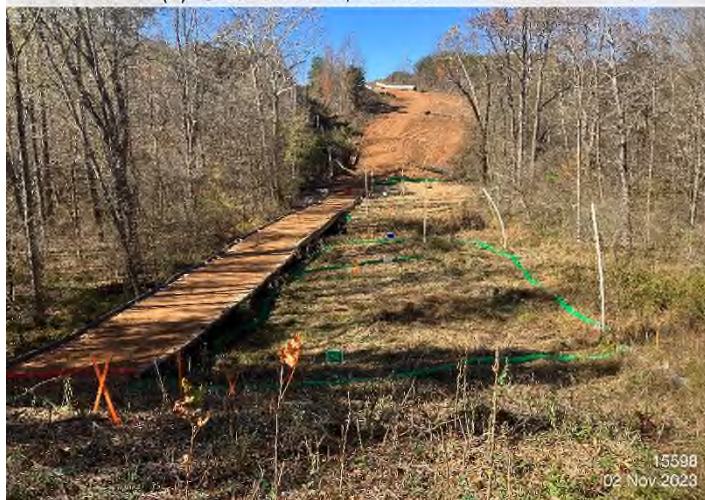
**Figure 4: STA 15598+00** – Controls installed and properly functioning.
