Project Name:	Mountain Valley Pipeline	Inspector:	Matthew Grant
Inspection Date:	Wednesday, November 29, 2023	Project Contact:	Brian Clauto
Spread H: Montgomery	Sta 12071-12150 ATWS 1163, 1162, 701, 1168 AR MN 270	Weather:	Dry

FIELD INSPECTION PHOTO LOG

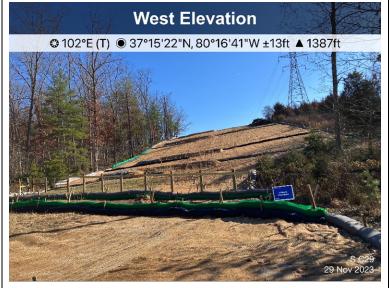
<u>Figure 4</u>: Sta 12137, ECD's are in place and stabilization has been applied.
