FIELD INSPECTION REPORT

Project Name:	Mountain Valley Pipeline	Inspector:	Marshall Willis
Inspection Date:	Tuesday, November 14, 2023	Project Contact:	Brian Clauto, Cory Chalmers
Spread H: Roanoke County	STA 12942+05 – 12960+00 STA 12915+20 – 12938+19 STA 12980+00 – 12994+02 MVP-RO-288 MVP-RO-287 MVP-RO-286	Weather:	Dry

FIELD INSPECTION PHOTO LOG

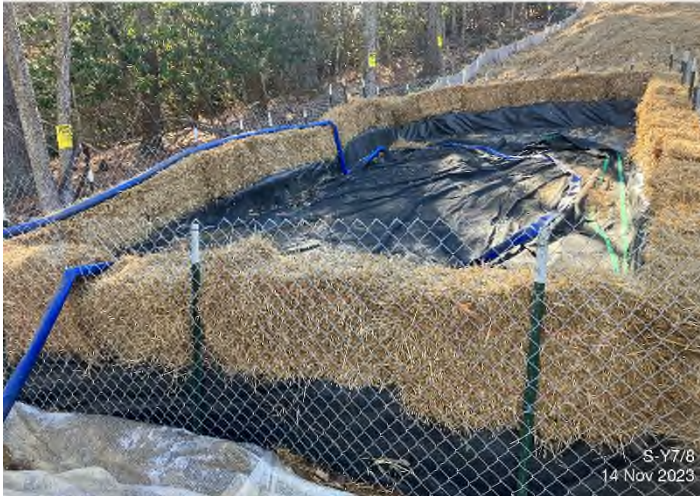
S-Y7/8
14 Nov 2023

Figure 1: Streams S-Y7 and S-Y8 – Controls installed and functioning properly.

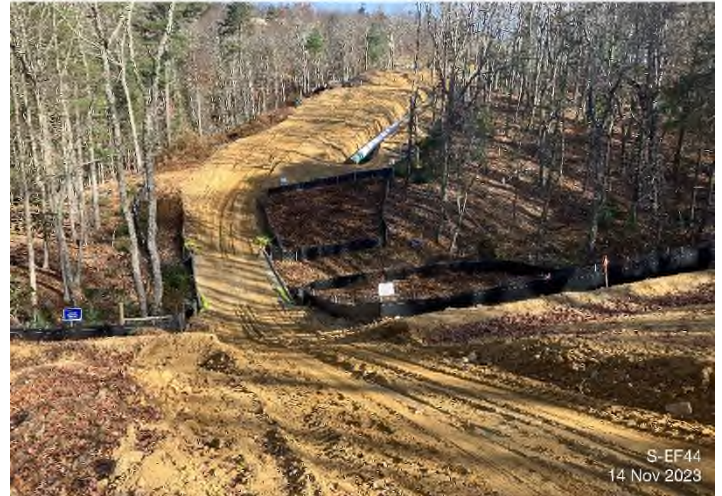
S-EF44
14 Nov 2023

Figure 2: Stream S-EF44 – Controls installed and functioning properly.

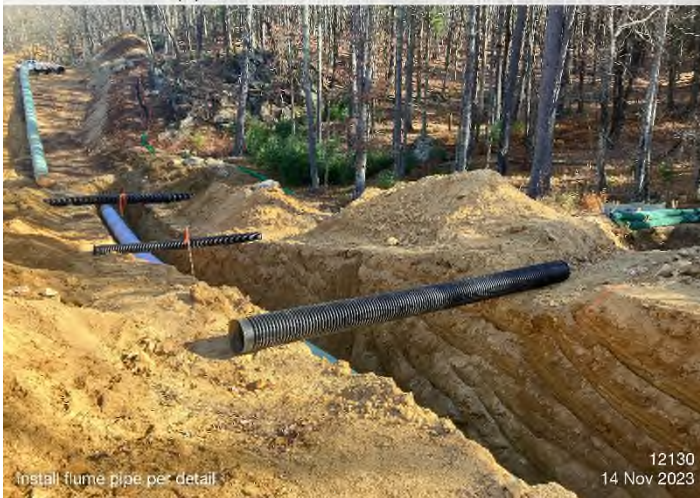
12130
14 Nov 2023

Figure 3: STA 12929+00 to 12937+00 – Install trench pipes per specification.

- STA 12929+00 to 12937+00: Install trench pipes per specification.

Deadline: Within 24-Hour of Notification

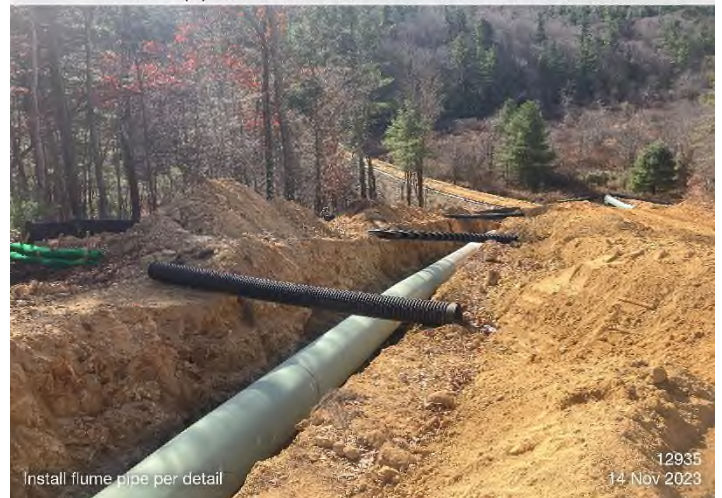
12935
14 Nov 2023

Figure 4: STA 12929+00 to 12937+00 – Install trench pipes per specification.
