## FIELD INSPECTION REPORT

| <b>Project Name:</b> | Mountain Valley Pipeline | <b>Inspector:</b> | Marshall Willis |

## FIELD INSPECTION PHOTO LOG

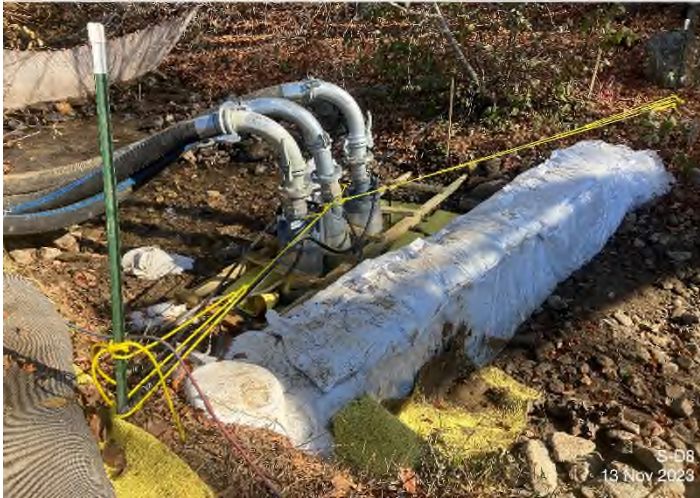
**Figure 1: Stream S-D8** – Controls in place and functioning properly.

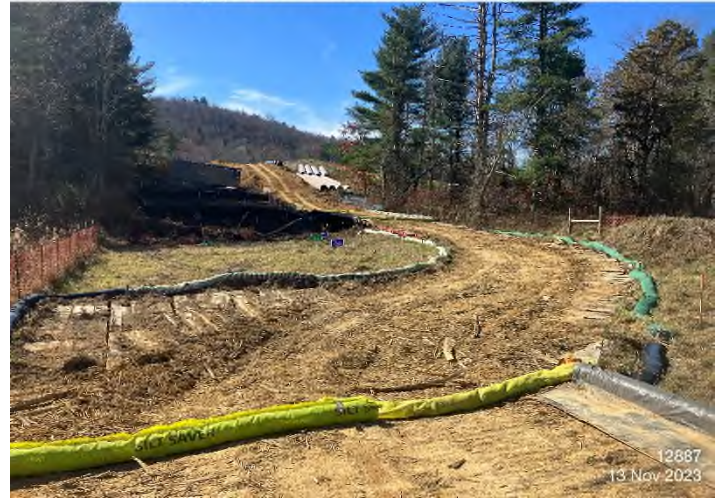
**Figure 2: STA 12887+00** – Controls in place and functioning properly.

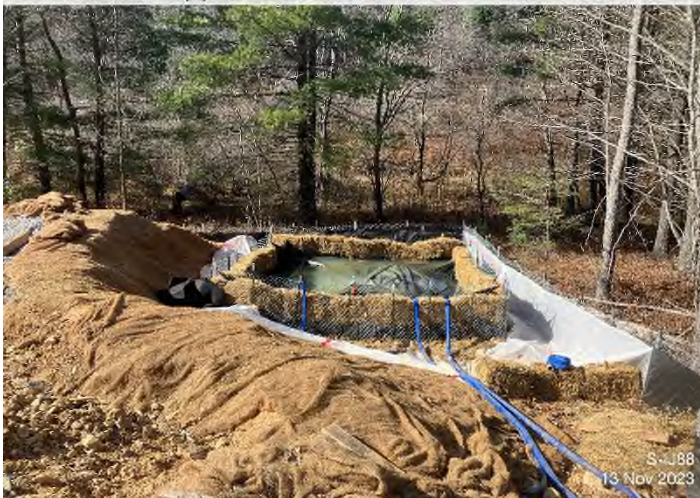
**Figure 3: Stream S-IJ88** – Controls in place and functioning properly.

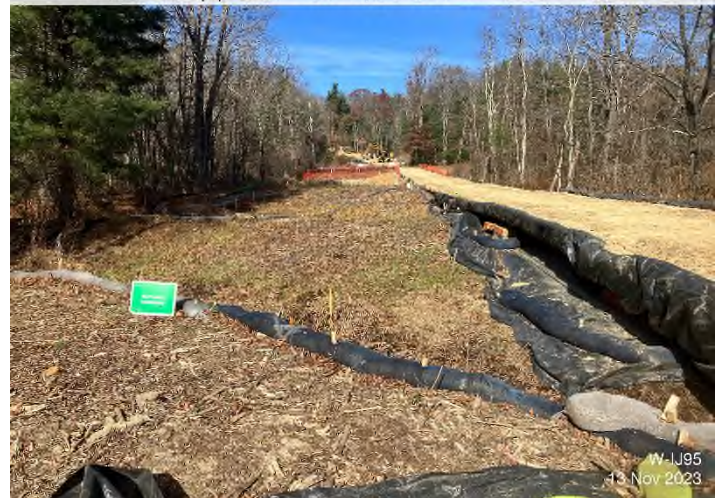
**Figure 4: Wetland W-IJ95** – Controls in place and functioning properly.
