## FIELD INSPECTION REPORT

<b>Project Name:</b>	Mountain Valley Pipeline	<b>Inspector:</b>	Marshall Willis
<b>Inspection Date:</b>	Wednesday, November 1, 2023	<b>Project Contact:</b>	Brian Clauto, Cory Chalmers
<b>Spread H: Roanoke County</b>	STA 12690+35 – 12699+00 STA 12794+32 – 12807+43 STA 12866+36 – 12890+00 MVP-RO-280 MVP-RO-283	<b>Weather:</b>	Dry

## FIELD INSPECTION PHOTO LOG

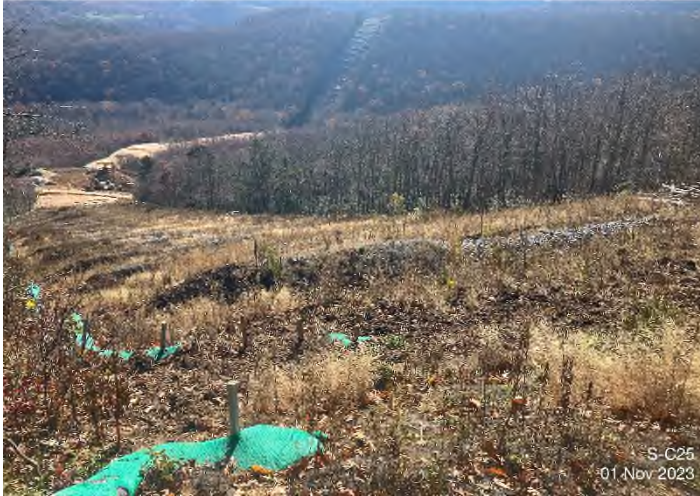
**Figure 1: STA 12691+00** – Controls installed and properly functioning.

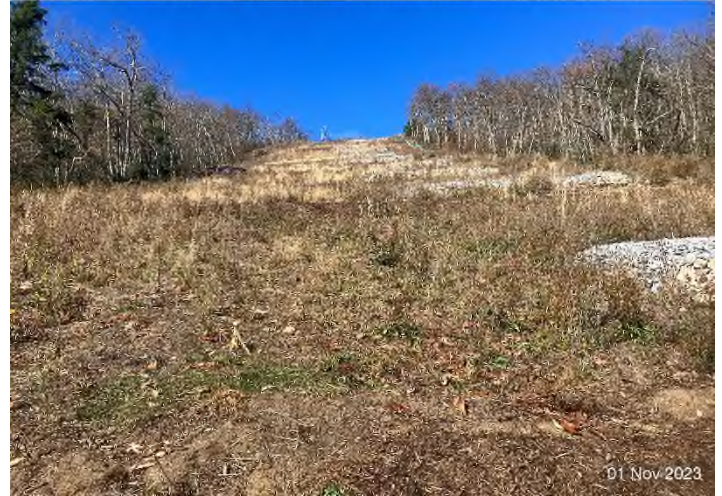
**Figure 2: STA 12699+00** – Controls installed and properly functioning.

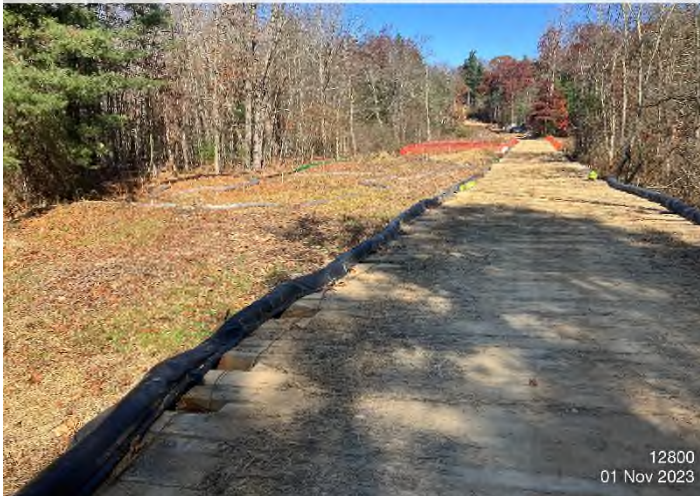
**Figure 3: STA 12800+00** – Controls installed and properly functioning.

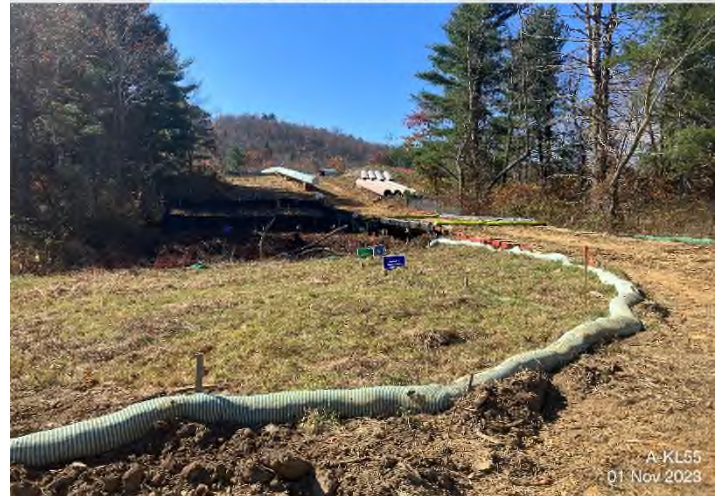
**Figure 4: Stram S-KL55** – Controls installed and properly functioning.
