## **FIELD INSPECTION REPORT**

Project Name:	Mountain Valley Pipeline	Inspector:	Marshall Willis
Inspection Date:	Monday, October 30, 2023	Project Contact:	Brian Clauto, Cory Chalmers
Spread H: Montgomery County	STA 12101+00 - 12110+00 STA 12119+17 - 12140+00 MVP-MN-272 MVP-MN-271	Weather:	Dry

## FIELD INSPECTION PHOTO LOG

**Project Name:** Mountain Valley Pipeline

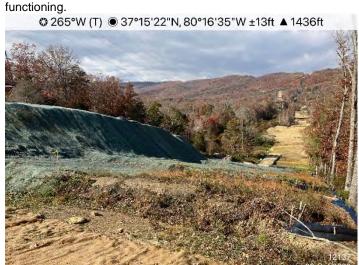
Figure 4: STA 12137+00 – Controls installed and properly
