FIELD INSPECTION REPORT

Project Name:	Mountain Valley Pipeline	Inspector:	Marshall Willis
Inspection Date:	Tuesday, December 5, 2023	Project Contact:	Brian Clauto, Cory Chalmers
Spread H: Montgomery County	STA 12031+51 – 12035+75 STA 12420+73 – 12435+16 STA 12445+19 – 12464+25 MVP-MN-268 MVP-MN-279	Weather:	Dry

FIELD INSPECTION PHOTO LOG

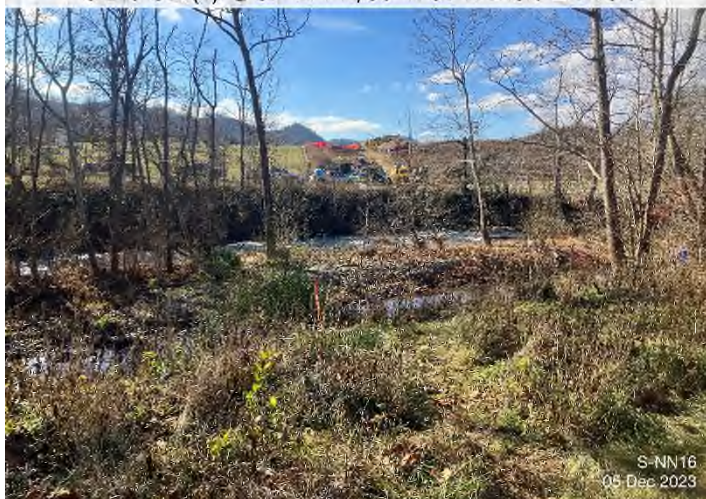
Figure 1: Stream S-NN16 – Controls installed and functioning properly.

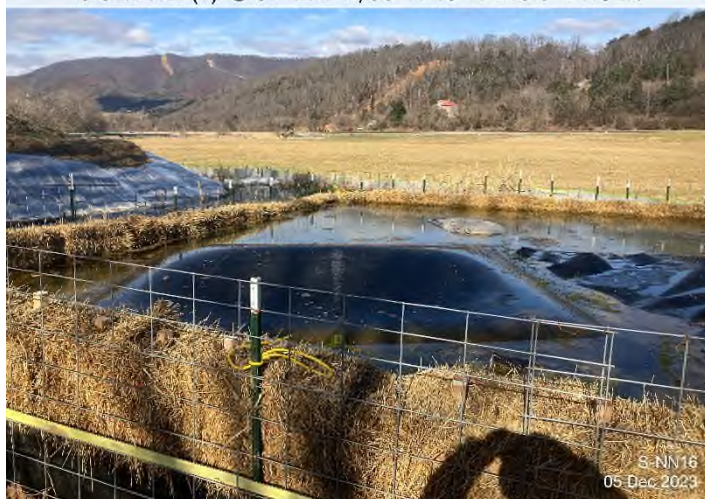
Figure 2: STA 12434+00 – Controls installed and functioning properly.

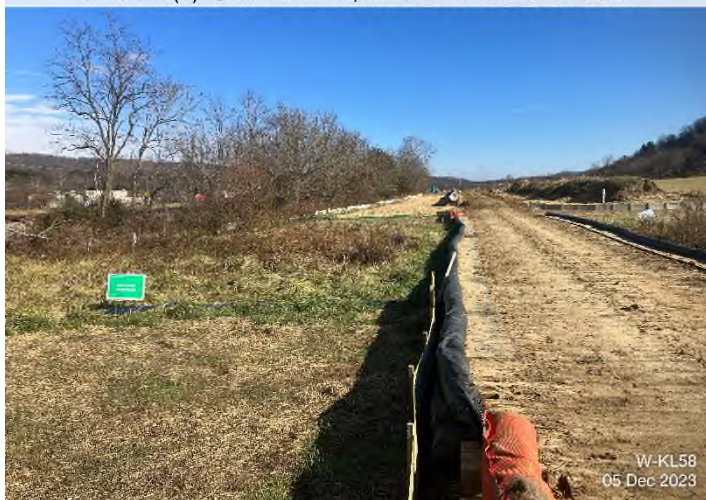
Figure 3: Wetland W-KL58 – Controls installed and functioning properly.

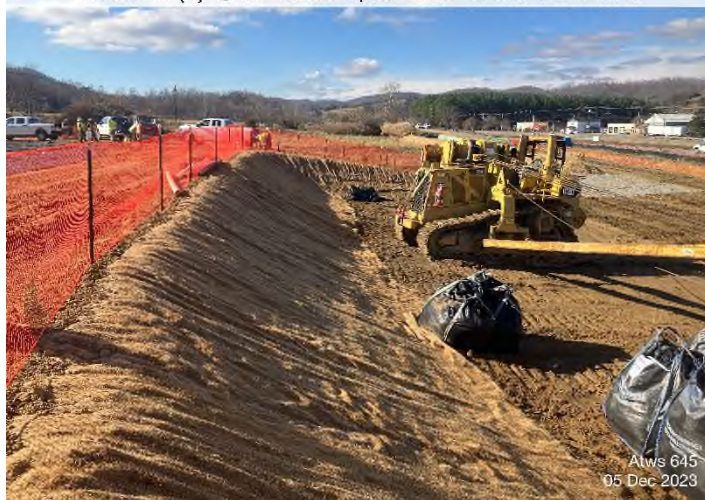
Figure 4: ATWS 645 – Controls installed and functioning properly.
