COMPLAINT INVESTIGATION REPORT

Project Name:	Mountain Valley Pipeline	Inspector:	Marshall Willis
Inspection Date:	Monday, December 4, 2023	Project Contact:	Brian Clauto, Cory Chalmers
Spread H: Roanoke County	MVP-RO-282 MVP-RO-283	Weather:	Wet

FIELD INSPECTION PHOTO LOG

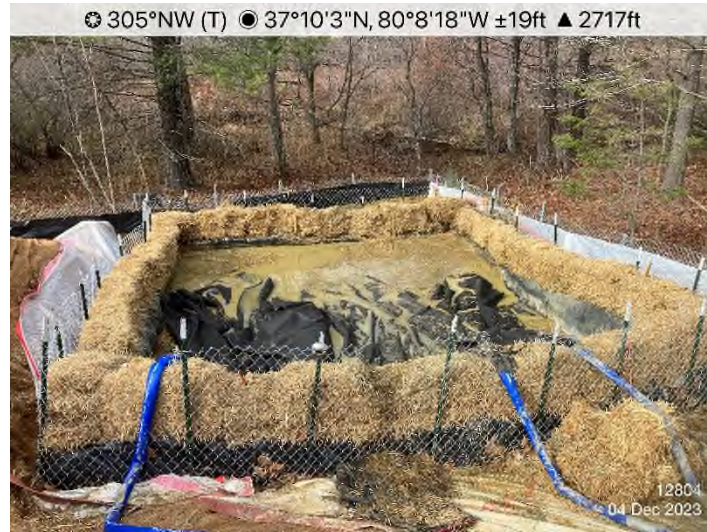
- Several locations were inspected along access roads RO-282 and RO-283. No dewatering was occurring along RO-282 which is closest to the location provided within the PREP report.
- Three dewatering structures were located from STA 12792+00 to 12807+00.
- The dewatering structure at STA 12804+00 was found to have sediment accumulation within the structure outside of the sediment bag. The source of the sediment within the structure occurred from a previous removal of a full sediment bag. No sediment deposition was found outside of the dewatering structure itself and no sediment was observed discharged from the LOD.
- A corrective action was noted to remove the sediment from within the dewatering structure to prevent the treated water becoming more turbid prior to being discharged as sheet flow to a well vegetated area.

Figure 1: STA 12804+00– Dewatering structure maintenance needed. Remove sediment from within dewatering structure.

- STA 12804+00: Remove sediment from within dewatering structure.

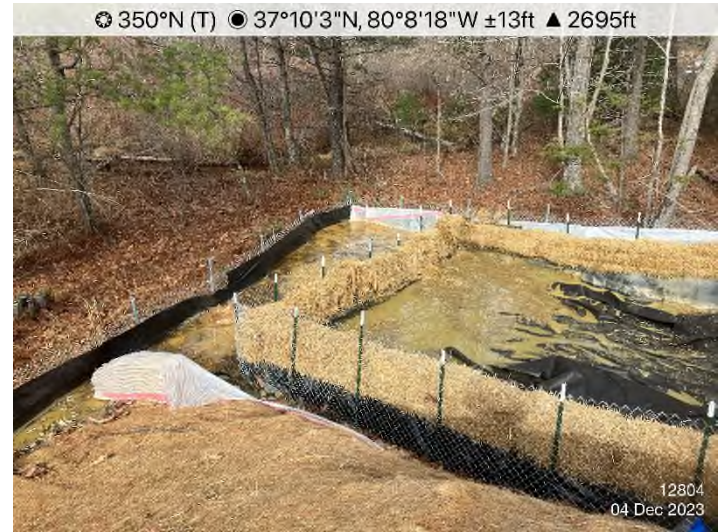
Figure 2: STA 12804+00 – Dewatering structure maintenance needed. Remove sediment from within dewatering structure.
