## COMPLAINT INVESTIGATION REPORT

Project Name:	Mountain Valley Pipeline	Inspector:	Marshall Willis
Inspection Date:	Thursday, November 30, 2023	Project Contact:	Brian Clauto, Cory Chalmers
Spread H: Roanoke County	STA 12848+00 – 12870+00	Weather:	Dry

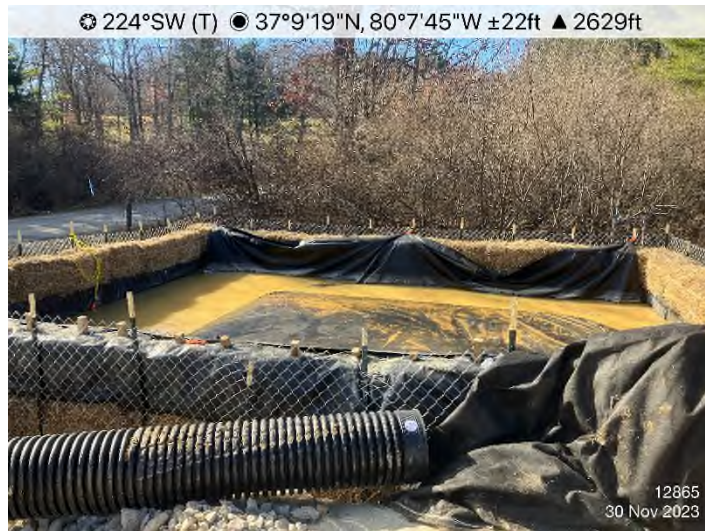
**Figure 1: STA 12865+00** – Dewatering structure on west side of Bottom Creek Road.

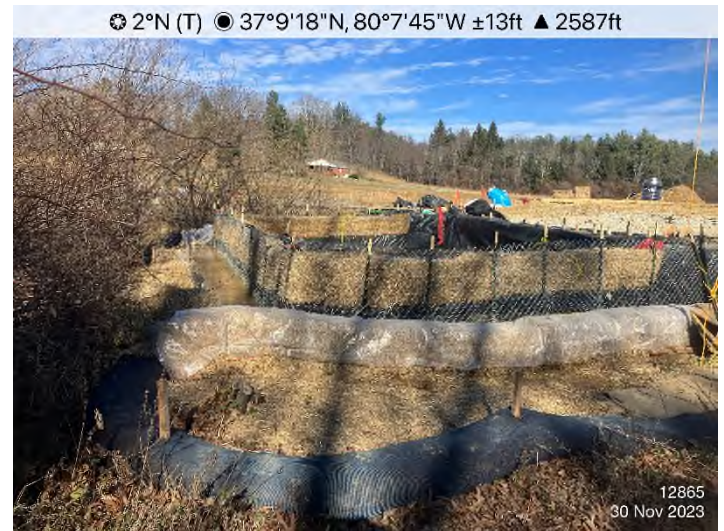
**Figure 2: STA 12865+00** – Dewatering structure on west side of Bottom Creek Road.

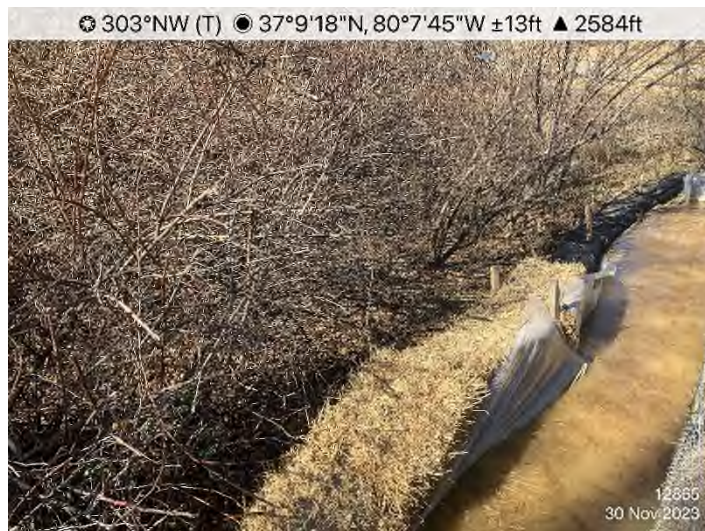
1. Dewatering structure in question is located on the west side of Bottom Creek Road and was functioning properly and discharging as sheet flow to a well vegetated area at the time of inspection.
2. Culvert underneath Bottom Creek Road, down-gradient of the dewatering structure in question was also inspected and had no observable impacts.
3. ECDs within the MVP LOD were per the approved plans and appeared to be functioning as designed.
4. No sediment discharged off ROW was found during the inspection.

**Figure 3: STA 12865+00** – Discharge point of dewatering structure on west side of Bottom Creek Road. Discharging to well vegetated area as sheet flow.

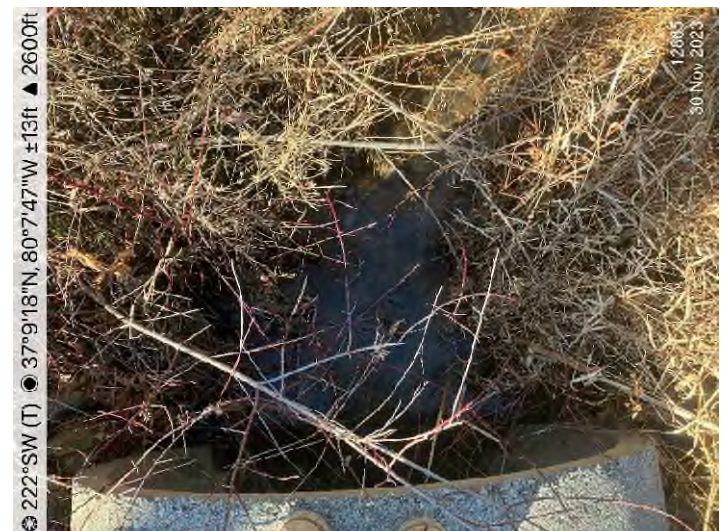
**Figure 4: Bottom Creek Road** – Upstream side of culvert under Bottom Creek Road. Culvert is downgradient of discharge location from dewatering operation.

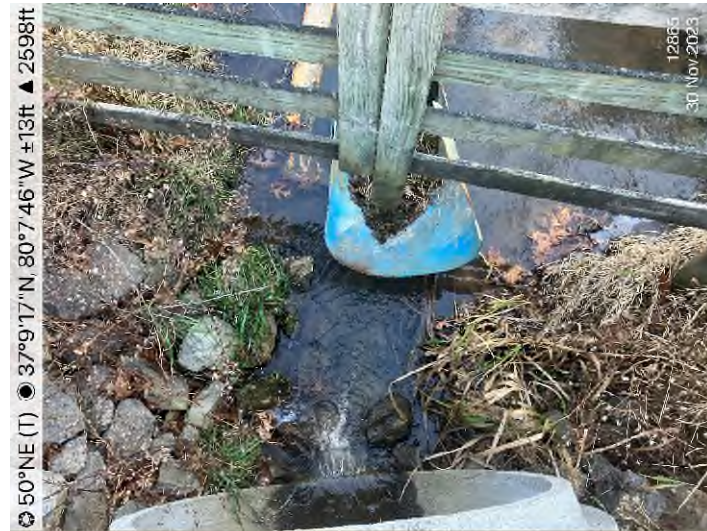
**Figure 5: Bottom Creek Road** – Downstream side of culvert under Bottom Creek Road. Culvert is downgradient of discharge location from dewatering operation.

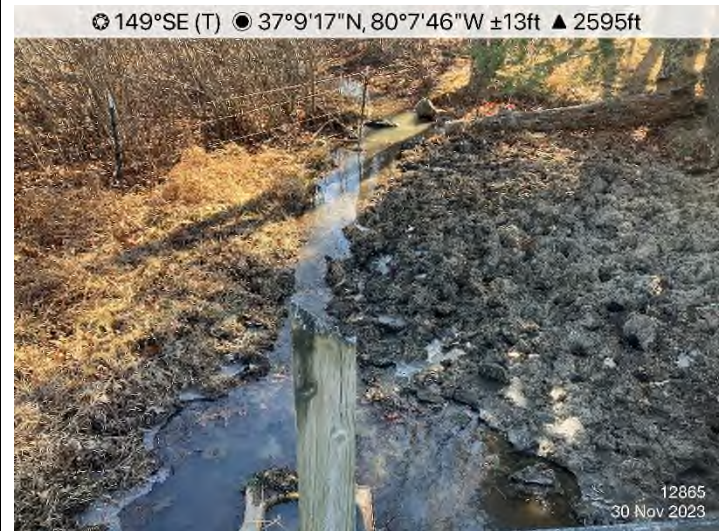
**Figure 6: Bottom Creek Road** – Downstream side of culvert under Bottom Creek Road. Culvert is downgradient of discharge location from dewatering operation. Showing “cows drinking site” as described in the PREP report.
