FIELD INSPECTION REPORT

Project Name:	Mountain Valley Pipeline	Inspector:	Marshall Willis
Inspection Date:	Wednesday, November 29, 2023	Project Contact:	Brian Clauto, Cory Chalmers
Spread H: Montgomery County	STA 12070+00 – 12155+00 MVP-MN-270	Weather:	Dry

FIELD INSPECTION PHOTO LOG

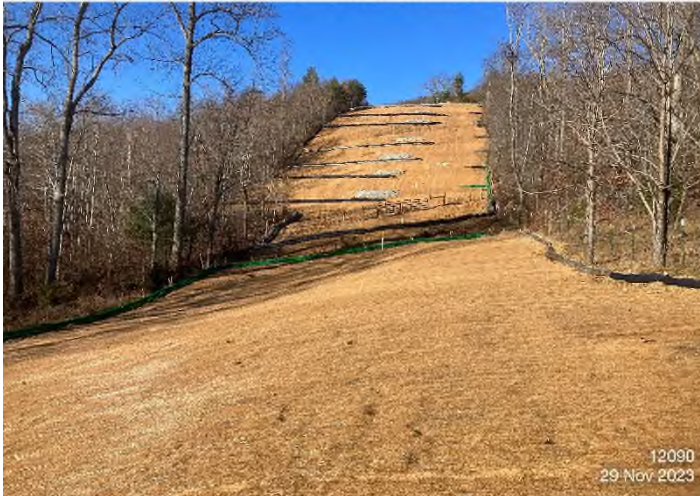
Figure 1: STA 12090+00 – Controls installed and functioning properly.

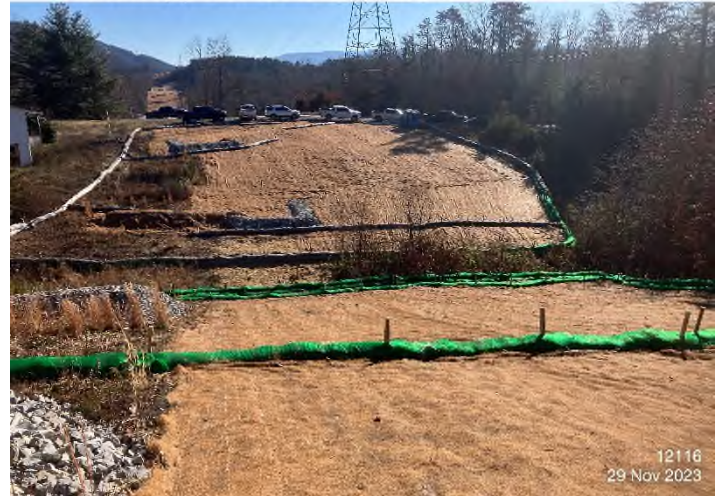
Figure 2: STA 12116+00 – Controls installed and functioning properly.

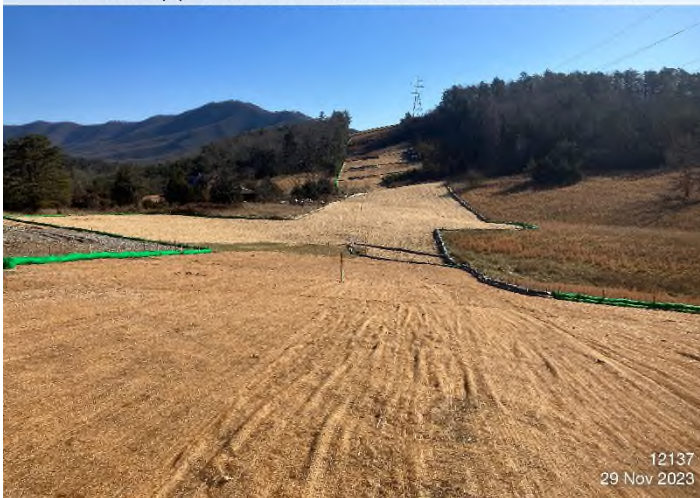
Figure 3: STA 12137+00 – Controls installed and functioning properly.

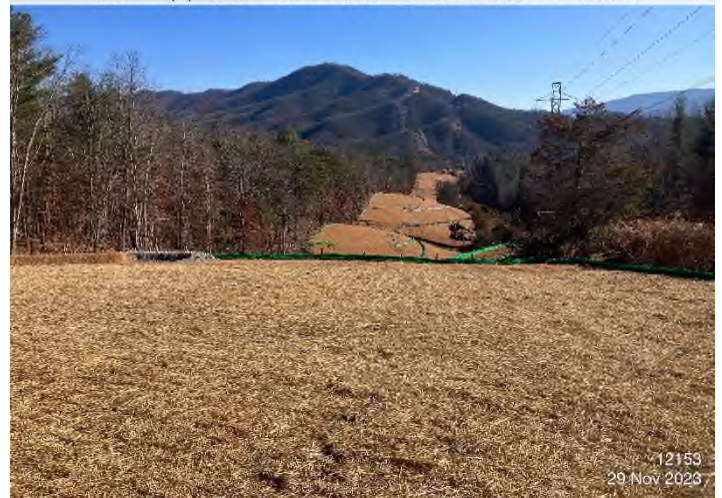
Figure 4: STA 12153+00 – Controls installed and functioning properly.
