FIELD INSPECTION REPORT

Project Name:	Mountain Valley Pipeline	Inspector:	Marshall Willis
Inspection Date:	Wednesday, December 13, 2023	Project Contact:	Brian Clauto, Cory Chalmers
Spread I: Franklin County	STA 14233+57 – 14249+19 STA 14411+09 – 14454+22 MVP-MLV-AR-32 MVP-FR-315	Weather:	Wet

FIELD INSPECTION PHOTO LOG

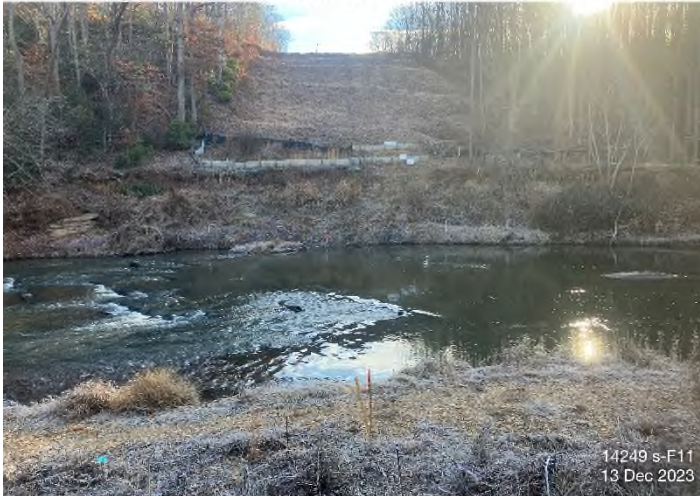
Figure 1: Stream S-F11 – Controls installed and functioning properly.

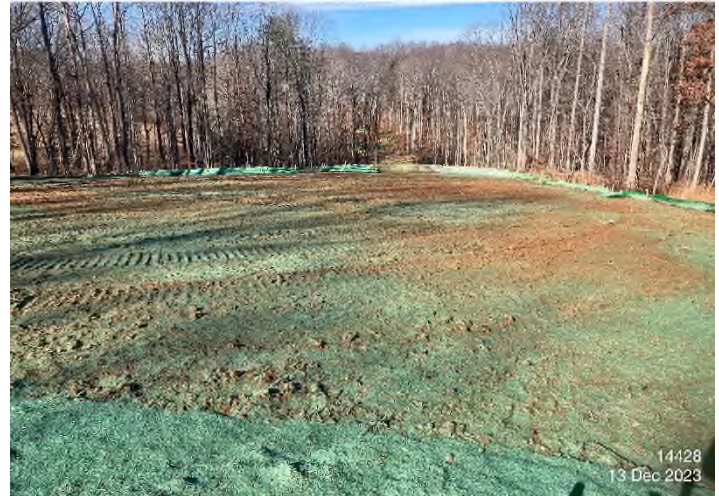
Figure 2: STA 14428+00 – Controls installed and functioning properly.

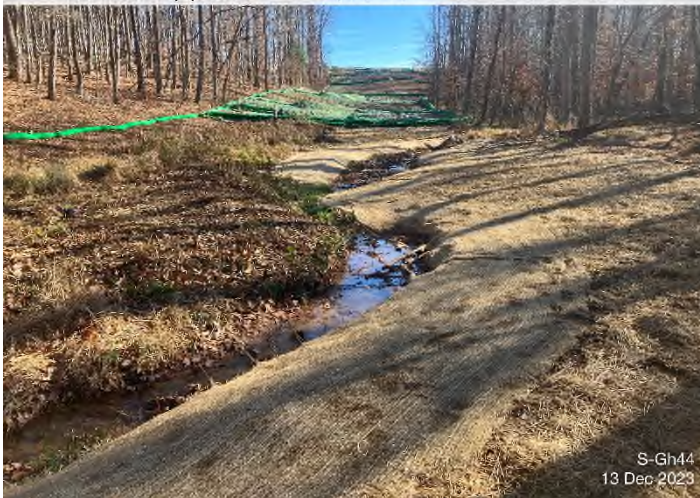
Figure 3: Stream S-GH44 – Controls installed and functioning properly.

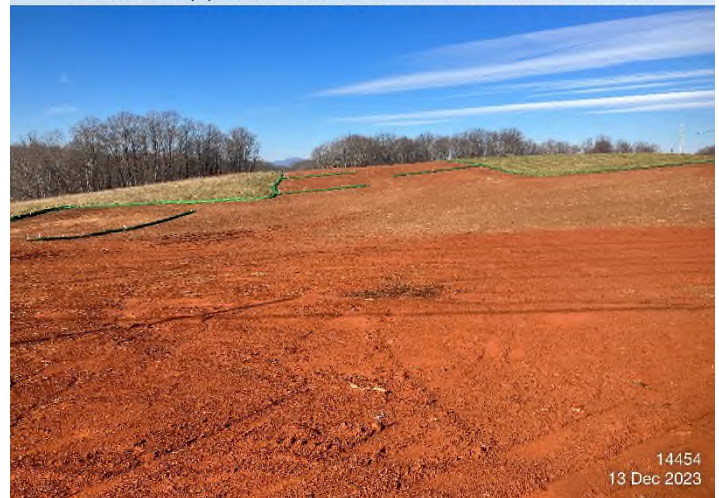
Figure 4: STA 14454+00 – Controls installed and functioning properly.
