## FIELD INSPECTION REPORT

| <b>Project Name:</b> | Mountain Valley Pipeline | <b>Inspector:</b> | Marshall Willis |
| <b>Inspection Date:</b> | Thursday, December 21, 2023 | <b>Project Contact:</b> | Brian Clauto, Cory Chalmers |
| <b>Spread I:<br/>Franklin County</b> | STA 13811+81 – 13875+73<br>MVP-FR-302<br>MVP-FR-303.01 | <b>Weather:</b> | Wet |

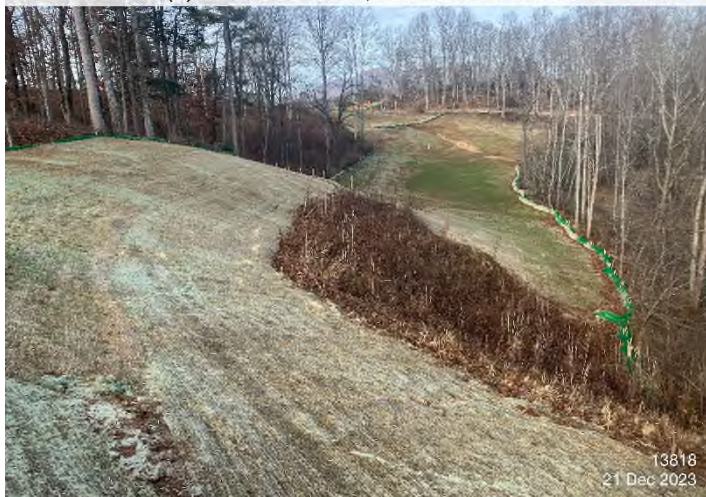
**Figure 1: STA 13818+00** – Controls installed and functioning properly.

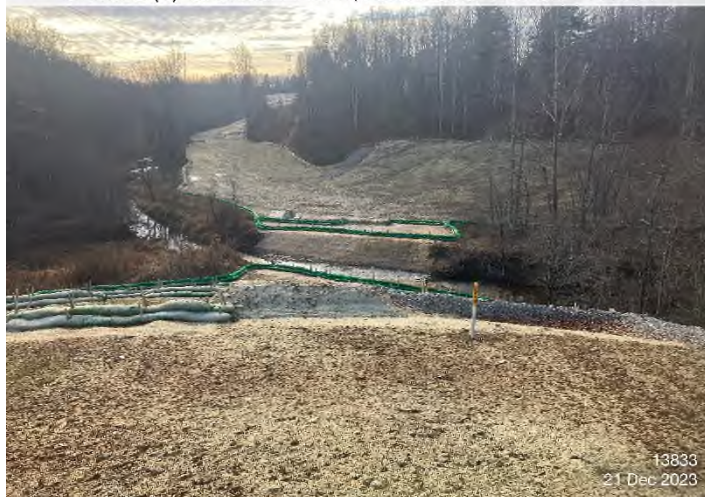
**Figure 2: STA 13833+00** – Controls installed and functioning properly.

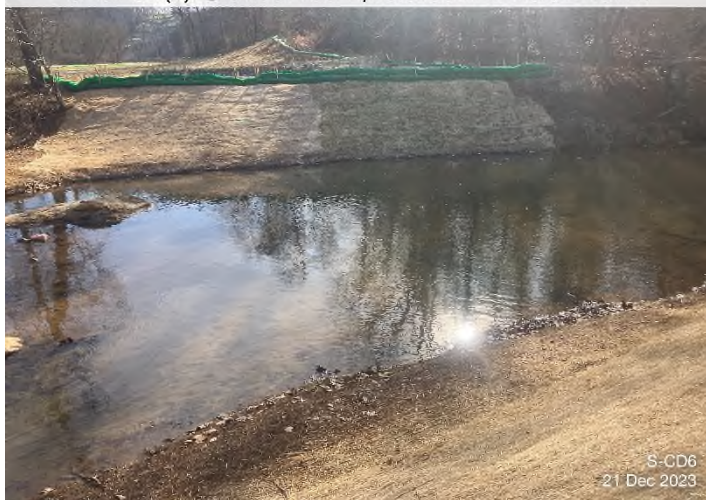
**Figure 3: Stream S-CD6** – Controls installed and functioning properly.

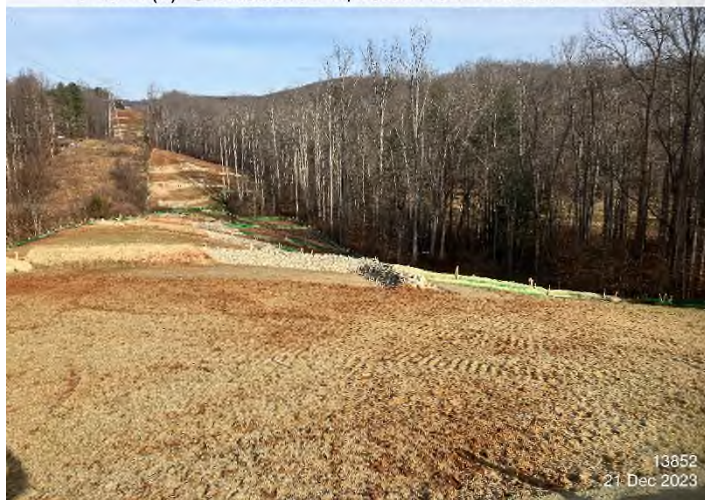
**Figure 4: STA 13852+00** – Controls installed and functioning properly.
