FIELD INSPECTION REPORT

Project Name:	Mountain Valley Pipeline	Inspector:	Marshall Willis
Inspection Date:	Tuesday, December 19, 2023	Project Contact:	Brian Clauto, Cory Chalmers
Spread I: Franklin County	STA 14333+27 – 14411+04 MVP-FR-313.01 MVP-FR-314 MVP-FR-315	Weather:	Wet

FIELD INSPECTION PHOTO LOG

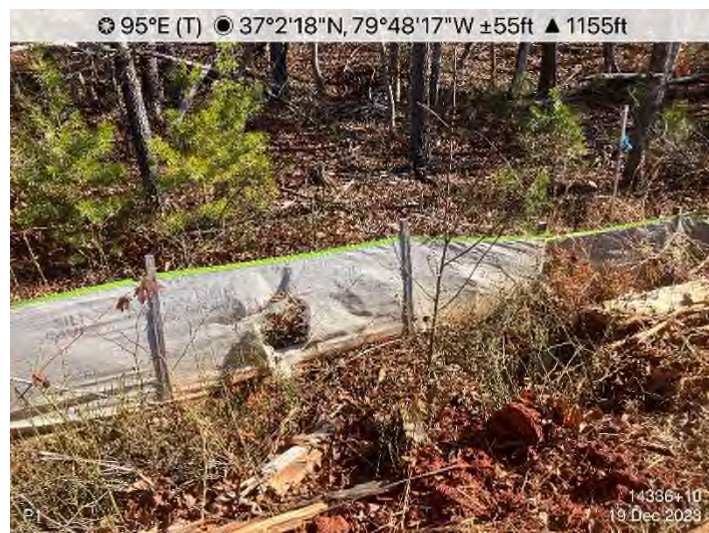
- STA 14336+10: P1 repair needed.
- STA 14355+39: WB lower than end treatment release point.
- MVP-FR-315: Construction debris off ROW.
- MVP-FR-315: Clean up fertilizer spill.

Figure 1: STA 14336+10 – P1 repair needed.

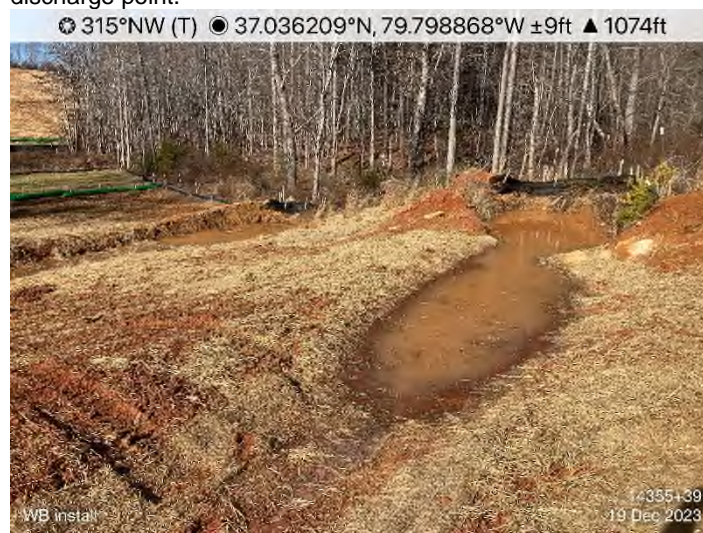
Figure 2: STA 14355+39 – Waterbar lower than end treatment discharge point.

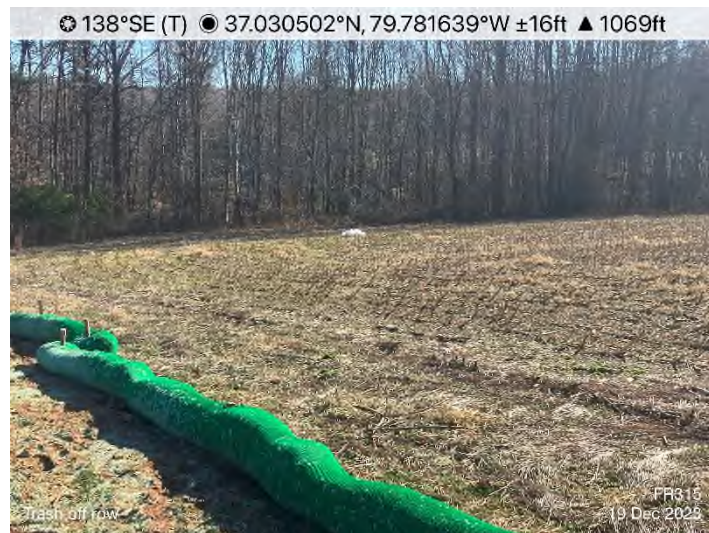
Figure 3: MVP-FR-315 – Retrieve construction debris off ROW.

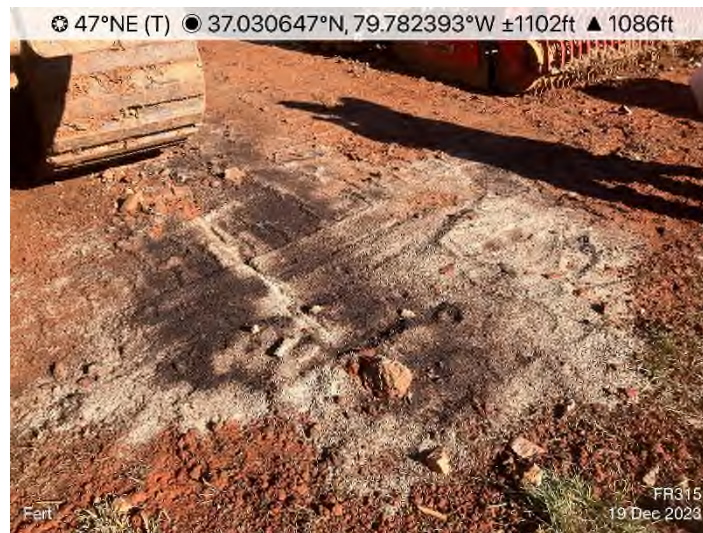
Figure 4: MVP-FR-315 – Clean up fertilizer spill.
