## **FIELD INSPECTION REPORT**

Project Name:	Mountain Valley Pipeline	Inspector:	Marshall Willis Brian Clauto, Cory Chalmers			
Inspection Date:	Monday, December 18, 2023	Project Contact:				
Spread I: Franklin County	STA 14233+57 - 14249+19 MVP-MLV-AR-32	Weather:	Wet

## FIELD INSPECTION PHOTO LOG

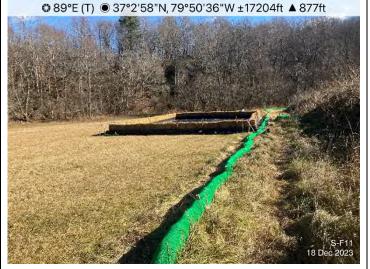
<u>Figure 4</u>: **ATWS 351A** – Controls installed and functioning properly.
