COMPLAINT INVESTIGATION REPORT

Project Name:	Mountain Valley Pipeline	Inspector:	Marshall Willis
Inspection Date:	Thursday, December 14, 2023	Project Contact:	Brian Clauto, Cory Chalmers
Spread H: Roanoke County	MVP-RO-287 STA 12955+04 – 12960+00	Weather:	Wet

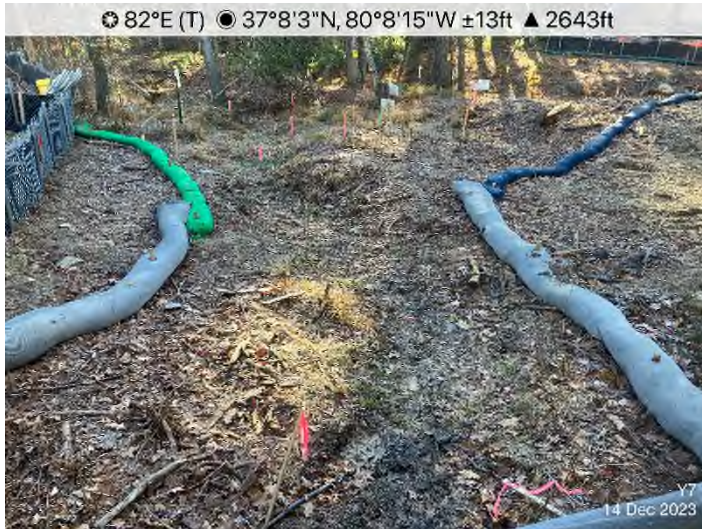
Figure 1: Stream S-Y7 – Controls installed and functioning properly.

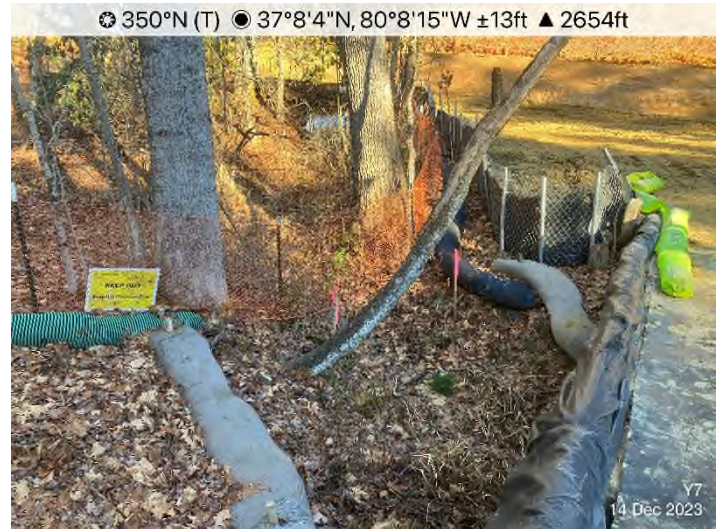
Figure 2: Stream S-Y7 – Controls installed and functioning properly.

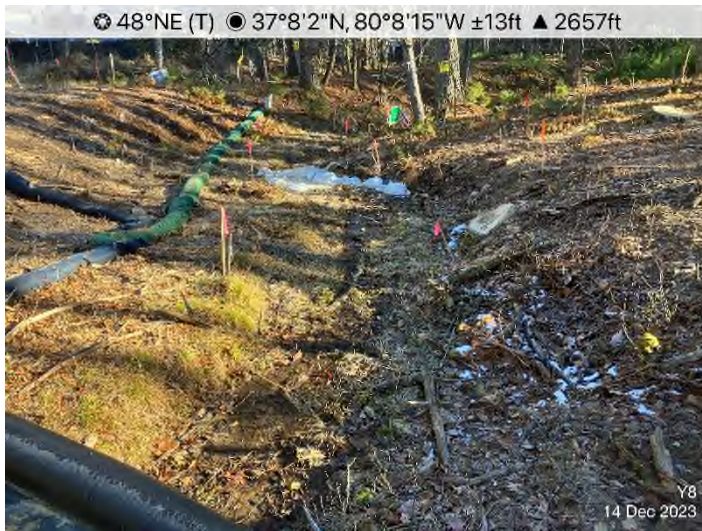
Figure 3: Stream S-Y8 – Controls installed and functioning properly.

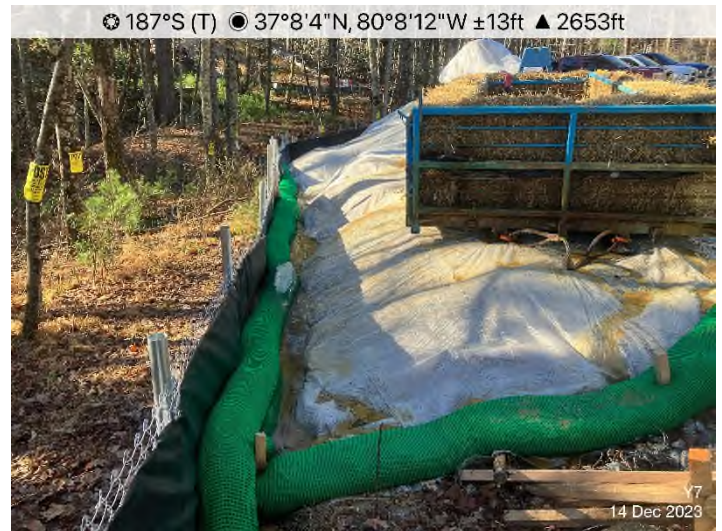
Figure 4: ATWS 1306 – Dewatering structure installed and functioning properly.
