FIELD INSPECTION REPORT

Project Name:	Mountain Valley Pipeline	Inspector:	Marshall Willis
Inspection Date:	Friday, January 12, 2024	Project Contact:	Brian Clauto, Cory Chalmers
Spread I: Franklin County	STA 14333+27 – 14311+09 MVP-FR-315	Weather:	Wet

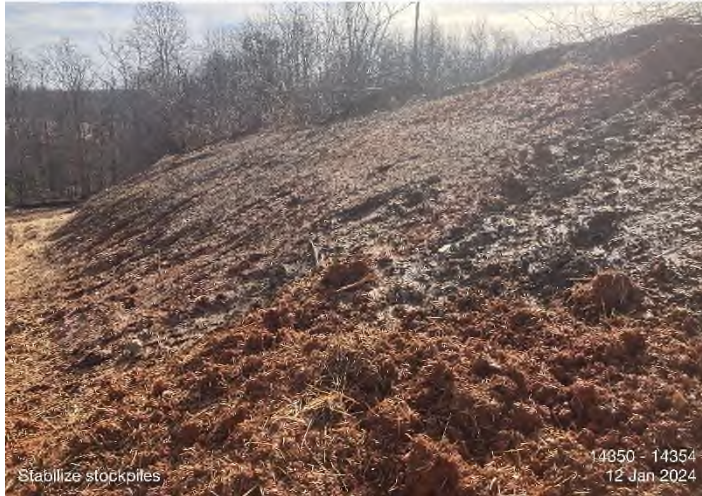
Figure 1: STA 14350+00 to 14354+00 – Restabilize stockpiles.

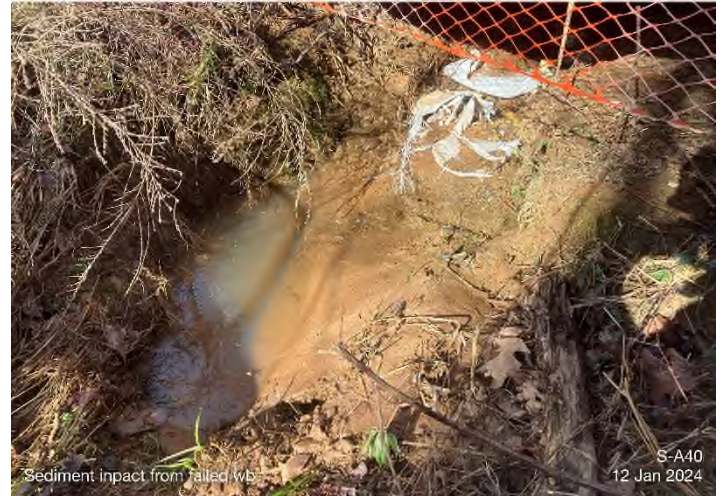
Figure 2: Stream S-A40 – Sediment impacting stream S-A40 from upslope waterbar failure.

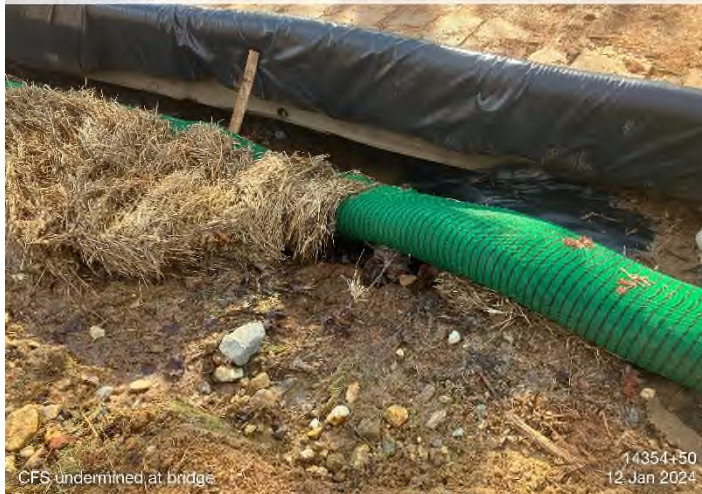
Figure 3: STA 14354+50 – CFS undermined.

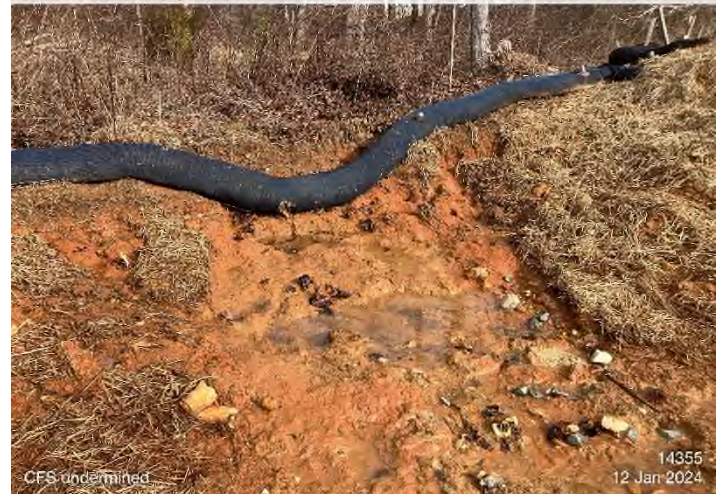
Figure 4: STA 14355+00 – CFS undermined.

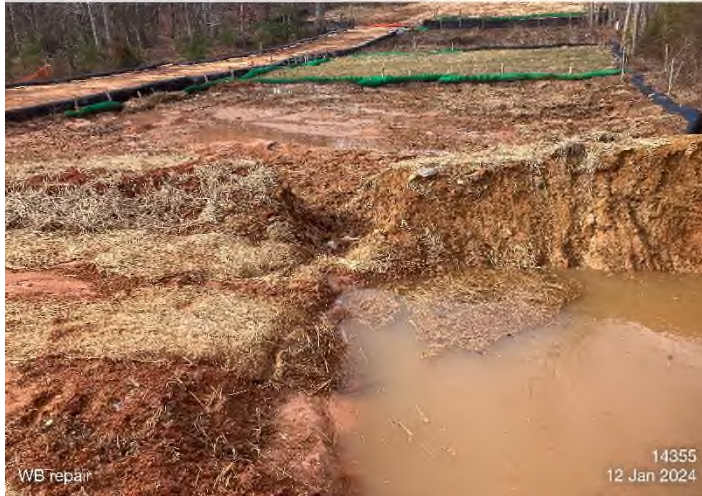
Figure 5: STA 14355+00 – Repair WB. Ensure WB discharges off ROW.

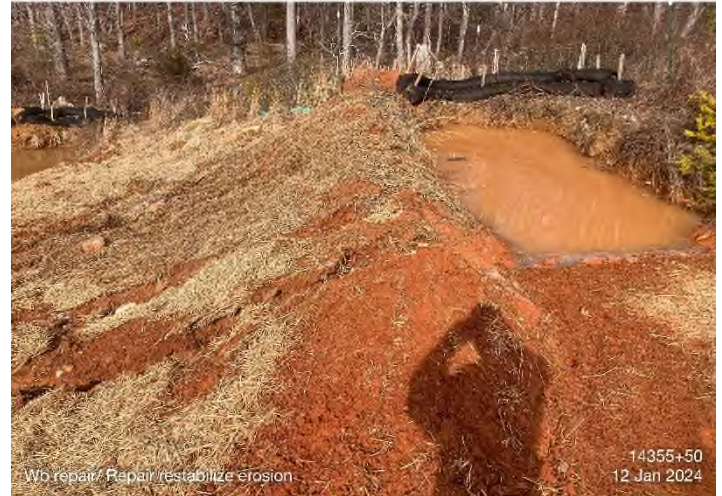
Figure 6: STA 14355+50 – Repair WB and repair/stabilize erosion. Ensure WB discharges off ROW.

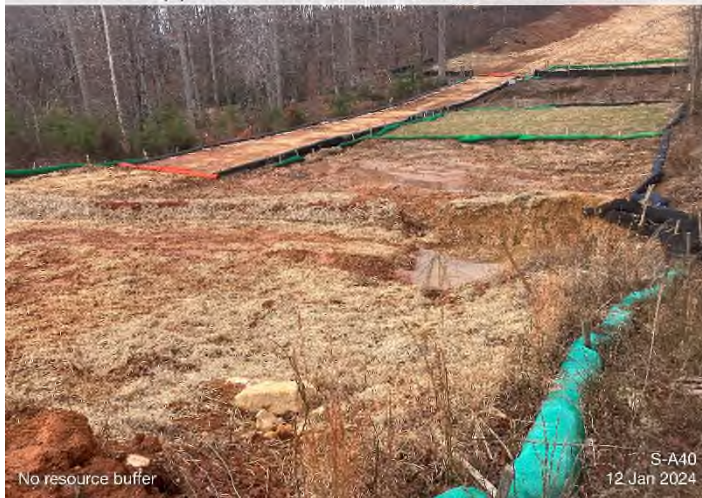
Figure 7: STA 14354+50 – Stabilize denuded area above resource S-A40.

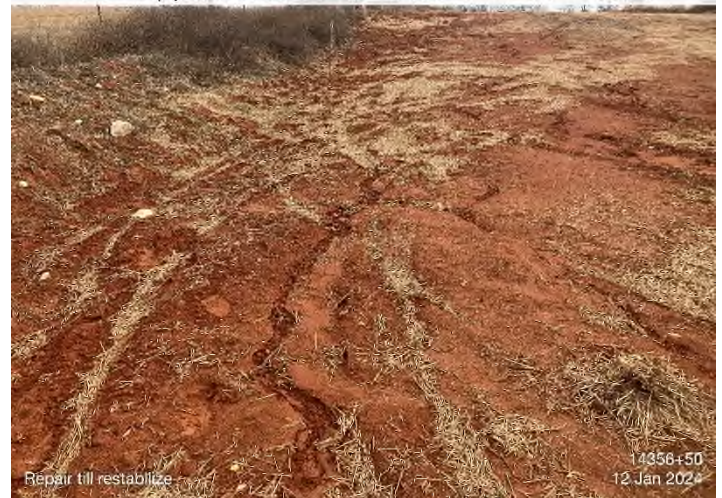
Figure 8: STA 14356+50 – Restabilize area.

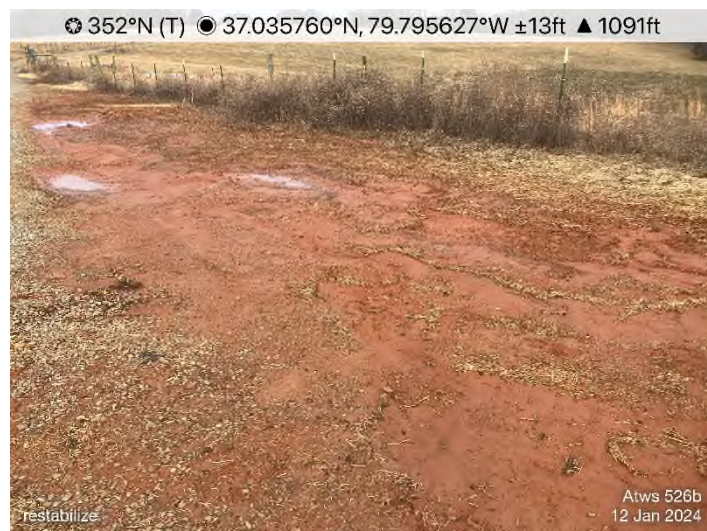
Figure 9: ATWS 526B – Restabilize denuded areas.

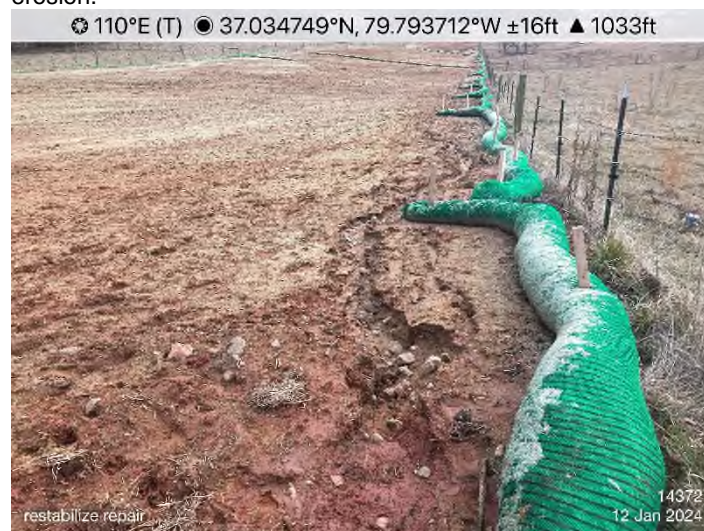
Figure 10: STA 14372+00 to 14386+00 – Repair and restabilize erosion.

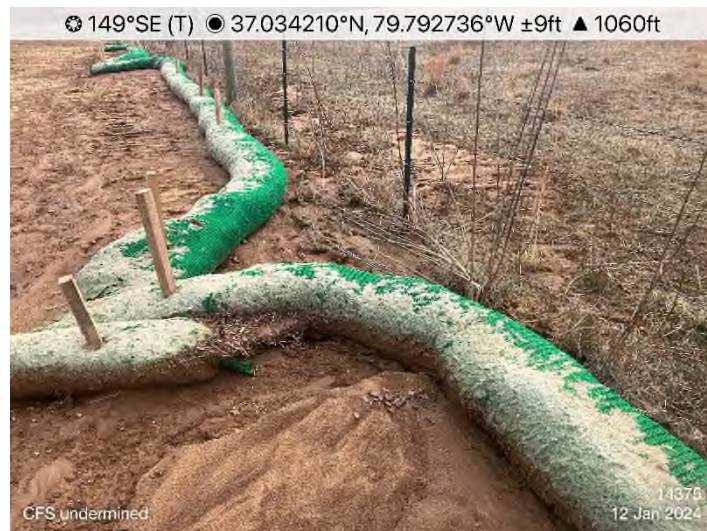
Figure 11: STA 14375+00 – CFS undermined.

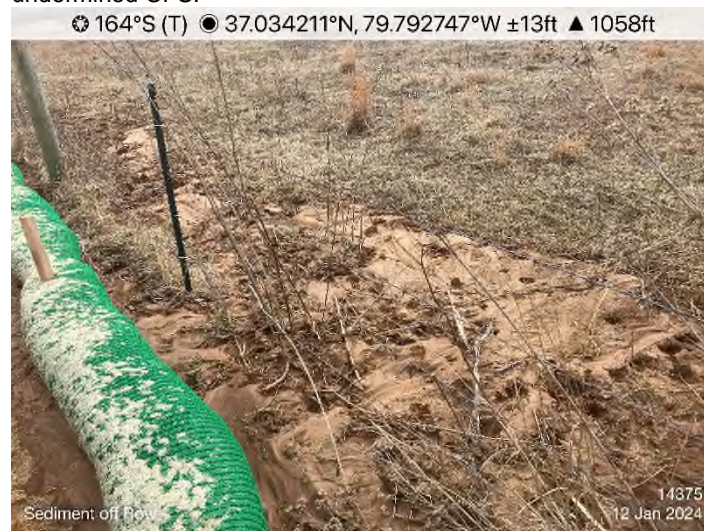
Figure 12: STA 14375+00 – Sediment discharged off ROW from undermined CFS.

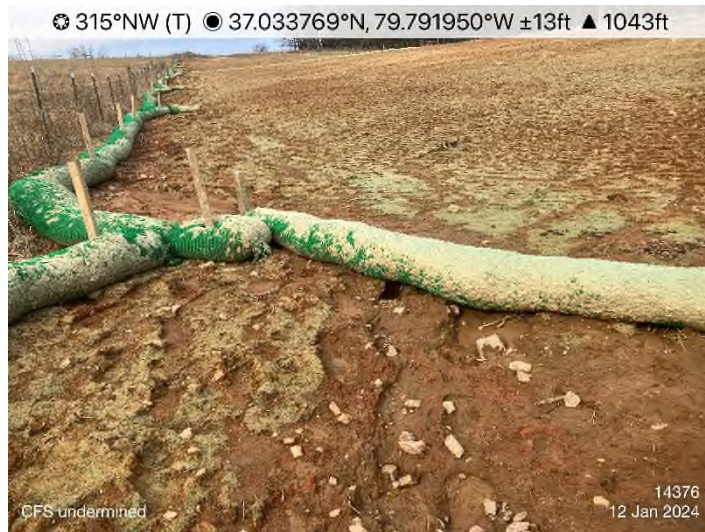
Figure 13: STA 14376+00 – CFS undermined.

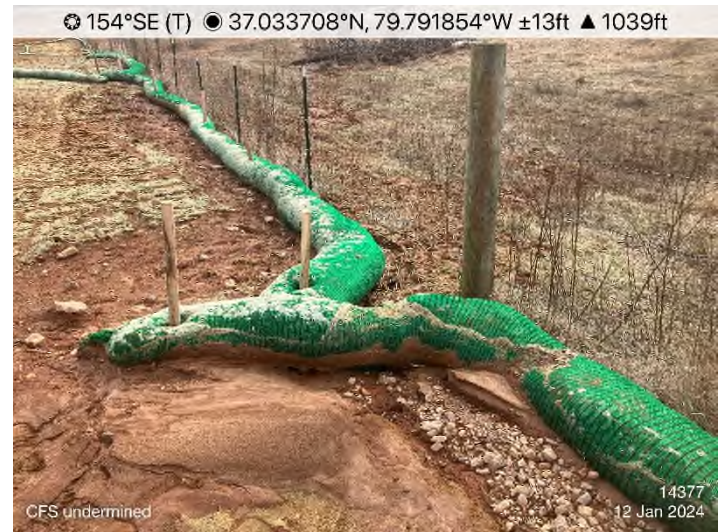
Figure 14: STA 14377+00 – CFS undermined.

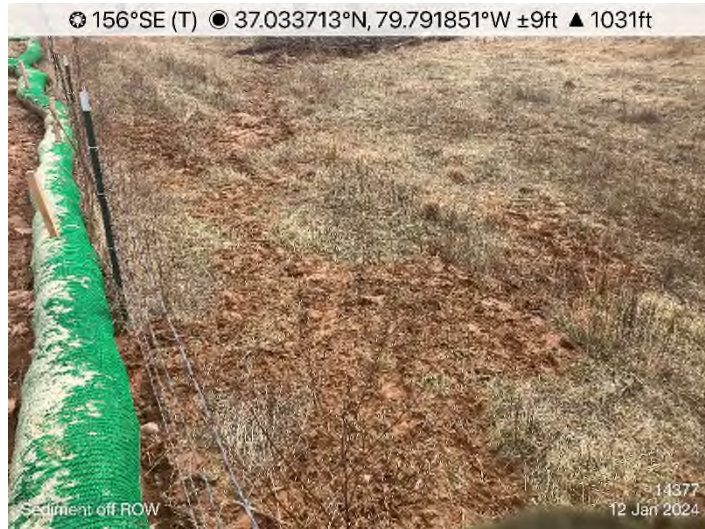
Figure 15: STA 14377+00 – Sediment discharged off ROW from undermined CFS.

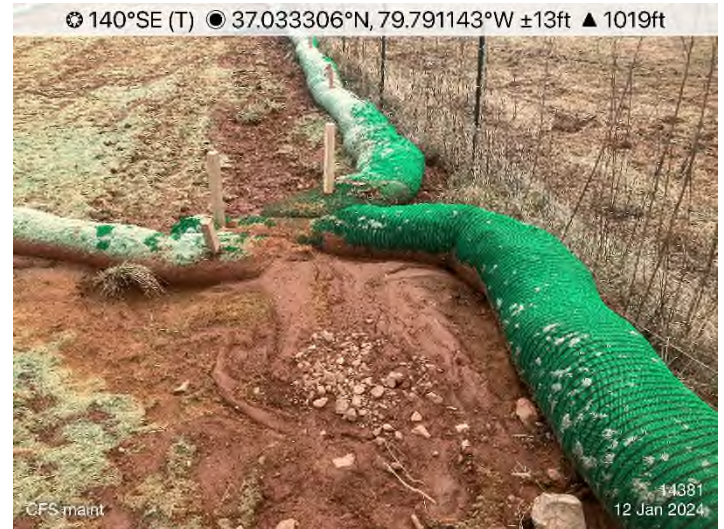
Figure 16: STA 14381+00 – CFS maintenance needed.

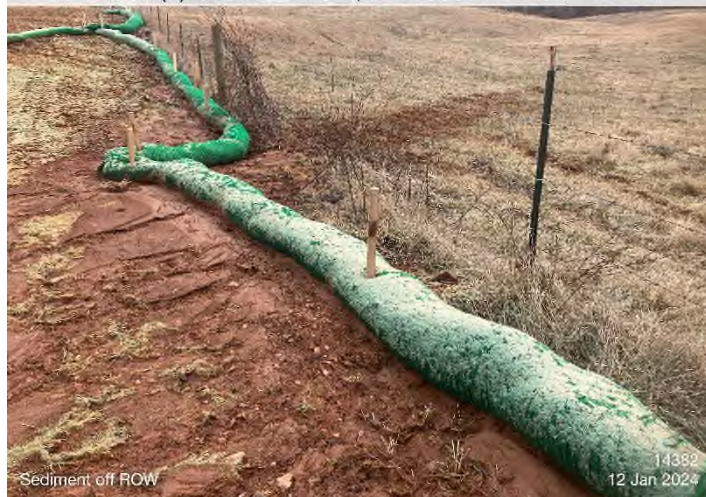
Figure 17: STA 14382+00 – Sediment off ROW from undermined CFS.

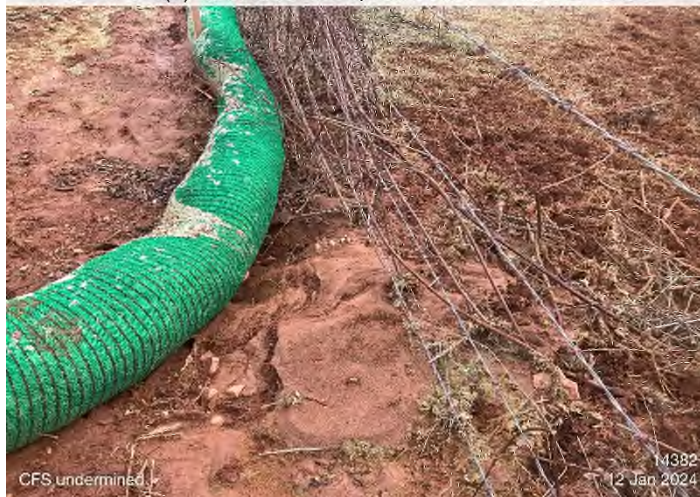
Figure 18: STA 14382+00 – CFS undermined.

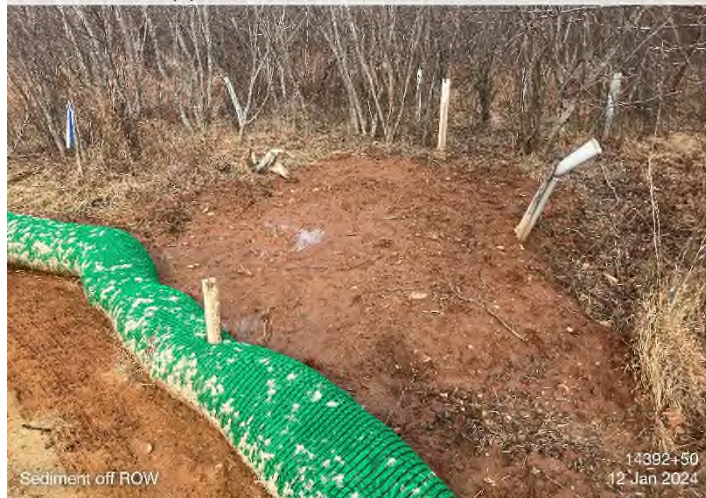
Figure 19: STA 14392+50 – Sediment off ROW.
