## FIELD INSPECTION REPORT

| Project Name: | Mountain Valley Pipeline | Inspector: | Marshall Willis |
| Inspection Date: | Monday, January 8, 2024 | Project Contact: | Brian Clauto, Cory Chalmers |
| Spread H:<br>Montgomery County | MVP-MN-268<br>MVP-MN-268.01 | Weather: | Wet |

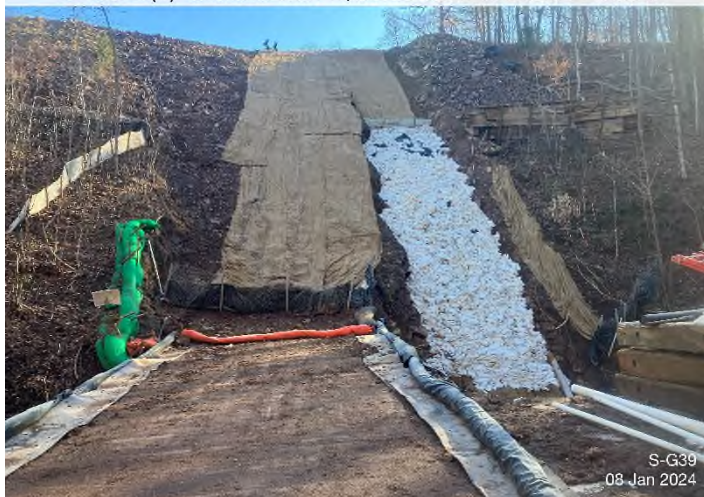
**Figure 1: Stream S-G39 – Controls installed and functioning properly.**

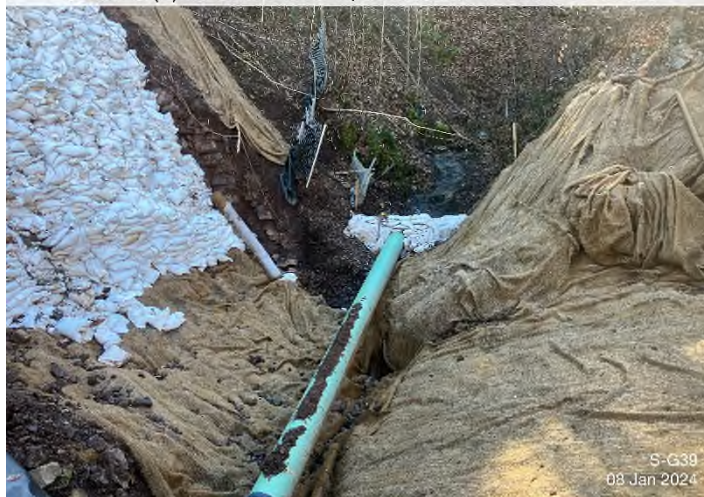
**Figure 2: Stream S-G39 – Controls installed and functioning properly.**

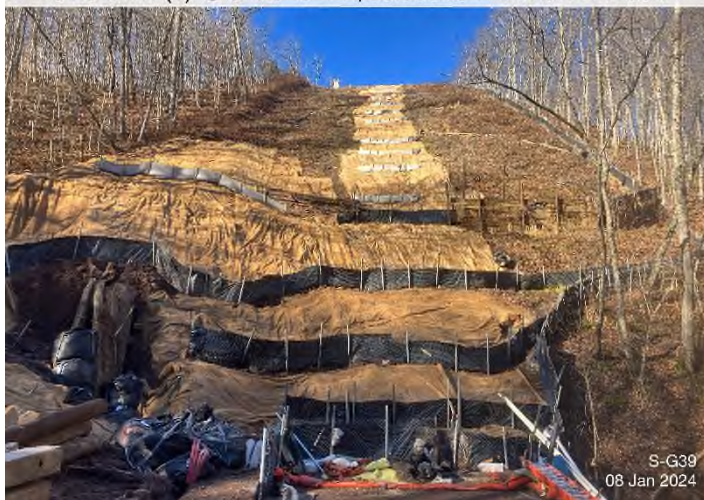
**Figure 3: Stream S-G39 – Controls installed and functioning properly.**

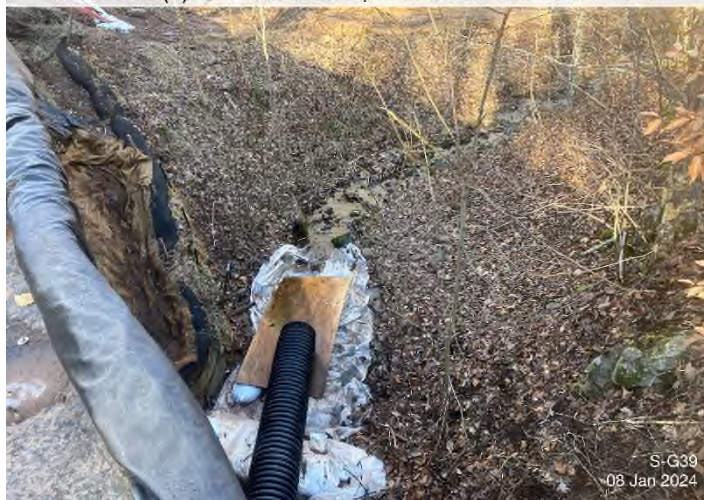
**Figure 4: Stream S-G39 – Controls installed and functioning properly.**
