COMPLAINT INVESTIGATION REPORT

Project Name:	Mountain Valley Pipeline	Inspector:	Marshall Willis
Inspection Date:	Wednesday, January 10, 2024	Project Contact:	Brian Clauto, Cory Chalmers
Spread H: Roanoke County	STA 12833+00 – 12870+00	Weather:	Wet

FIELD INSPECTION PHOTO LOG

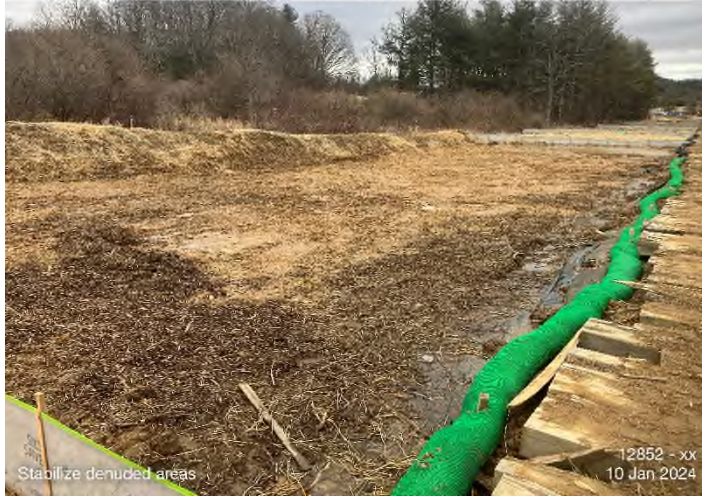
Figure 1: STA 12833+00 to 12865+00 – Seed/stabilize inactive denuded areas.

- STA 12833+00 through 12865+00: Stabilize denuded areas that are inactive.
- STA 12846+50: Repair erosion control matting.

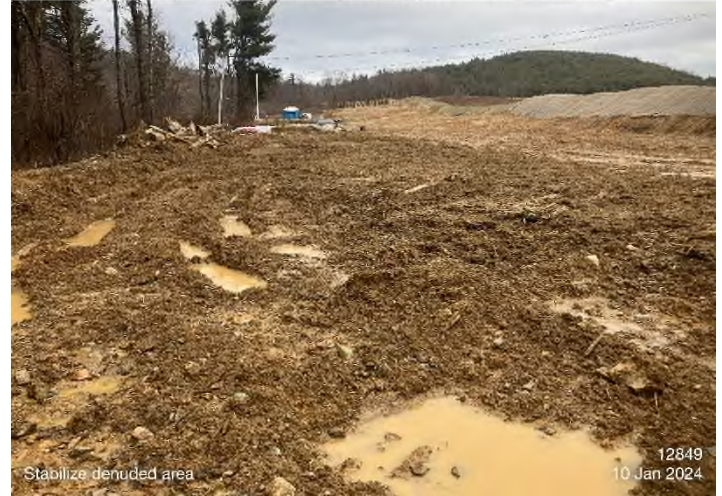
Figure 2: STA 12833+00 to 12865+00 – Seed/stabilize inactive denuded areas.

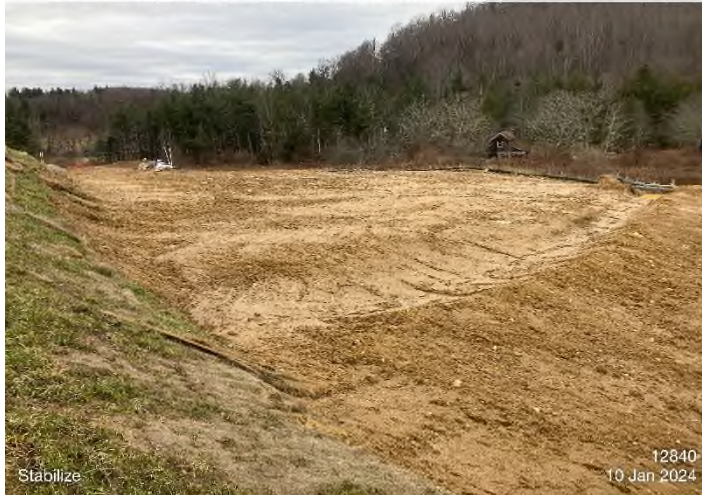
Figure 3: STA 12833+00 to 12865+00 – Seed/stabilize inactive denuded areas.

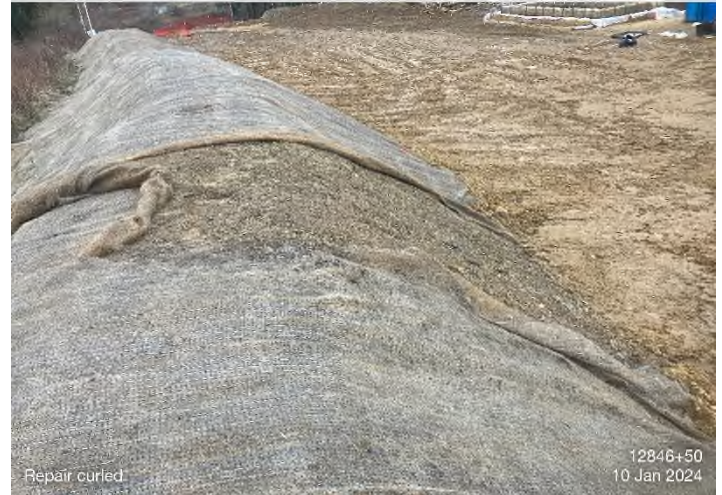
Figure 4: STA 12846+50 – Repair erosion control matting.
