COMPLAINT INVESTIGATION REPORT

Project Name:	Mountain Valley Pipeline	Inspector:	Marshall Willis
Inspection Date:	Wednesday, January 10, 2024	Project Contact:	Brian Clauto, Cory Chalmers
Spread H: Franklin County	STA 13410+00 – 13424+00	Weather:	Wet

Background: This investigation was conducted in response to a complaint (IR#: 312116) submitted to PREP on January 09, 2024. The incident description is "lots of muddy water escaping from ROW" located at "pipeline crossing east side of Cahas Mt. Rd. near apple orchard".

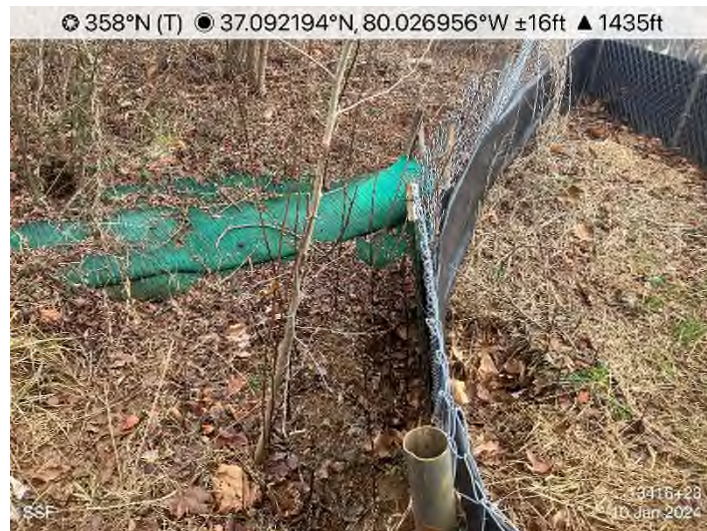
Figure 1: STA 13416+23 – CFS undermined.

- STA 13416+23: Repair undermined SSF.
- STA 13416+23: Retrieve and stabilize sediment discharged off ROW.
- STA 13417+00: CFS clean out needed.
- STA 13417+00: Sump clean out needed.
- STA 13420+00: Stabilize stockpiles and fill slopes.
- STA 13417+00: Repair undermined CFS.
- ATWS 1351: Repair erosion control matting.
- ATWS 1351: Repair CFS.
- ATWS 1351: Repair erosion control matting.
- ATWS 1351: Repair secondary containment.

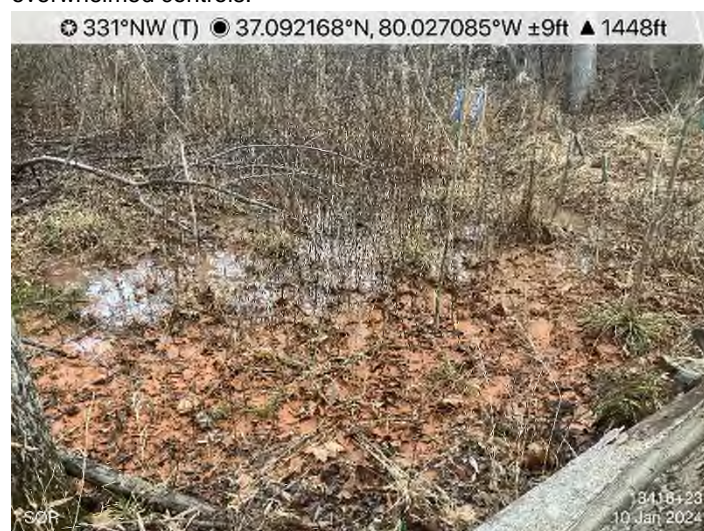
1. West side of Cahas Road is fully restored and is stabilized with erosion control matting.
2. East side of Cahas Mountain Road is under active construction.
3. Several corrective actions were noted during the inspection and are listed below.
4. Sediment was discharged off the ROW at approx. STA 13416+23 due to overwhelmed ECDs.

Figure 2: STA 13416+23 – Sediment discharged off ROW due to overwhelmed controls.

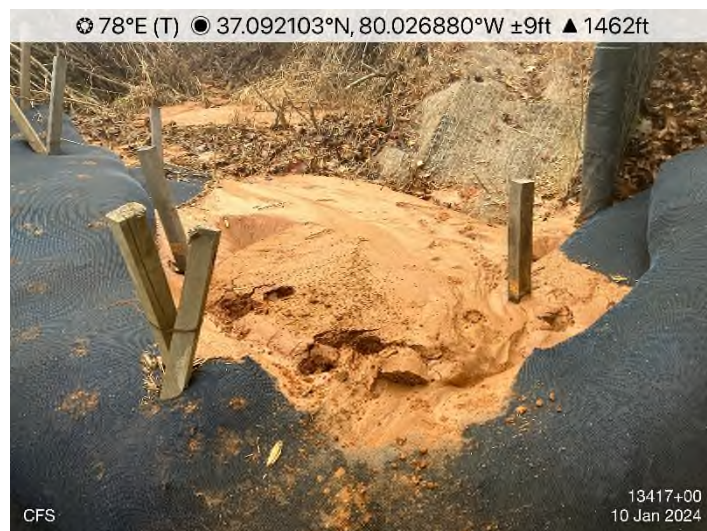
Figure 3: STA 13417+00 – CFS full of sediment.

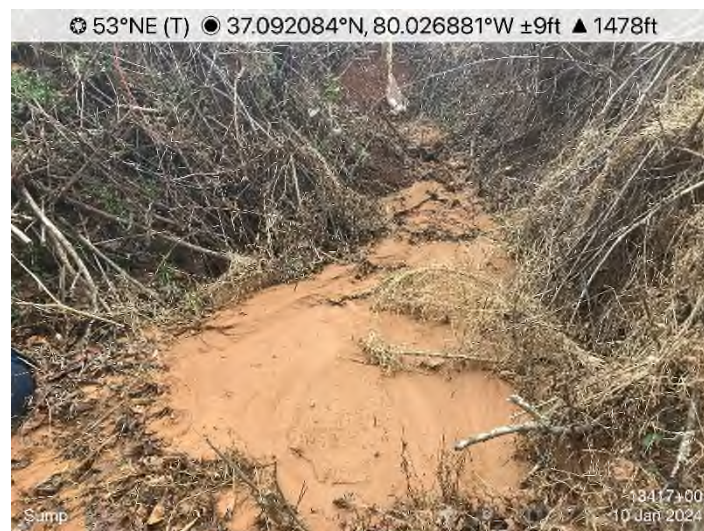
Figure 4: STA 13417+00 – Sump full of sediment.

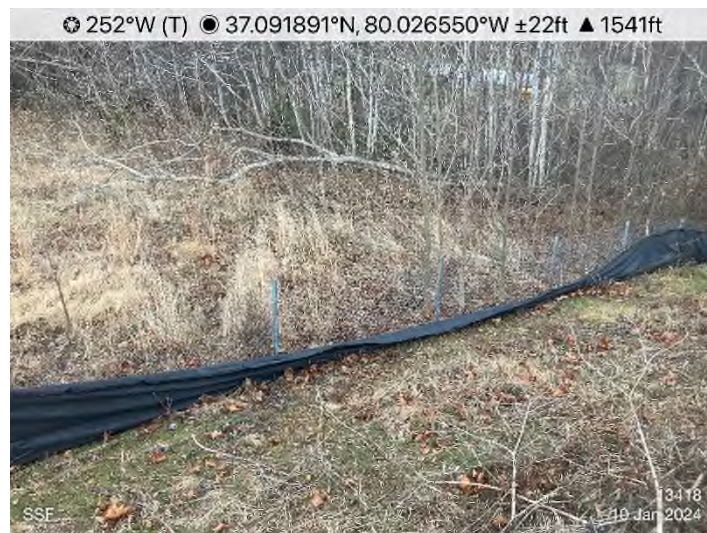
Figure 5: STA 13418+00 – SSF maintenance needed.

- STA 13418+00: SSF maintenance needed.
- STA 13420+68: SSF maintenance needed.

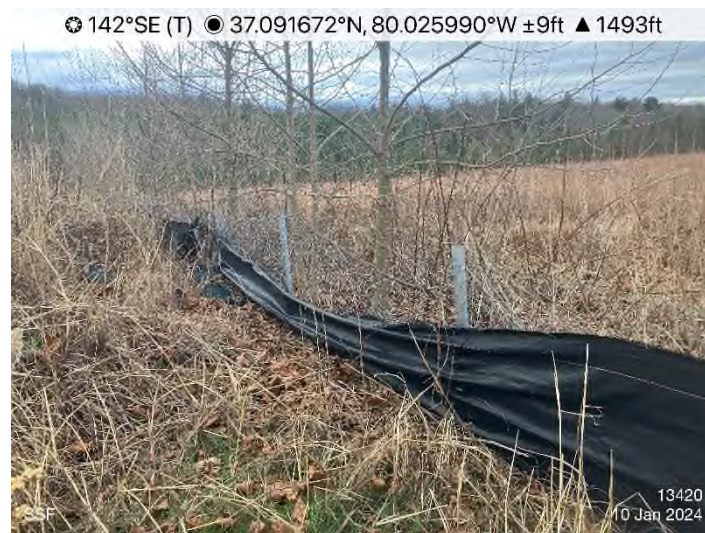
Figure 6: STA 13420+00 – SSF maintenance needed.

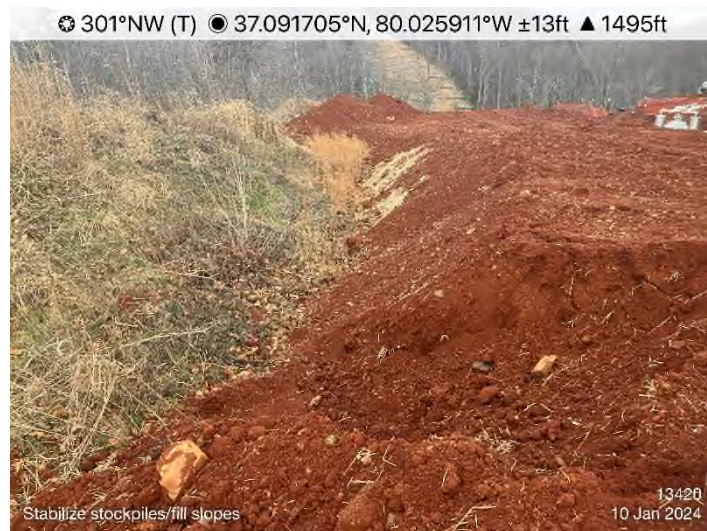
Figure 7: STA 13420+00 – Stabilize stockpiles and fill slopes.

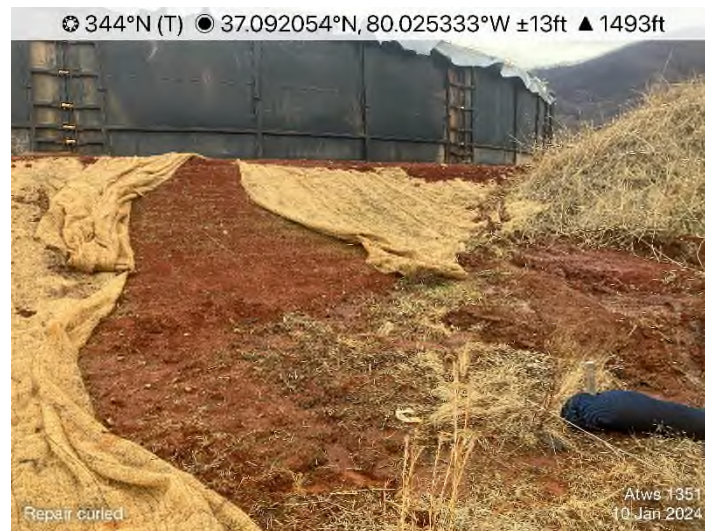
Figure 8: ATWS 1351 – Repair erosion control matting.

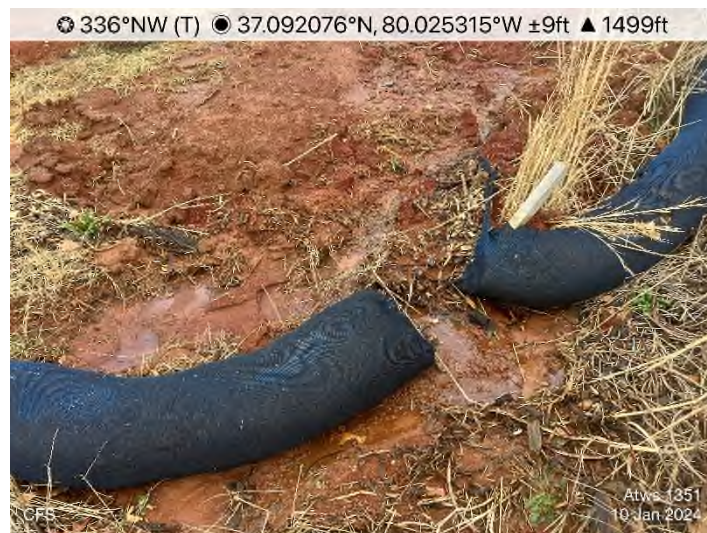
Figure 9: ATWS 1351 – Repair CFS.

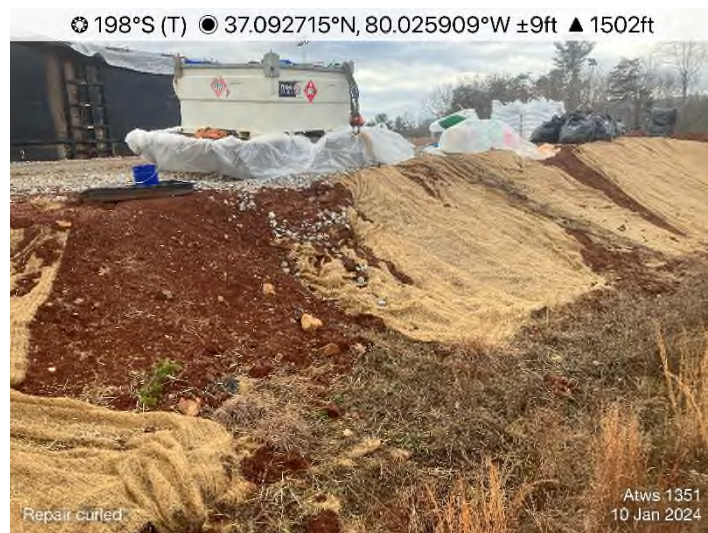
Figure 10: ATWS 1351 – Repair erosion control matting.

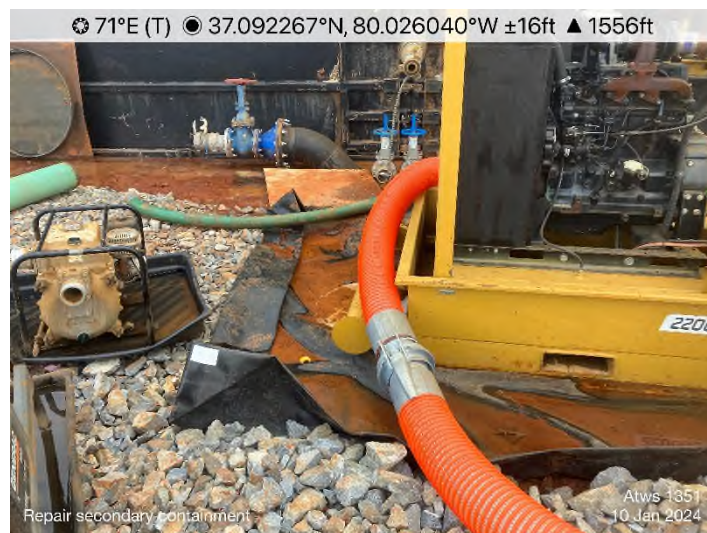
Figure 11: ATWS 1351 – Repair secondary containment.

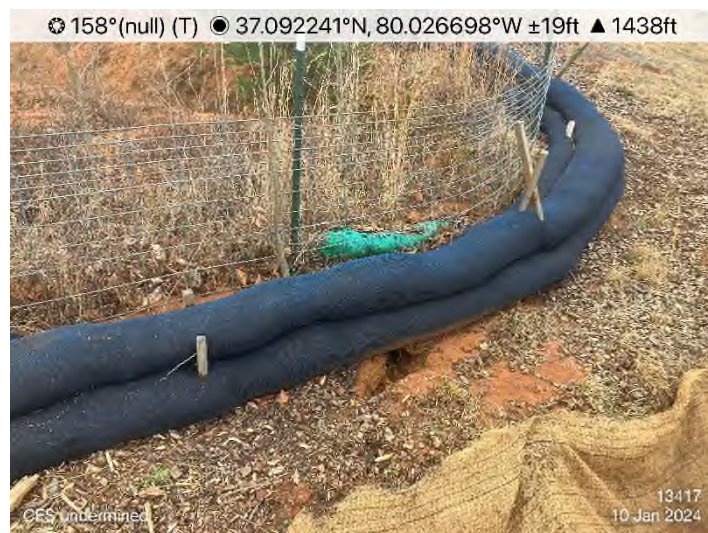
Figure 12: STA 13417+00 – CFS undermined.
