## FIELD INSPECTION REPORT

| Project Name: | Mountain Valley Pipeline | Inspector: | Marshall Willis |
| Inspection Date: | Friday, January 26, 2024 | Project Contact: | Brian Clauto, Cory Chalmers |

## FIELD INSPECTION PHOTO LOG

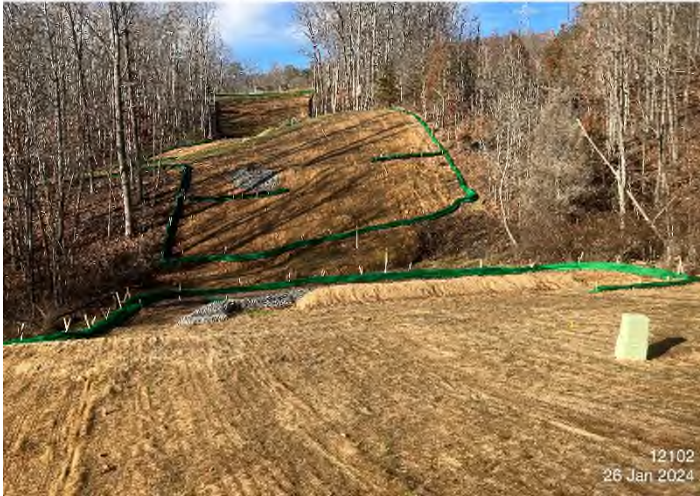
**Figure 1: STA 12102+00** – Controls in place and functioning properly.

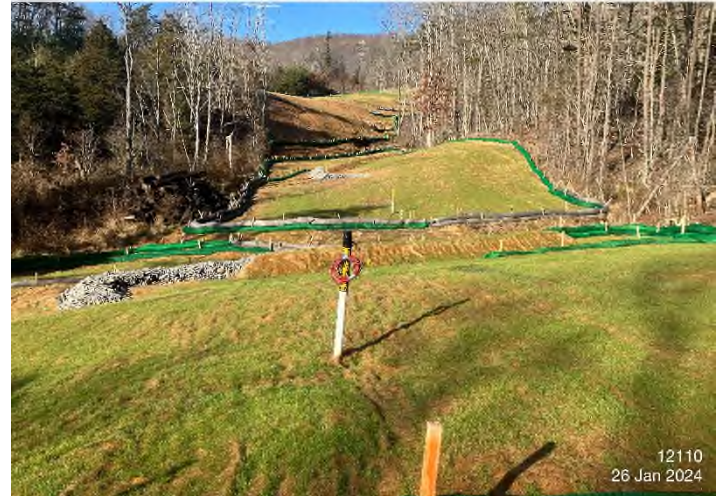
**Figure 2: STA 12110+00** – Controls in place and functioning properly.

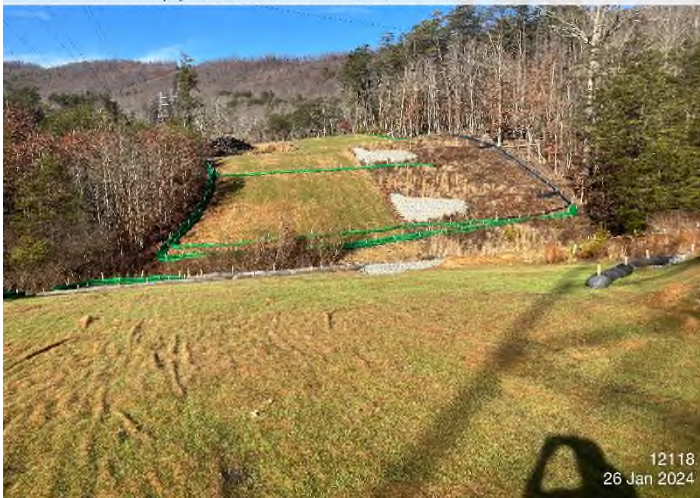
**Figure 3: STA 12118+00** – Controls in place and functioning properly.

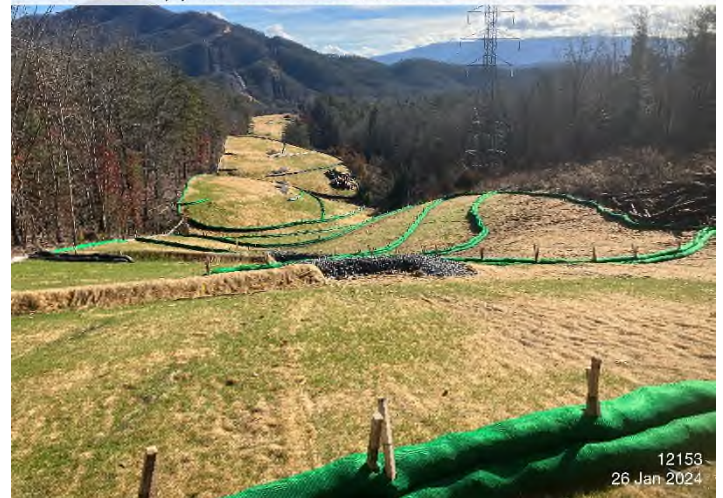
**Figure 4: STA 12153+00** – Controls in place and functioning properly.
