FIELD INSPECTION REPORT

Project Name:	Mountain Valley Pipeline	Inspector:	Marshall Willis
Inspection Date:	Thursday, January 25, 2024	Project Contact:	Brian Clauto, Cory Chalmers
Spread I: Pittsylvania County	MVP-PI-337 Spot Check (Toshes to Hwy 29)	Weather:	Rainy

FIELD INSPECTION PHOTO LOG

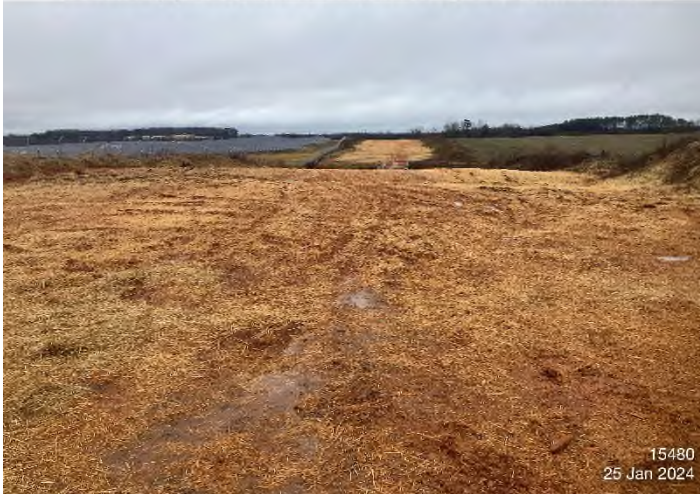
Figure 1: STA 15480+00 – Controls in place and functioning properly.

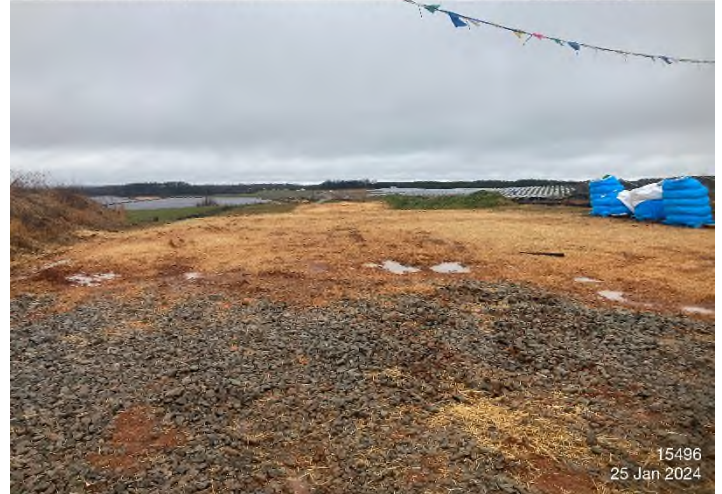
Figure 2: STA 15496+00 – Controls in place and functioning properly.

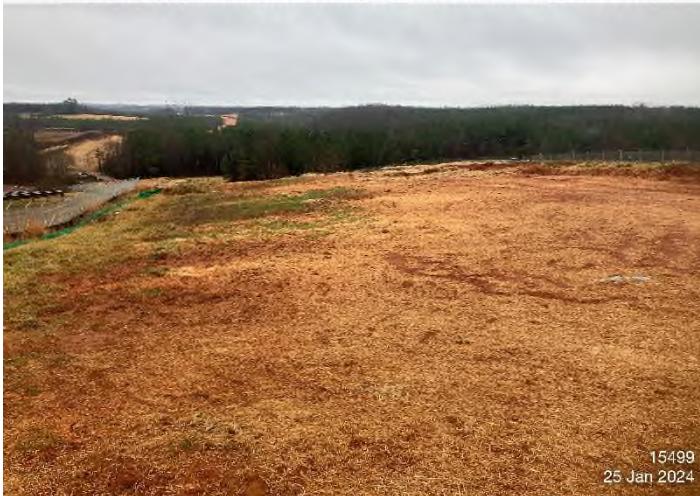
Figure 3: STA 15499+00 – Controls in place and functioning properly.
