## FIELD INSPECTION REPORT

| Project Name: | Mountain Valley Pipeline | Inspector: | Marshall Willis |
| Spread I:<br>Franklin County | STA 14233+00 – 14250+00<br>MVP-MLV-AR-32 | Weather: | Wet |

## FIELD INSPECTION PHOTO LOG

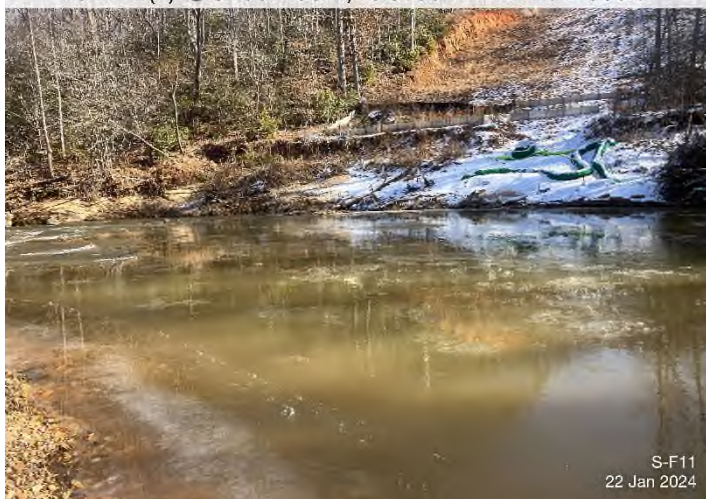
**Figure 1: Stream S-F11** – Controls in place and functioning properly.

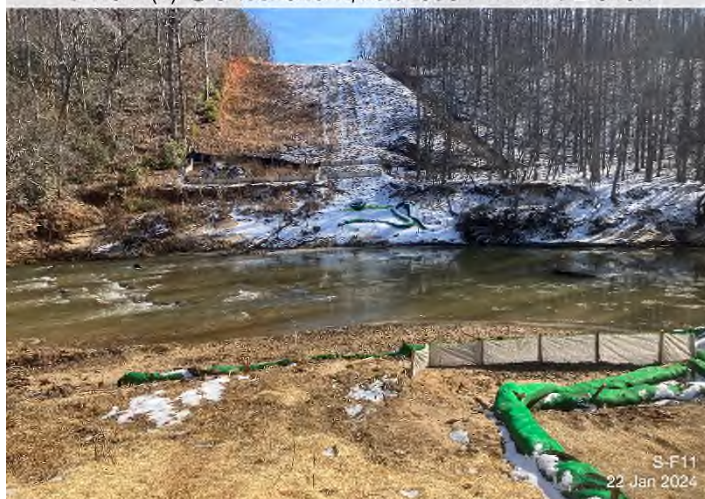
**Figure 2: Stream S-F11** – Controls in place and functioning properly.

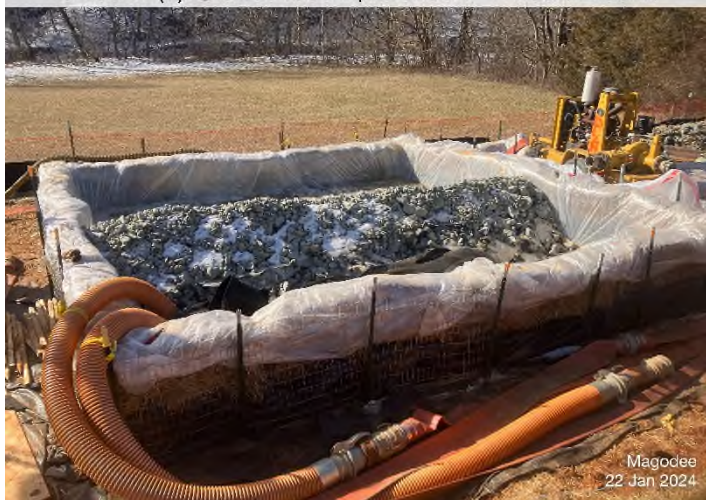
**Figure 3: Stream S-C19** – Controls in place and functioning properly.

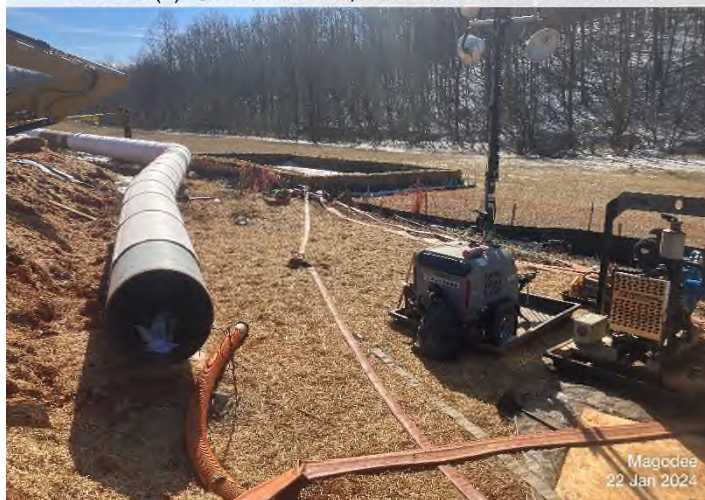
**Figure 4: Stream S-C19** – Controls in place and functioning properly.
