## FIELD INSPECTION REPORT

| <b>Project Name:</b> | Mountain Valley Pipeline | <b>Inspector:</b> | Marshall Willis |

## FIELD INSPECTION PHOTO LOG

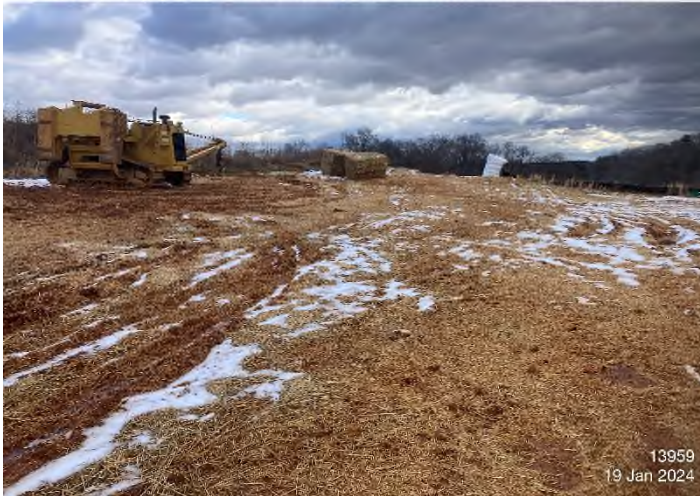
**Figure 1: STA 13959+00** – Controls in place and functioning properly.

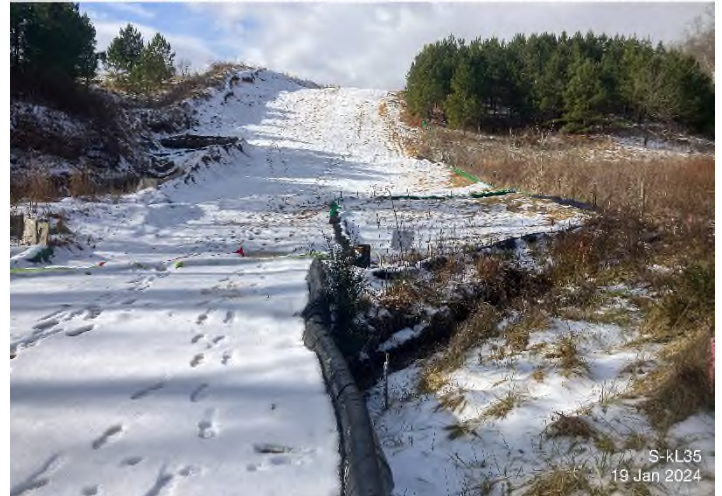
**Figure 2: Stream S-KL35** – Controls in place and functioning properly.

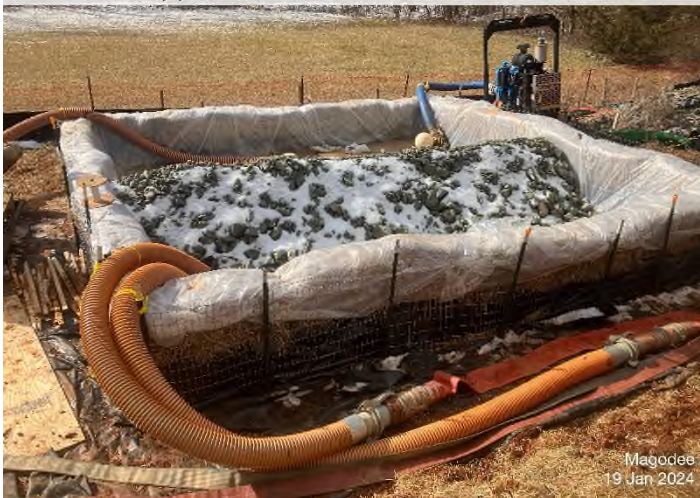
**Figure 3: Stream S-C19** – Controls in place and functioning properly.

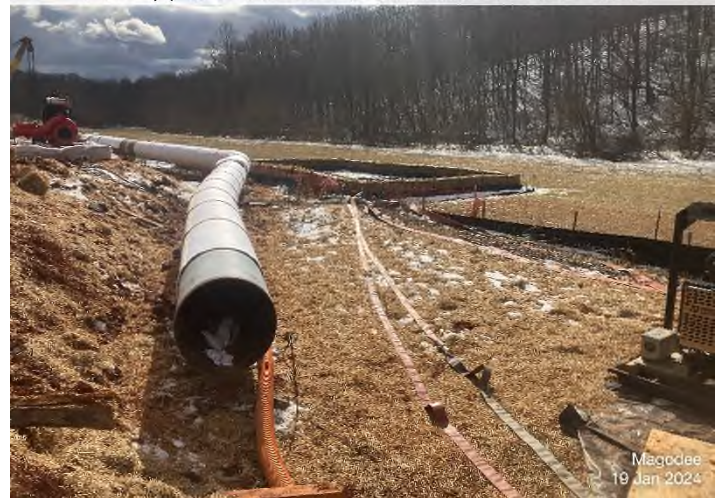
**Figure 4: Stream S-C19** – Controls in place and functioning properly.
