## FIELD INSPECTION REPORT

| Project Name: | Mountain Valley Pipeline | Inspector: | Marshall Willis |
| Inspection Date: | Wednesday, January 17, 2024 | Project Contact: | Brian Clauto, Cory Chalmers |
| Spread I:<br>Franklin County | STA 13680+00 – 13710+10<br>STA 14233+00 – 14240+00<br>MVP-MLV-AR-32 | Weather: | Snow |

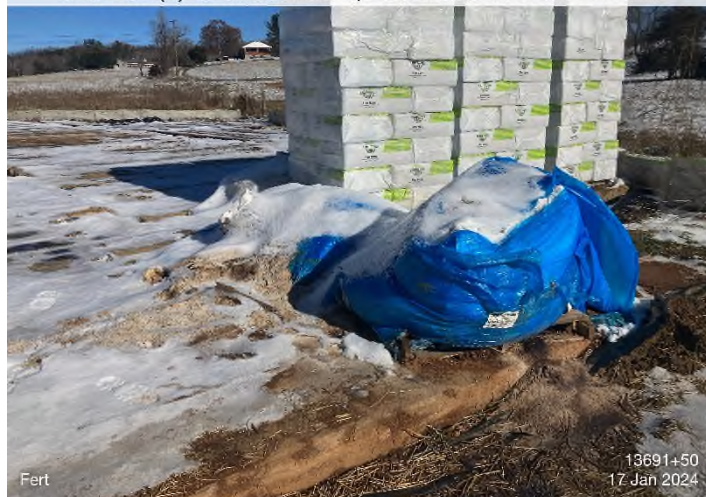
**Figure 1: STA 13691+00** – Clean up spilled fertilizer and properly store.

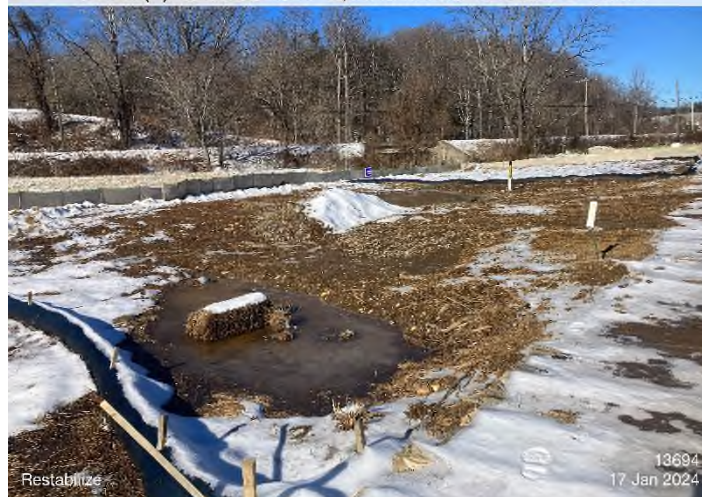
**Figure 2: STA 13694+00** – Restabilize denuded area.

- STA 13694+00 to 14354+00: Restabilize denuded area.

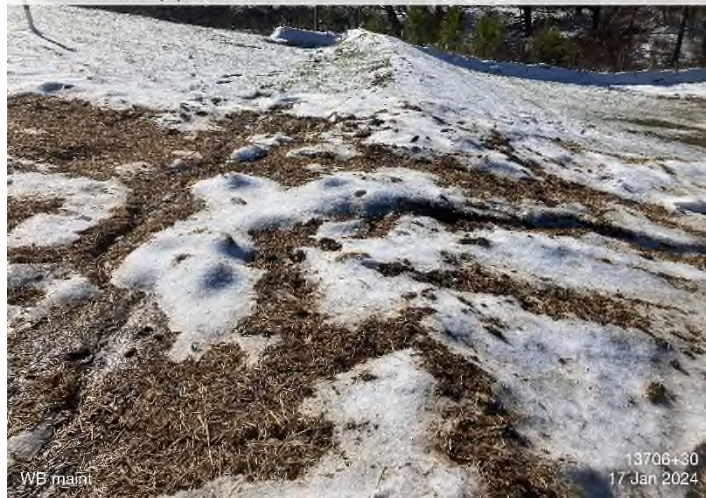
**Figure 3: STA 12706+30** – Waterbar topped and needs maintenance.

- STA 13691+00: Clean up spilled fertilizer and properly store.
- STA 13706+30: Waterbar topped, needs maintenance. Repair and restabilize erosion.

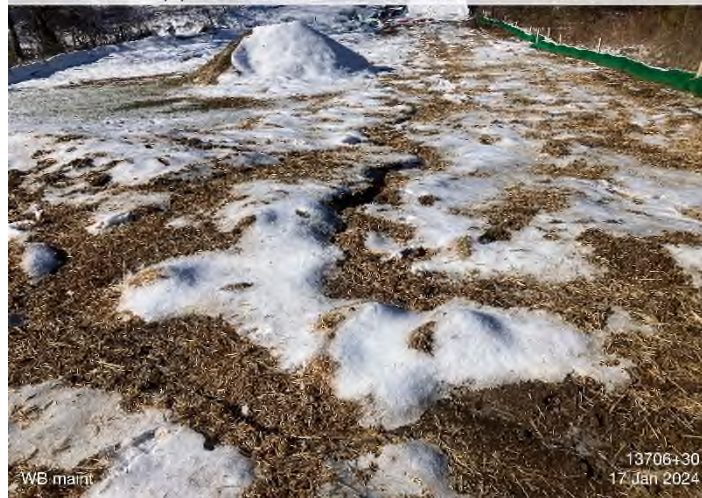
**Figure 4: STA 12706+30** – Repair/restabilize erosion.
