FIELD INSPECTION REPORT

Project Name:	Mountain Valley Pipeline	Inspector:	Marshall Willis
Inspection Date:	Friday, February 2, 2024	Project Contact:	Brian Clauto, Cory Chalmers
Spread H: Montgomery County Roanoke County	MVP-MN-268 MVP-MN268.01 MVP-RO-278.01 STA 12030+00 – 12033+00 STA 12543+00 – 12546+00	Weather:	Wet

FIELD INSPECTION PHOTO LOG

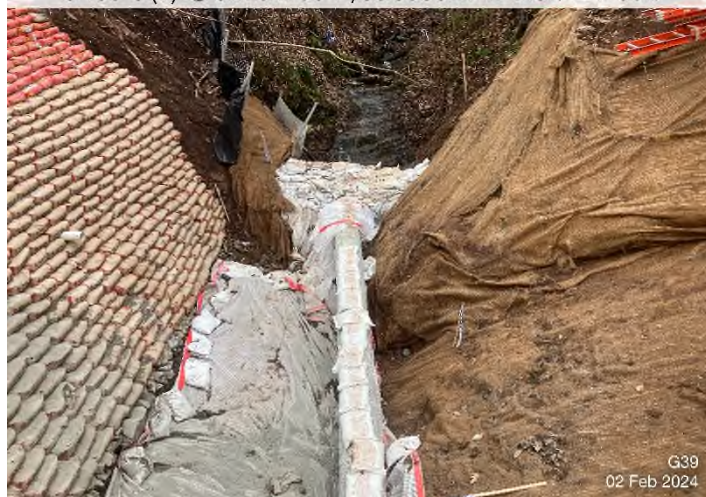
Figure 1: Stream S-G39 – Controls in place and functioning properly.

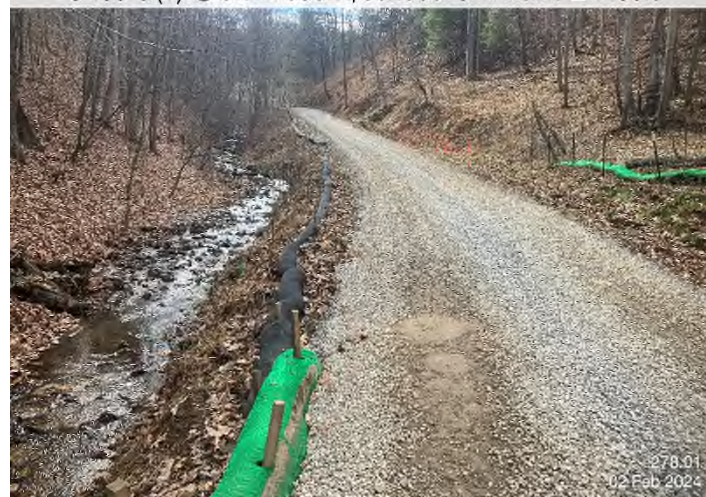
Figure 2: MVP-RO-278.01 – Controls in place and functioning properly.

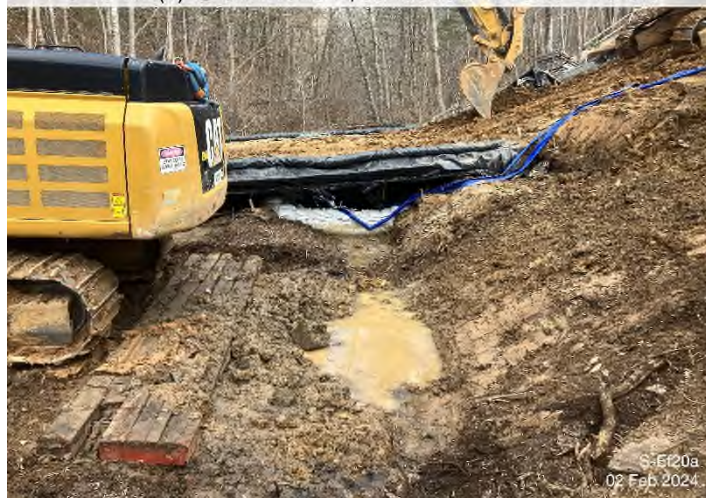
Figure 3: Stream S-EF20a – Controls in place and functioning properly.

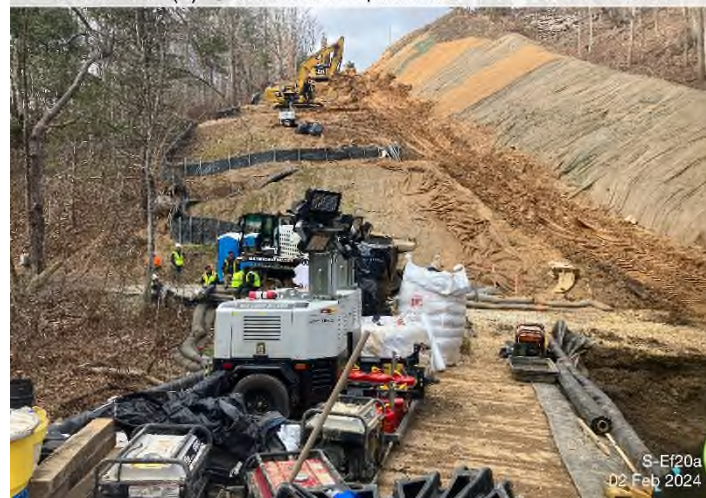
Figure 4: Stream S-EF20a – Controls in place and functioning properly.
